Condition Assessment and Rehabilitation Plan Hangar One

for NASA Headquarters and
Ames Research Center, California

Volume 1
Condition Assessment

Hangar One – Ames Research Center, Moffett Field, CA

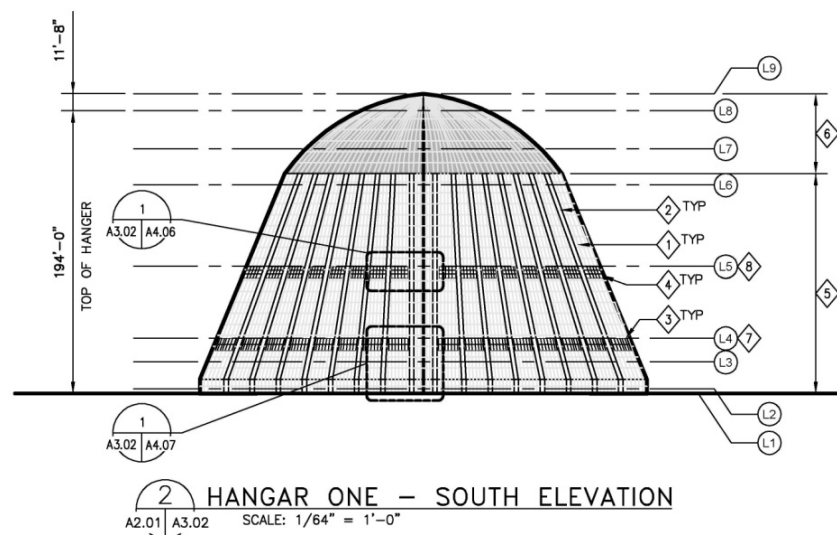
Figure 2.11

Large “clam shell” or “orange peel” hangar doors are located at both the north and south ends of the hangar structure. Each half-dome shaped hangar door has two independent leaves and operate by running on steel-wheeled travelers that are set on tracks. 150 horsepower, electric motors operate the travelers to retract the hangar door panels to their open position. As designed each leaf of the hangar doors traveled approximately 12 feet per minute and took approximately 12 minutes to fully open or close.

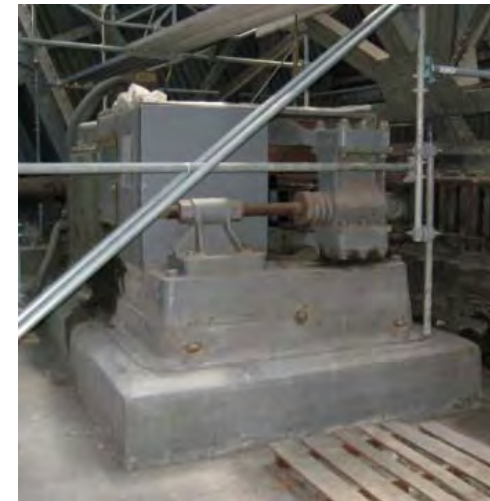
Figure 2.12

There are four individual motors that operate the hangar doors – one motor for each door leaf. The south hangar doors were last known to be operational in 2001 according to the Page & Turnbull Condition Matrix (see Appendix B) but have not been operated since. Additionally, at this time only three of the four motors are known to be operational. The non-working motor is located on the north hangar door. The last known operational date for the north hangar doors is not known. Each motor is located on top of a concrete curb, inside the hangar. They are located on either side of the hangar door openings. Of the three remaining operational hangar door motors it is expected that each will require maintenance and cleaning in order to become fully functional in the future. The missing motor will need to be replaced, or located, refurbished, and re-installed.

There are two dog houses at the top of the hangar that contain mechanisms for the hangar doors. These mechanisms have leaked oil over time. As part of the Navy removal action the oil has been drained and the dog houses cleaned. Some items may not be able to be thoroughly cleaned due to inability to completely disassemble some pieces or difficult locations of equipment.

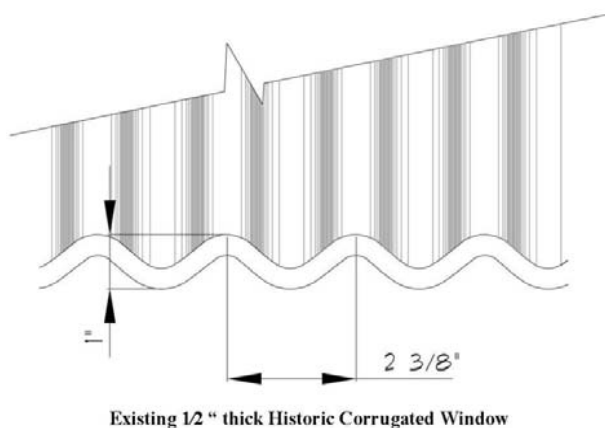
Figure 2.20

The corrugated windows represent one of the important features contributing to the historic value of the exterior of the hangar. Chicken wire panels with wooden frames have been installed at the interior of the windows (see figure 2.21) in isolated locations in order to minimize the potential for broken pieces of the glass to fall to the hangar floor below.

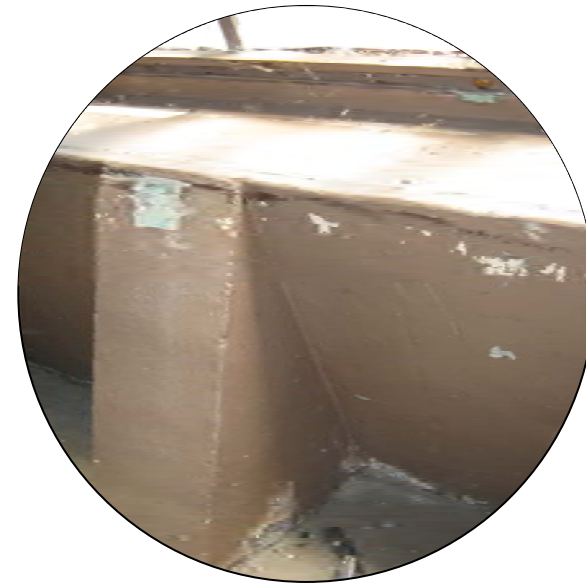
Figure 3-16: Concrete Wall at Hangar Perimeter, From Inside

The concrete perimeter walls also appear to be in good condition. No concrete decay was noted during the site visit. The new doors in the hangar wall were saw cut through the concrete. The saw cut portion may need to be replaced for historical reasons.

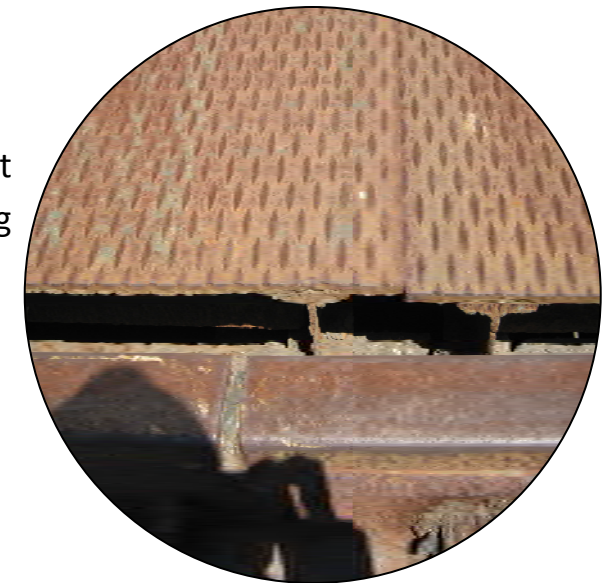
Figure 3-28: Repair Pit at Hangar Exterior Showing Corrosion

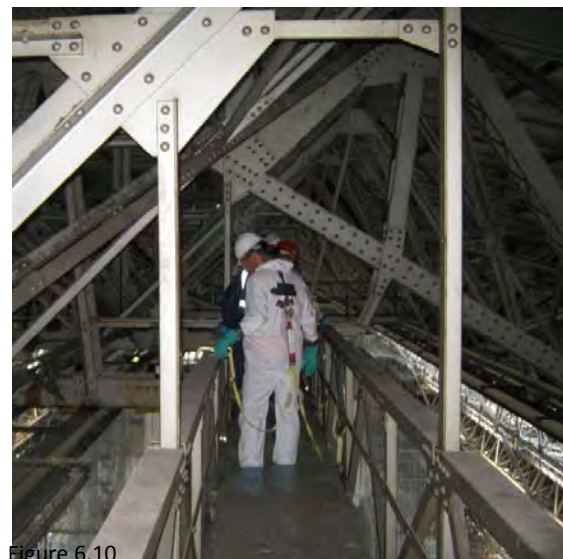
Figure 6.10

The catwalk guardrails, as originally designed, were installed at a height of 38" above the deck elevation. Current code requires a guardrail height of 42". This four inch height increase must be achieved either by retrofitting a new (visually different) guardrail extension to the top angle, or by lowering the deck
