## **Appendix F**

### **Photographs**

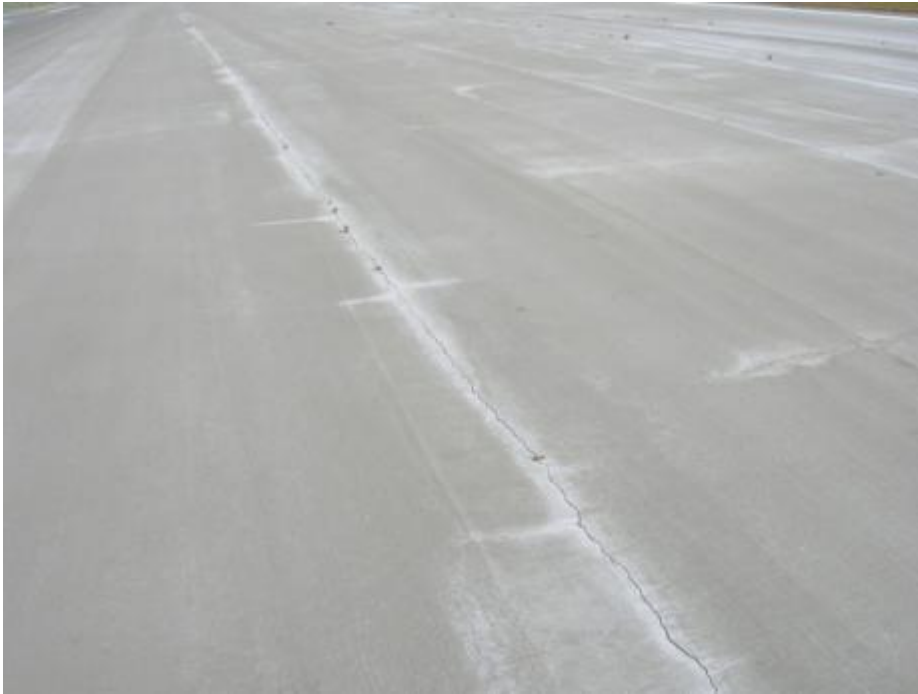
Photo 1. Runway 14R, Sections R06A and R07A, Polymer Concrete Micro-Overlay. Staining at crack.

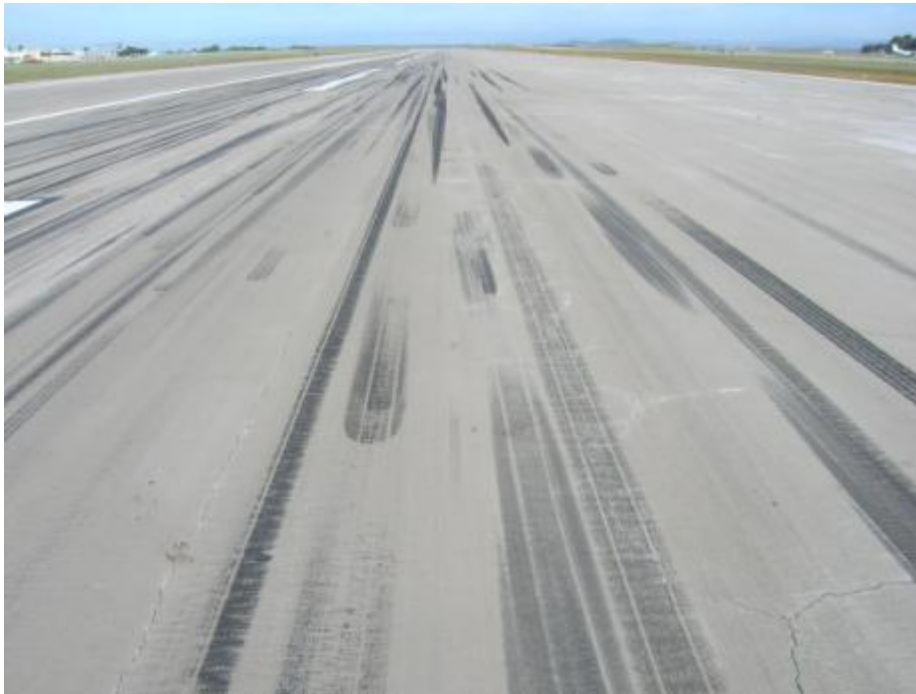
Photo 2. Runway 14R, Sections R06A and R07A, Polymer Concrete Micro-Overlay, Cracking.

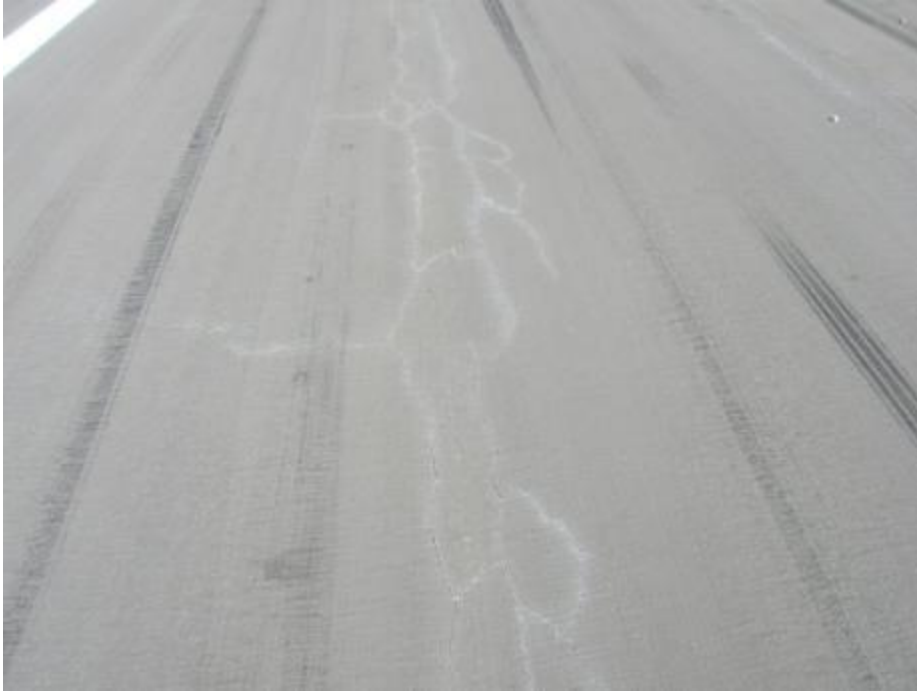
Photo 3. Runway 14R, Sections R06A and R07A, Polymer Concrete Micro-Overlay. Cracking.

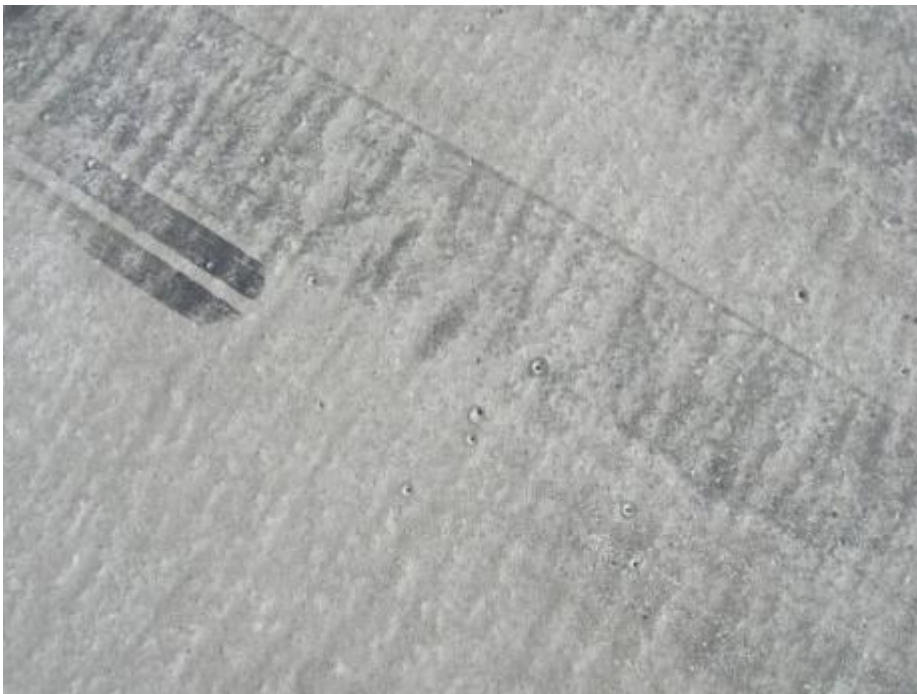
Photo 4. Runway 14R, Section R06A, Polymer Concrete Micro-Overlay, Surface Finishing .

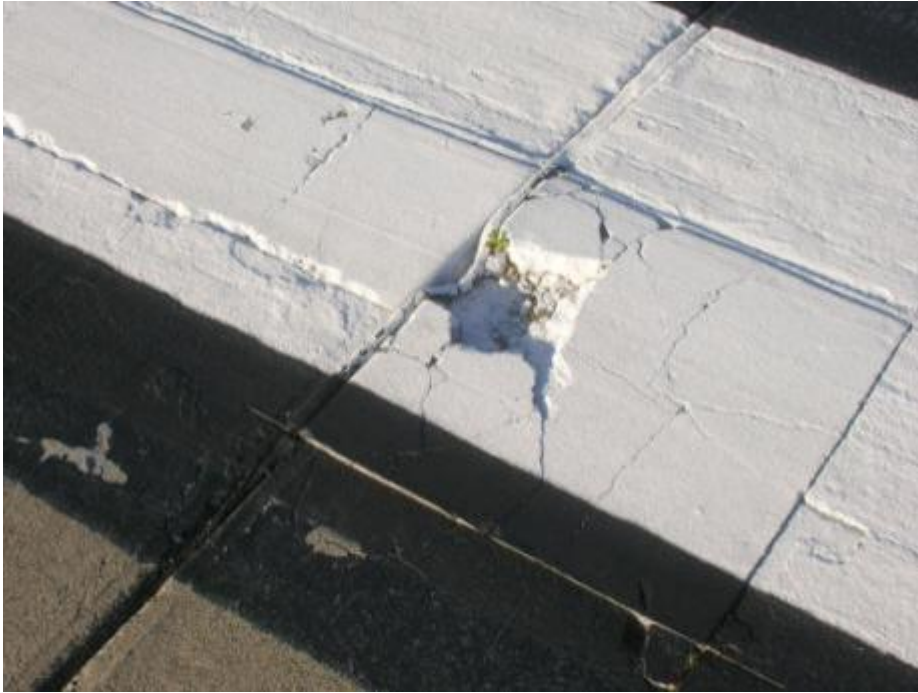
Photo 5. Runway 14L, Section R01A, Sample unit 25, High Severity Small Patch.

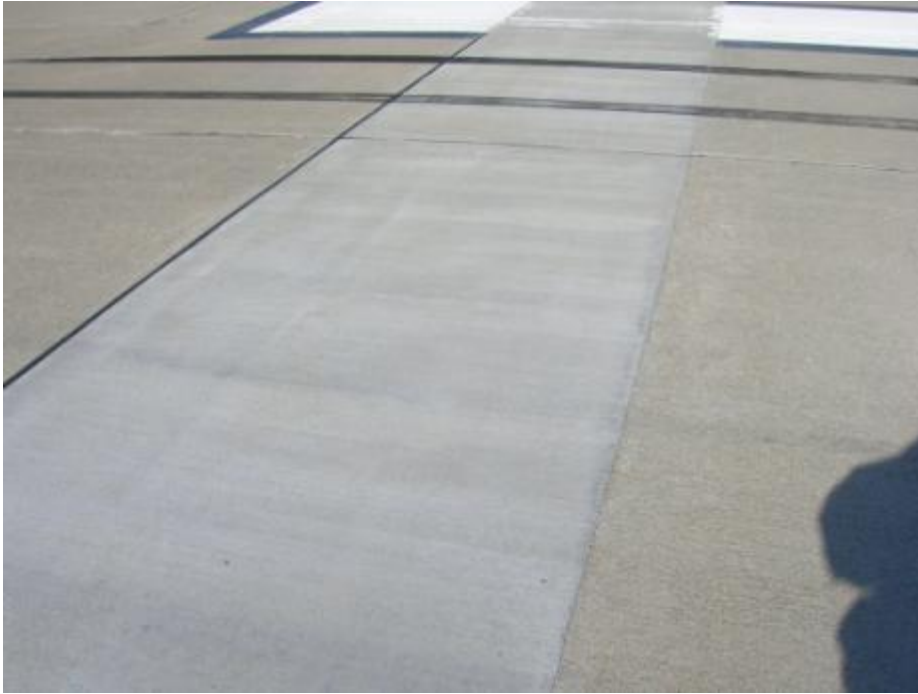
Photo 7. Runway 14L, Section R03C, Low Severity Large Patch.

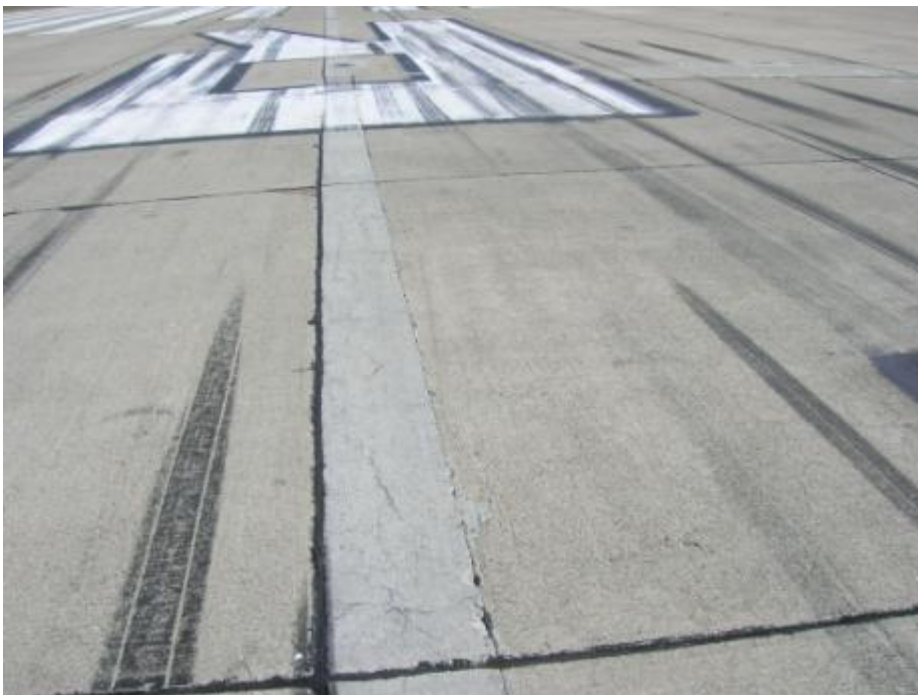
Photo 8. Runway 14L, Section R04A, Medium Severity Large Patch

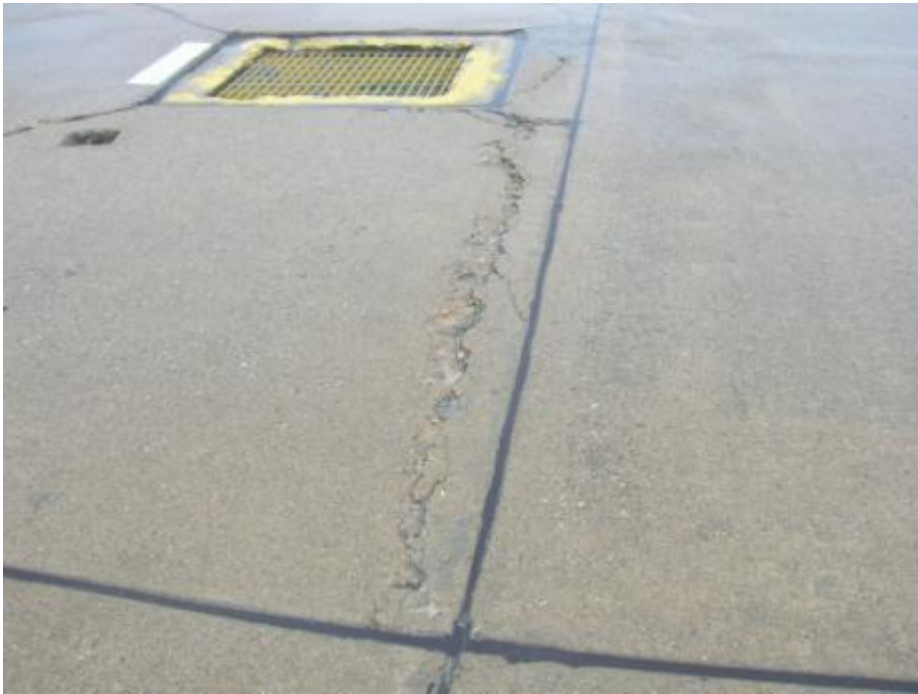
Photo 9. West Apron, Section A20B, High Severity Linear Transverse Diagonal Cracking.

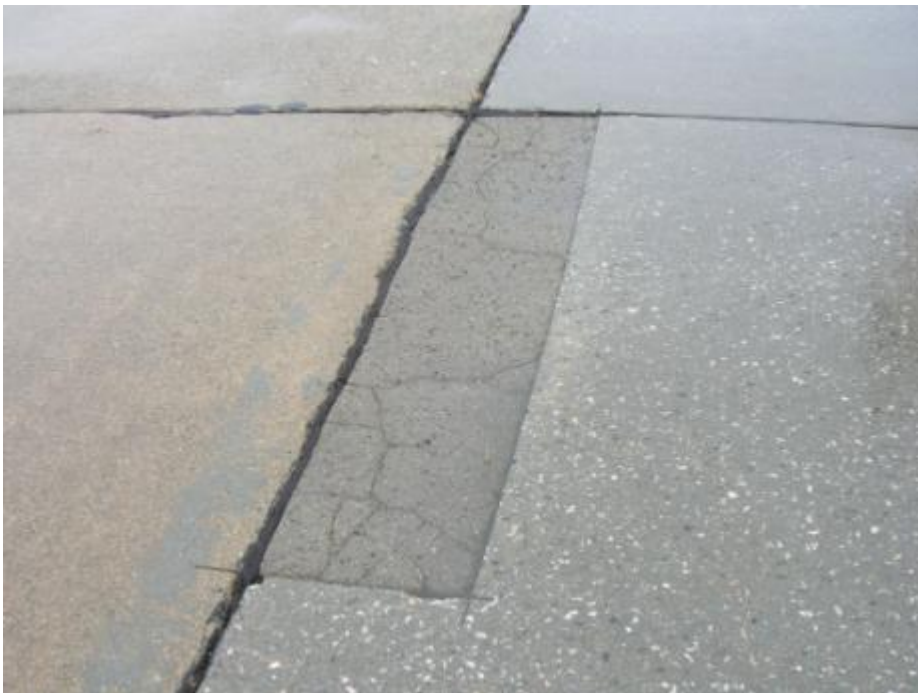
Photo 10. West Apron, Section A22B, Medium Severity Large Patch.

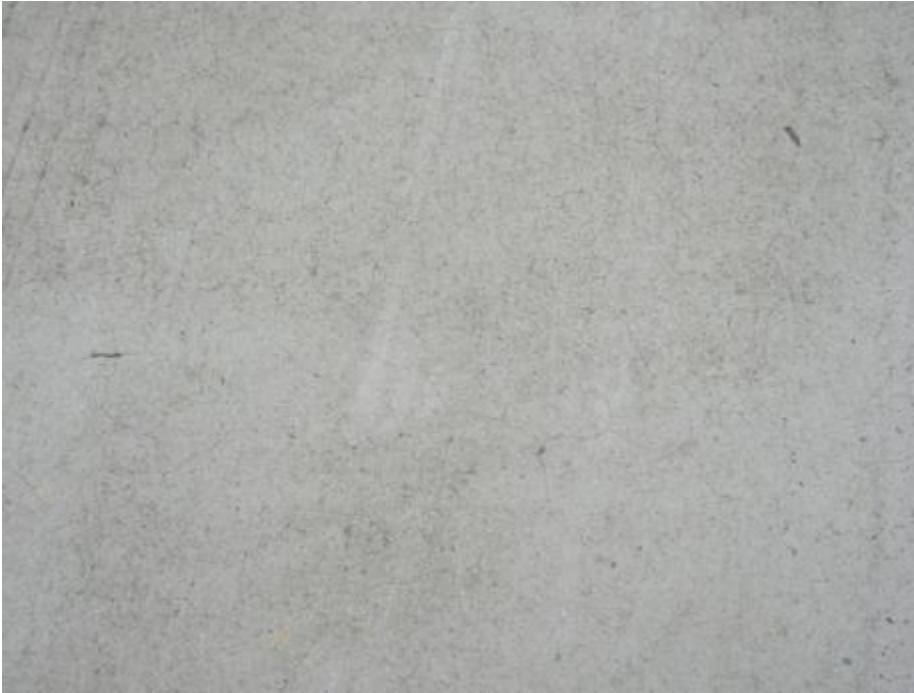
Photo 11. West Apron, Section A22B, Low Severity Scaling/Map Crazing.

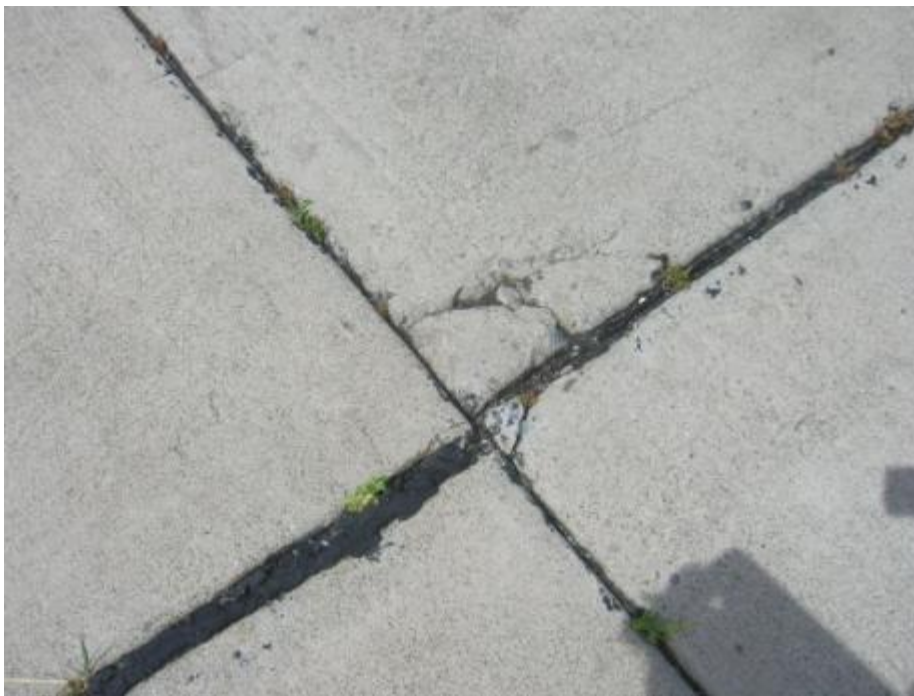
Photo 12. Taxiway AA, Section T12A, Medium Severity Corner Spall and High Severity Joint Seal Damage.

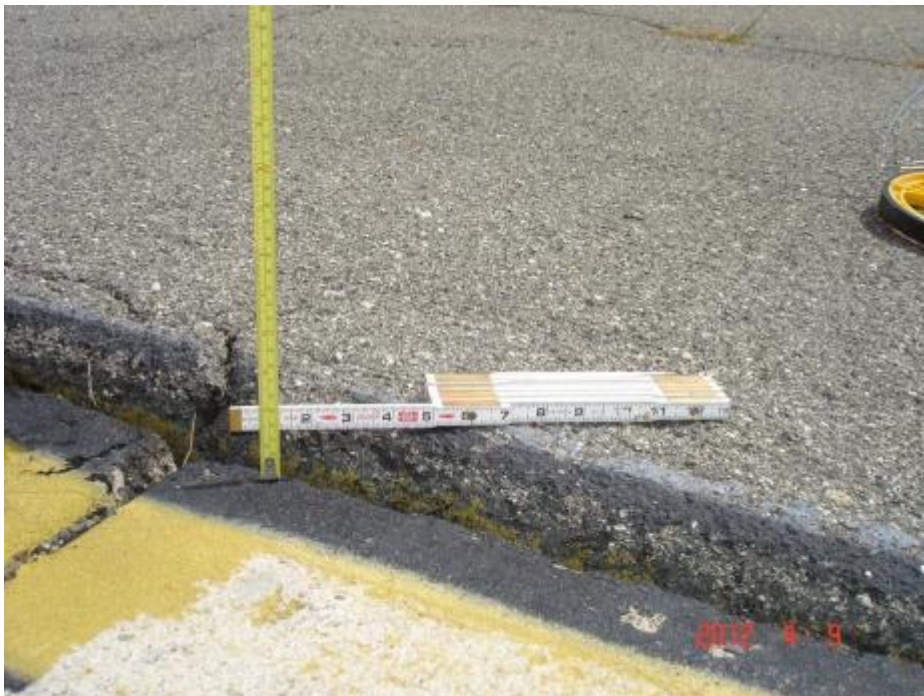
Photo 13. Runway 32L, Section R11A, wide joint between AC and PCC.

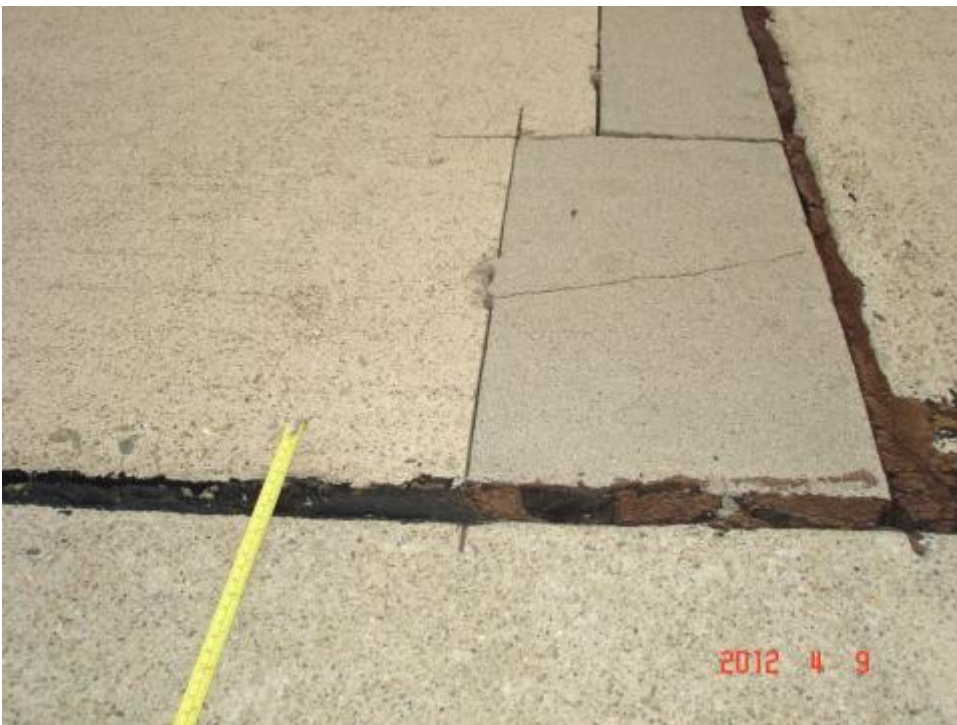
Photo 14. Runway 32L, Section R11A, wide joint opening recommended for repair.

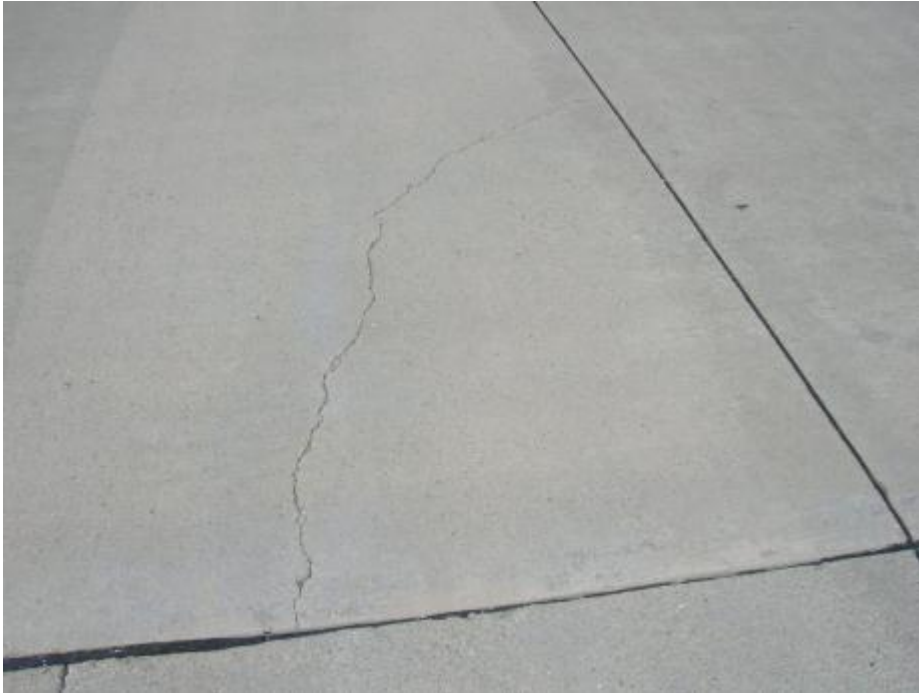
Photo 15. Taxiway B, Section T21C, Low Severity Corner Break.

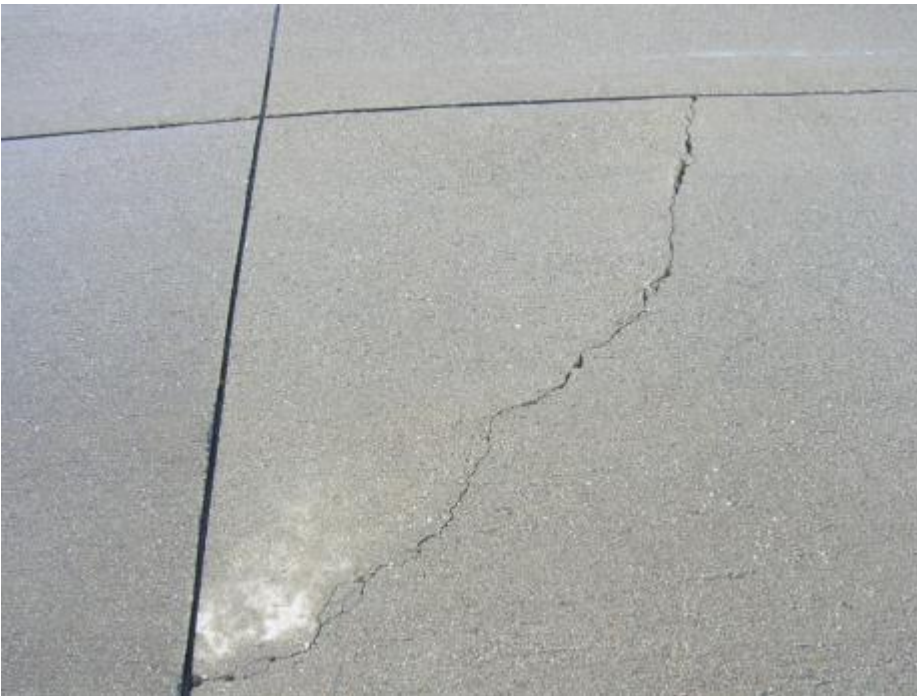
Photo 16. Taxiway A, Section T20C, Medium Severity Corner Break.

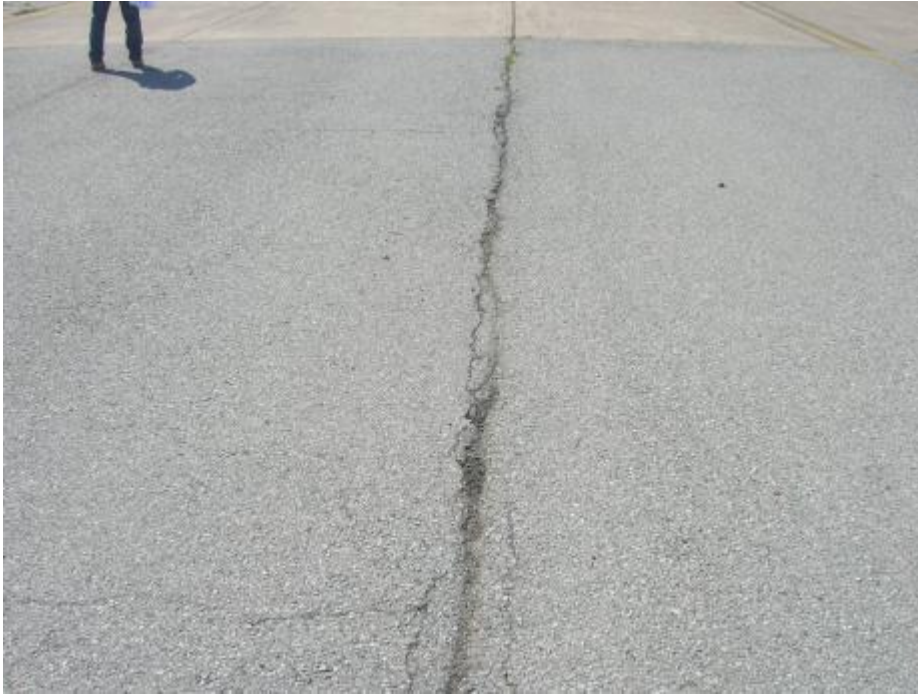
Photo 17. East Taxiway, Section T02A, Low to High Severity Linear Cracking.

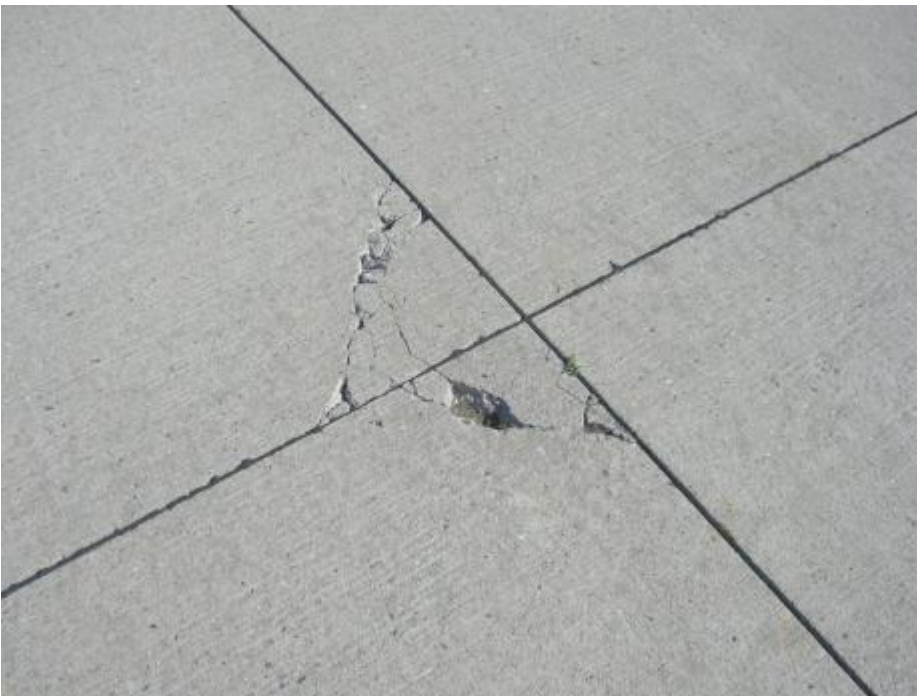
Photo 18. East Taxiway, Section T04A, High Severity Corner Spall.

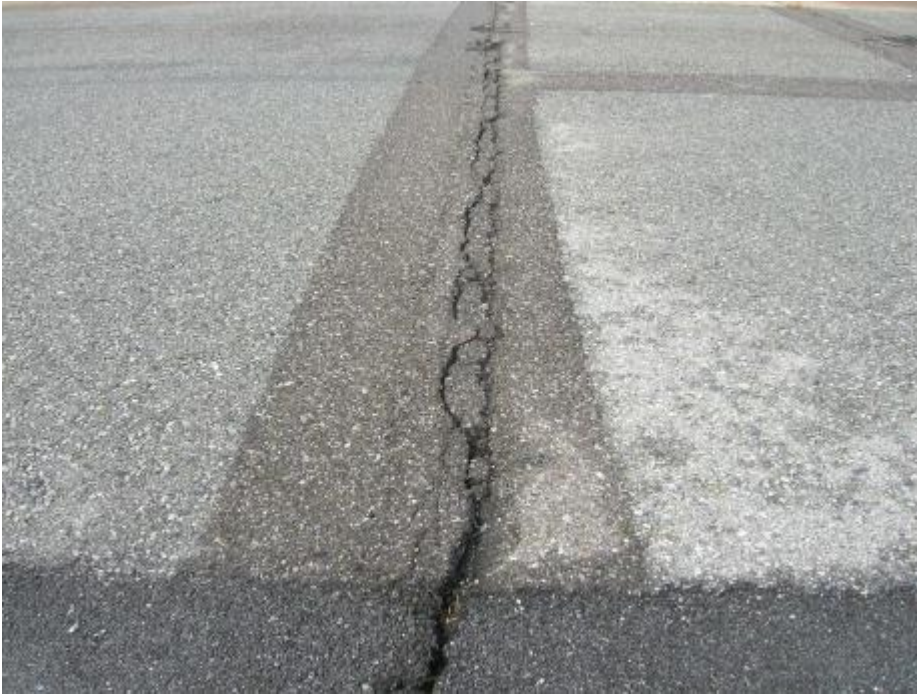
Photo 19. West Taxiway, Section T17A, Medium to High Linear Cracking.

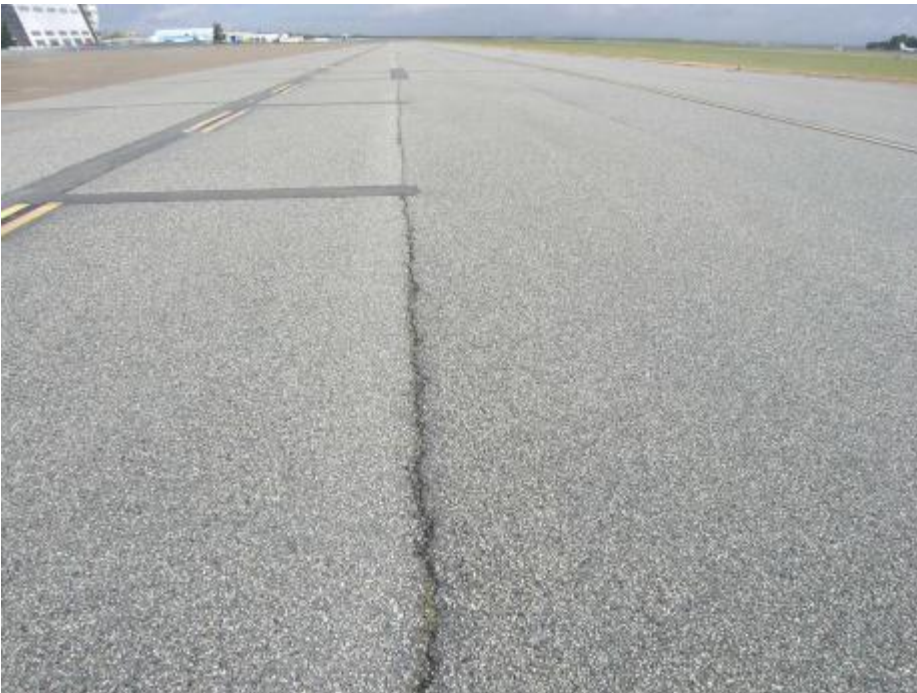
Photo 20. West Taxiway, Section T17A, Low to Medium Linear Cracking.
