**U.S. Naval Air Station Moffett Field**  
**Building 20 Re-Use Guidelines**  
Final

Moffett Federal Air Field, California  
.....

October 2000

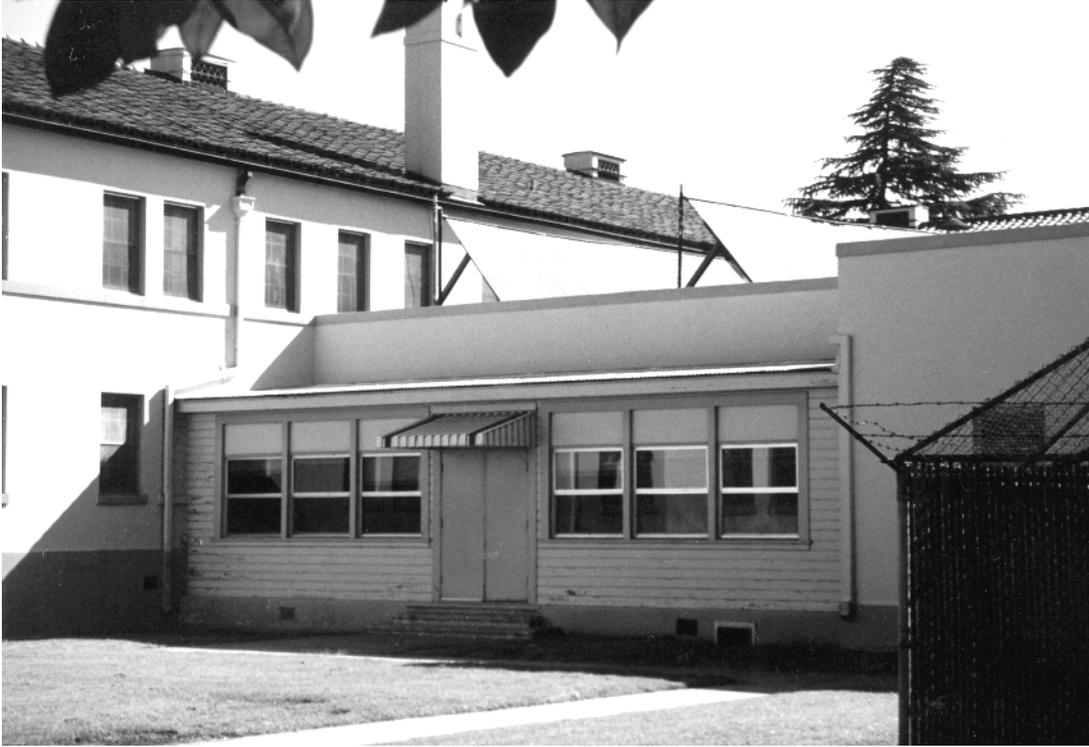
Exterior View of Non-contributing Porch Enclosure (west)  
Building 20  
Moffett Field

If modifications are made to the building, the following are seen as non-contributing elements which could be removed: the additions at terraces #2 and #3, the small one story additions at the kitchen and court #1, and the porch covering in court #1.

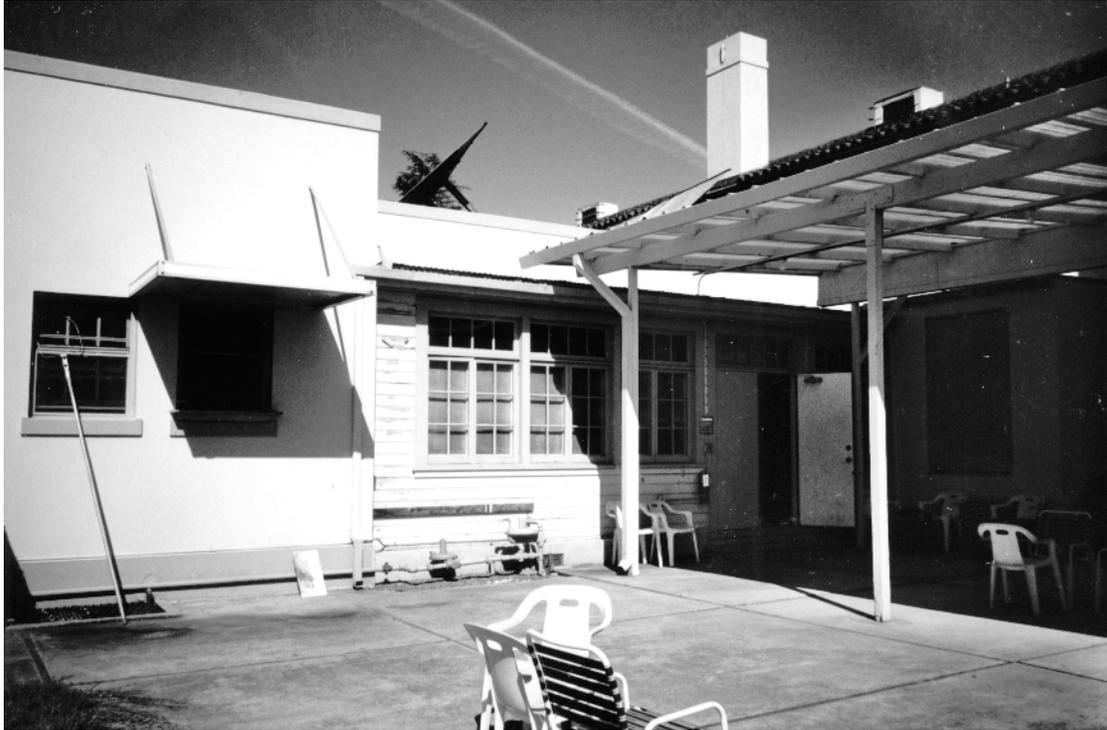
Exterior View of Non-contributing Porch Enclosure (east)  
Building 20  
Moffett Field

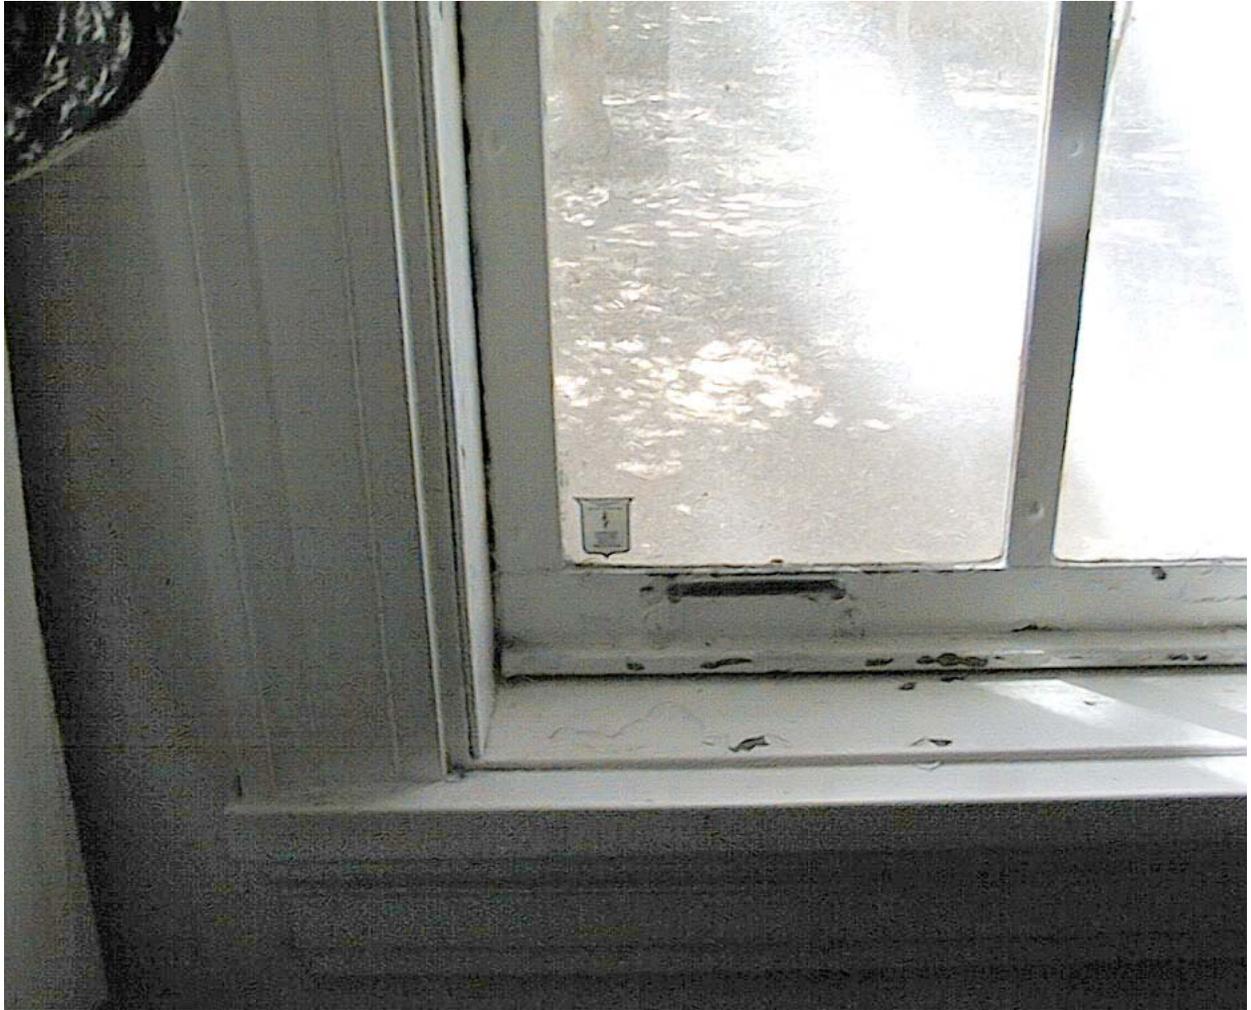
Detail of Double Hung Metal Windows  
Building 20  
Moffett Field

As a historic building, Building 20 is exempt from the energy code, however, measures to reduce energy consumption and provide for user comfort are recommended. These may include ceiling insulation, attic insulation, and exterior wall insulation where the walls are opened during construction. The existing steel sash windows are historic features and they should be repaired and weather-stripped rather than replaced.

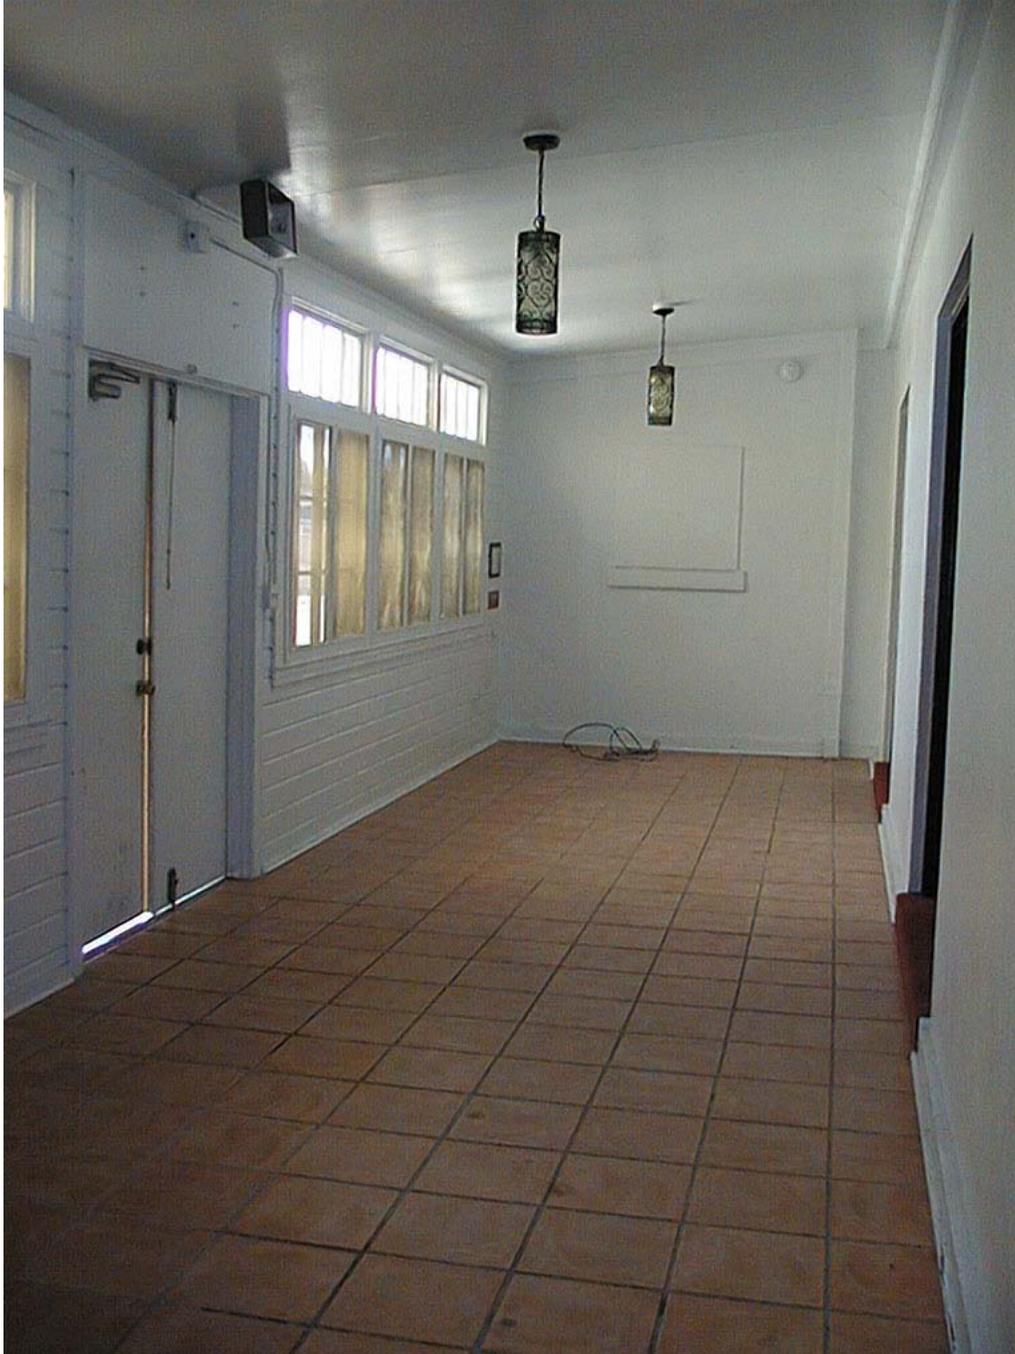
Non-contributing Porch Enclosure  
Building 20  
Moffett Field

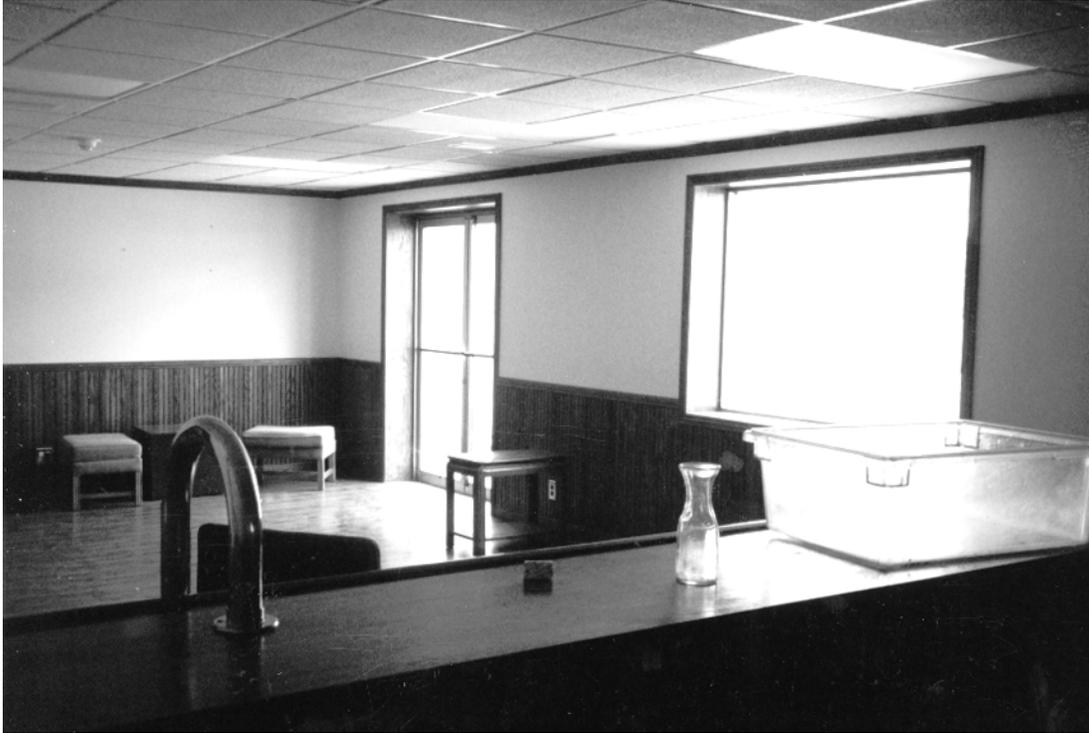
The greatest level of change has occurred to the spaces closest to the entrance lobby. The Reading and Captain's Rooms to the northwest of the lobby have had a significant level of alteration. Walls have been removed, new walls have been constructed, and finishes have been concealed. The area which has seen the greatest level of change are the three bedrooms to the south east of the lobby. In this area of the building, walls that once separated bedrooms have been removed. A suspended acoustical ceiling and faux-wood flooring have been installed and furring out of the existing walls has occurred.

Non-contributing Alterations - First Floor East of Lobby  
Building 20  
Moffett Field

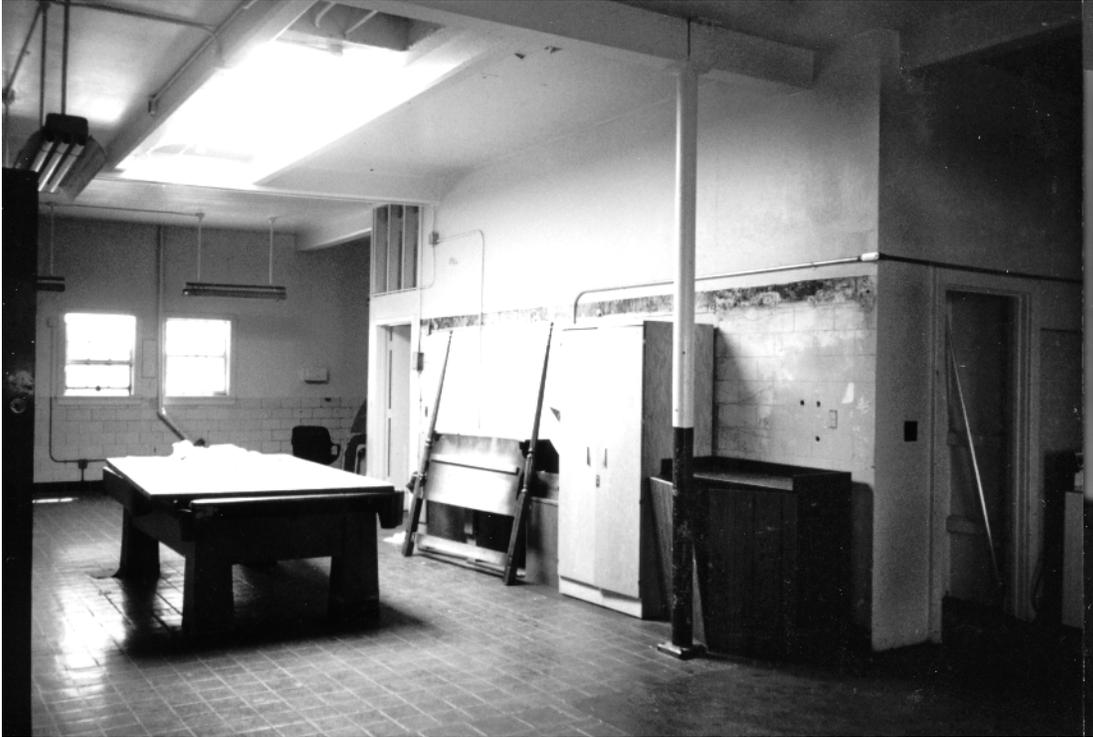
Kitchen  
Building 20  
Moffett Field

Spatially, the building remains almost completely true to its original form. The original progression of space from public to private is unchanged. The public spaces are still understood, as they were intended to be, as the core of the building. Alterations that have occurred have been minor. Most of the original finishes and features described above remain intact although throughout the building the historic flooring has been concealed under carpeting, the historic light fixtures in the central east/west corridor have been replaced, and some of the wall tiles in the kitchen have been damaged.

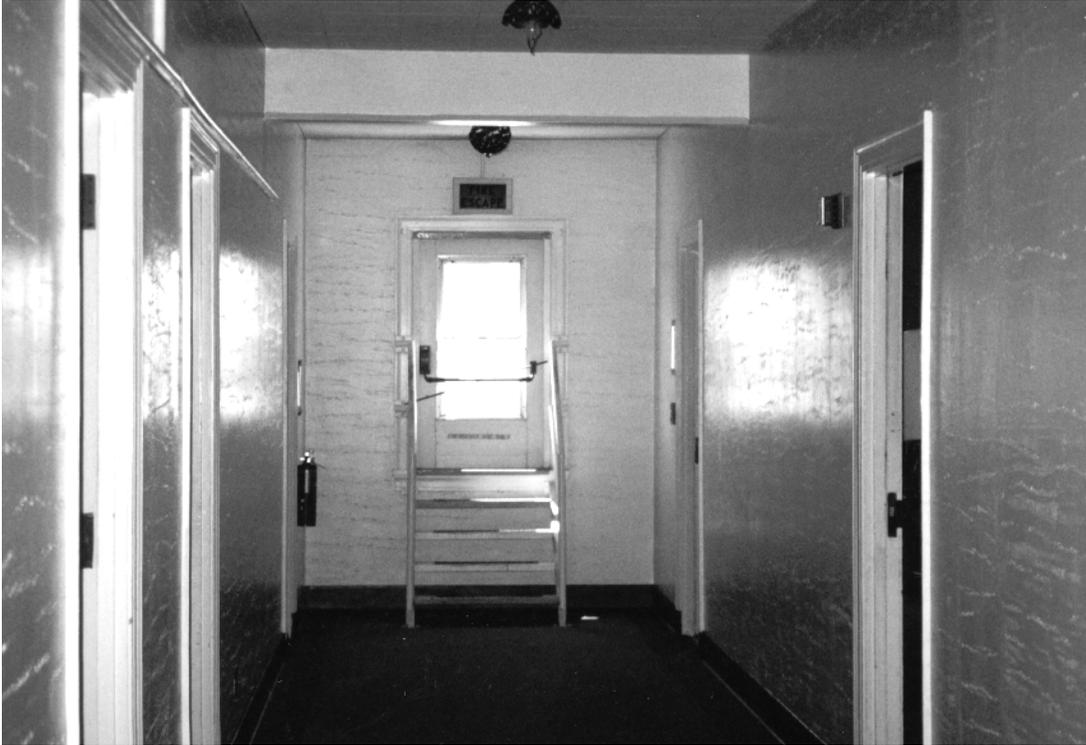
The corridors have also been affected by minor alterations usually due to attempts at resolving code issues related to exiting requirements. At the rear, southern end of the second floor corridors, the former window assemblies have been removed and replaced with metal exit stairs. However, it should be noted that the size of the window openings has not been altered. When the Navy made the building unisex, visual screen walls were installed in the corridor on the second floor. The stairs have also seen little or no change. In an attempt to resolve exiting issues, the original exterior doors have been re-hung to swing in the direction of travel.

Existing Window Modified for Emergency Exit  
Building 20  
Moffett Field
