U.S. Naval Air Station Moffett Field
Building 23 Re-Use Guidelines
Final

prepared by
Architectural Resources Group
Architects, Planners & Conservators,
Inc.
San Francisco, California

October 2000

U.S. Naval Air Station Moffett Field
Building 23 Re-Use Guidelines

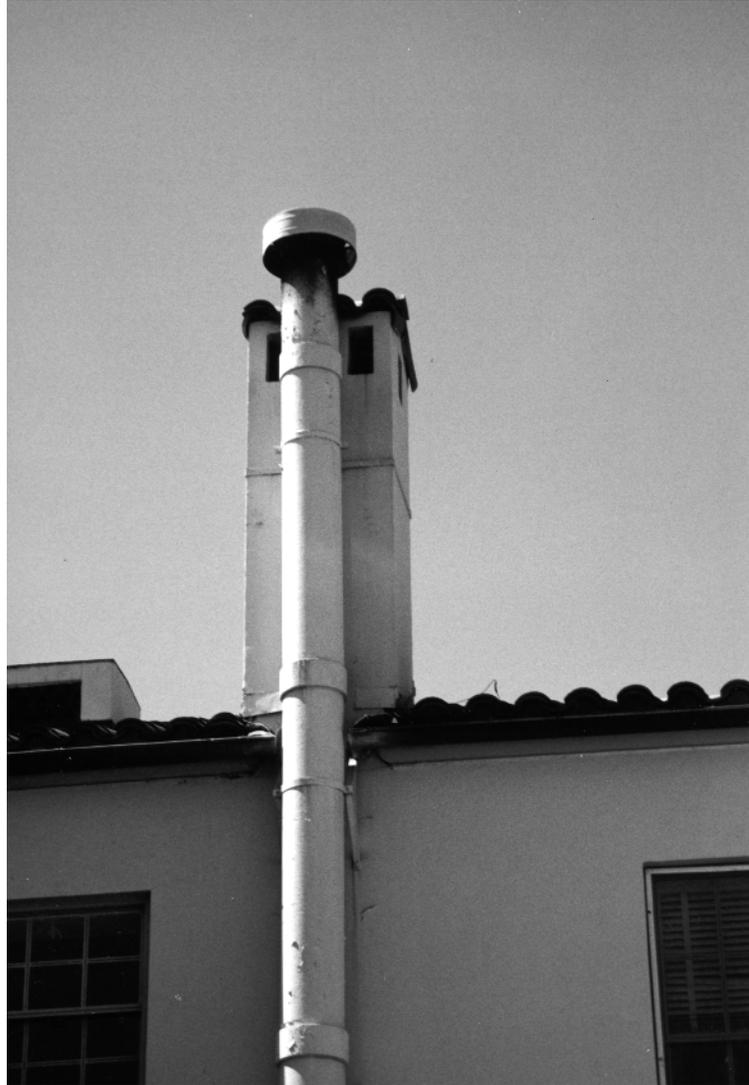
Non-contributing Sheet Metal Flue with Original Flue Beyond
Building 23
Moffett Field

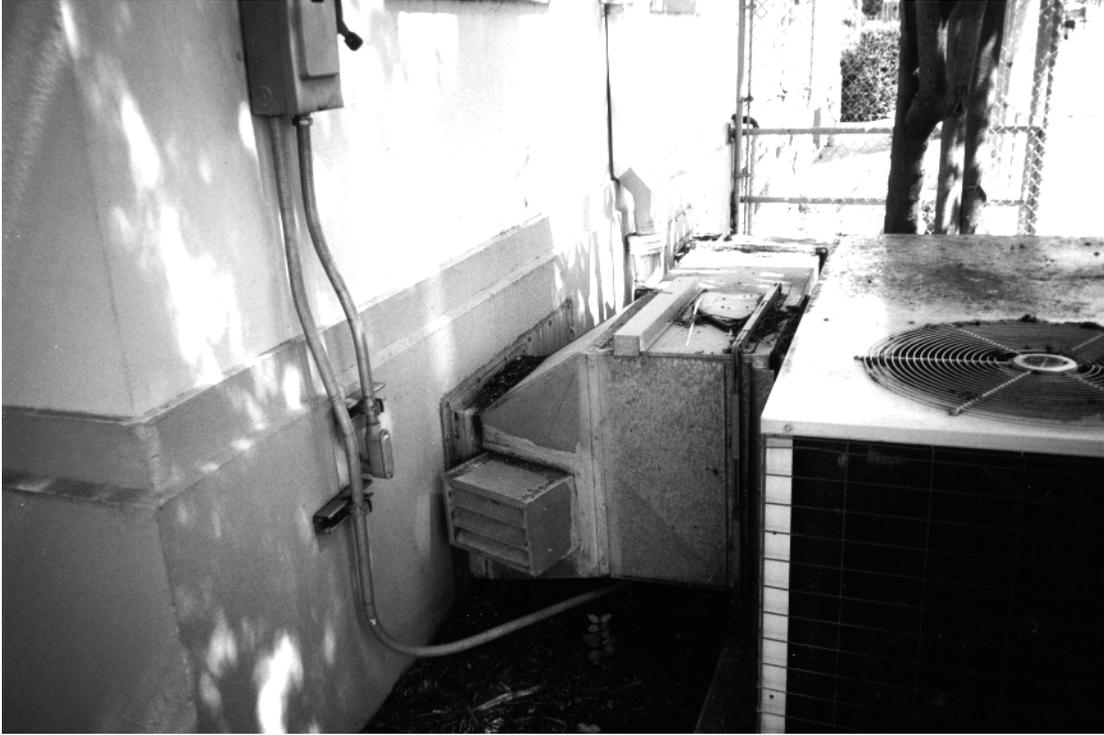
HVAC Equipment at Original Crawlspace Vent
Building 23
Moffett Field

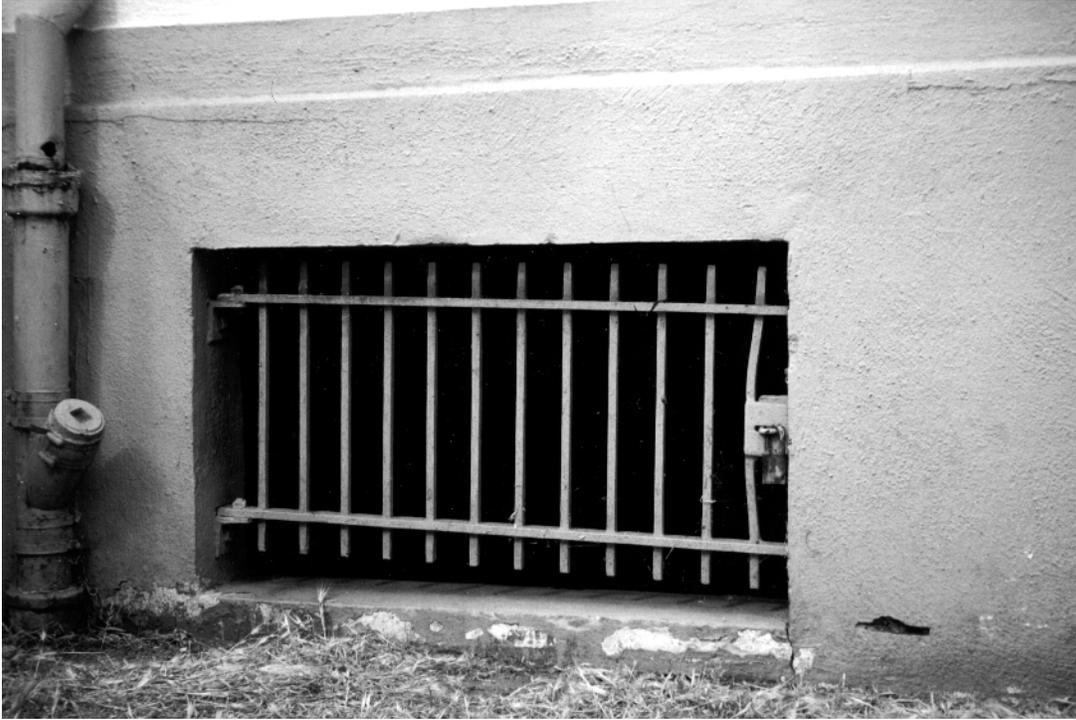
| XII. Character-Defining Features | | | | |
|---|---|---|---|---|
| Foundations Vent | Metal | C | G/P | At crawl space only |

Typical Crawl Space Vent
Building 23
Moffett Field

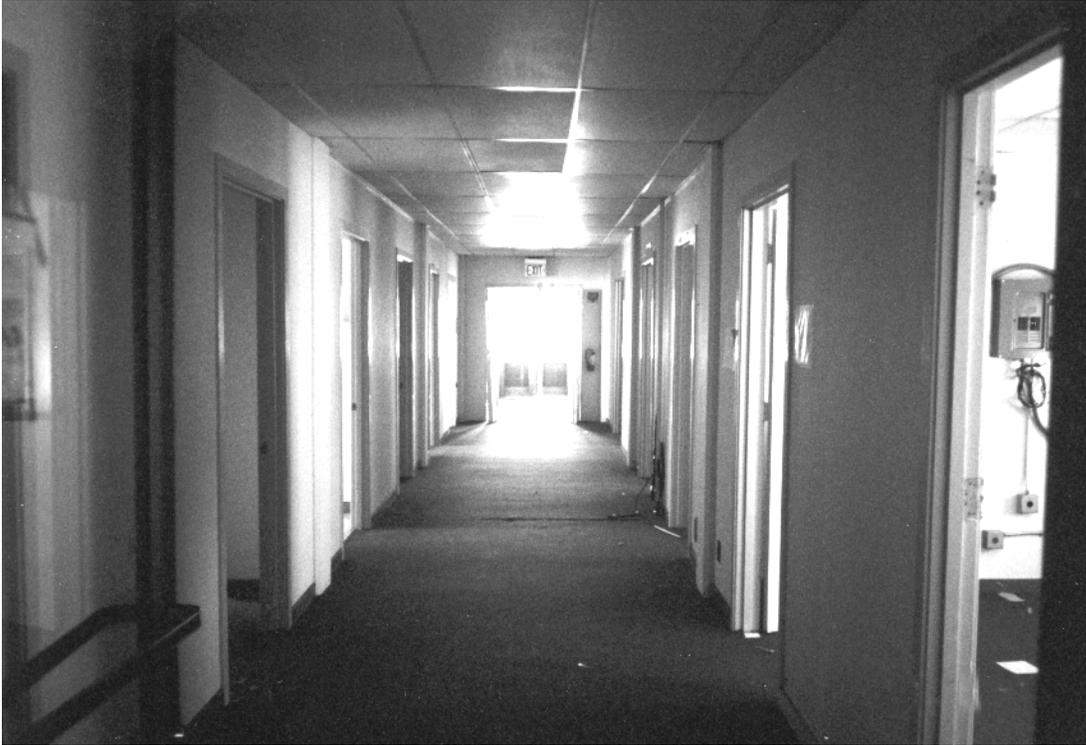
Non-contributing Infill Construction - Second Floor
Building 23
Moffett Field

Since the remainder of the building has been significantly altered, removal of interior partitions would not diminish the historic significance. In fact, the level of significance of the open ward and solarium on the

second floor, and the open ward in the 1935 addition, would be raised by removing the non-contributing partition walls and infill construction. Consideration should also be given to remove the three non-contributing metal exit stairs and replace them with new internal exit stairs. Consideration should be given to removing the existing non-contributing addition to the east wing.

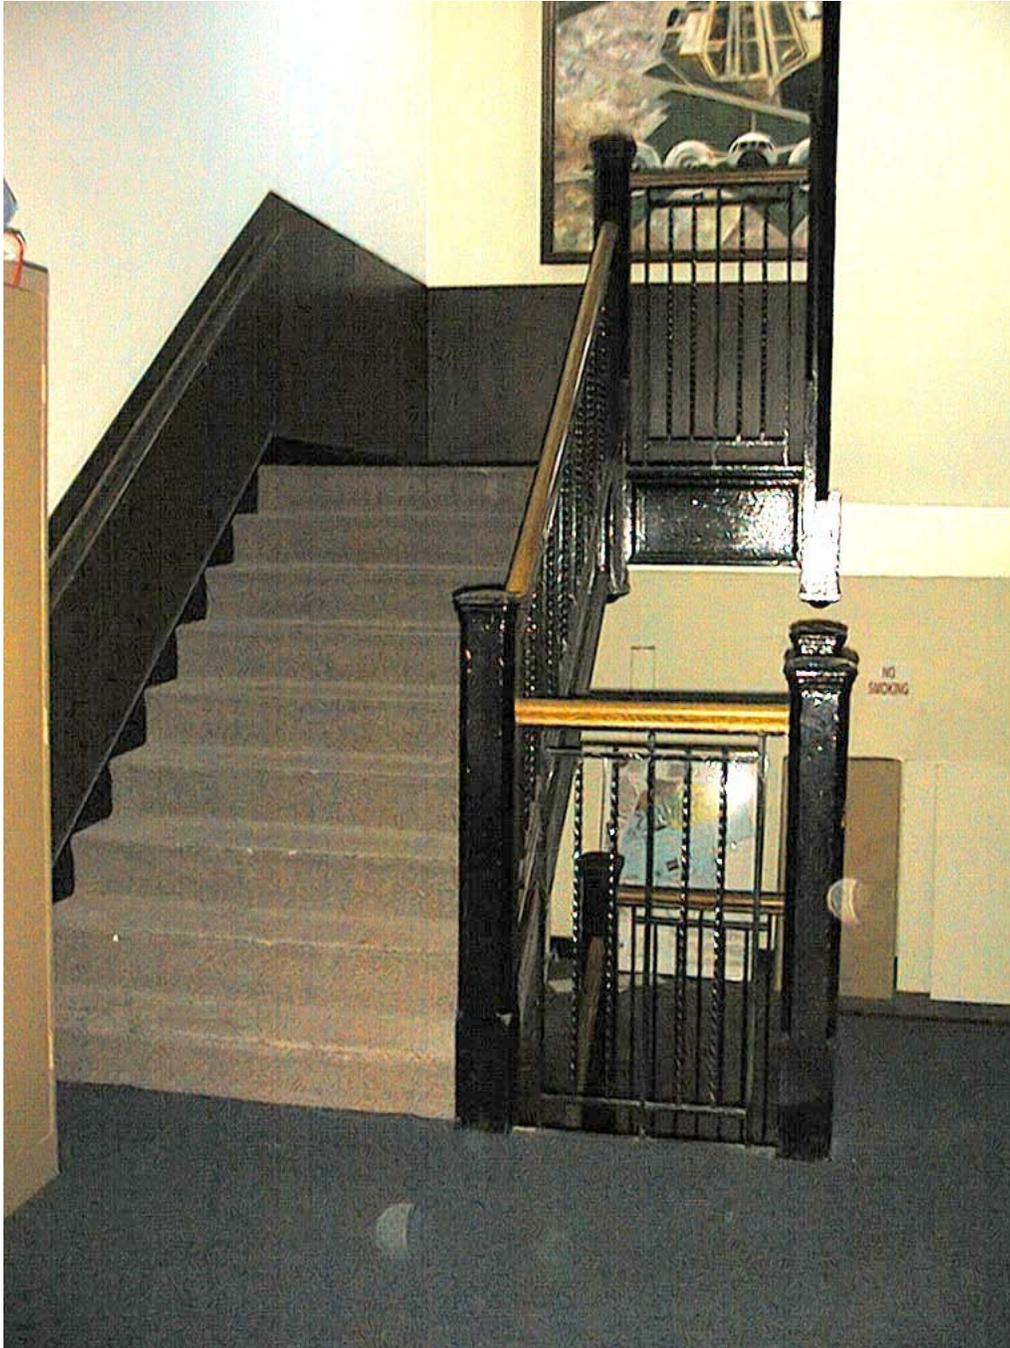
Central Stair
Building 23
Moffett Field

Stairs: Provide code compliant handrails at the front entry. Provide code compliant handrails which

are compatible with the existing design at the secondary entrances and at the existing interior stairs. Consideration should be given to seek approval to use the new additional stairs as the required code compliant stairways, thereby necessitating only one code compliant handrail on the wall of the existing interior stairway. If the existing emergency stairways are left in place, then modify the existing handrails to meet code.

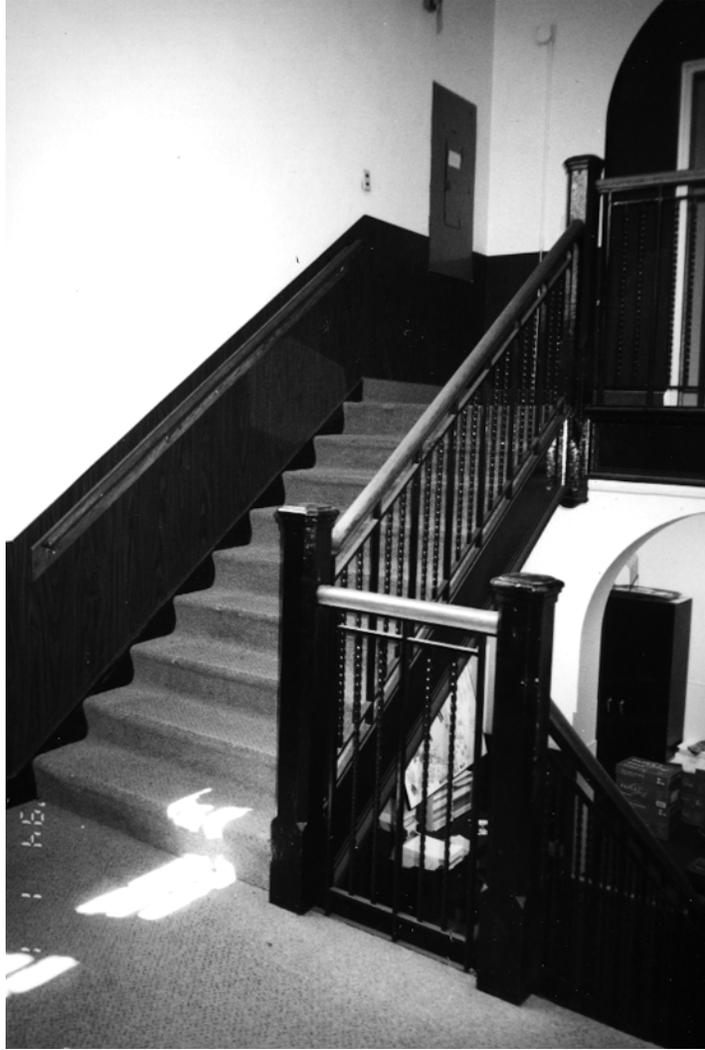
Central Stair
Building 23
Moffett Field

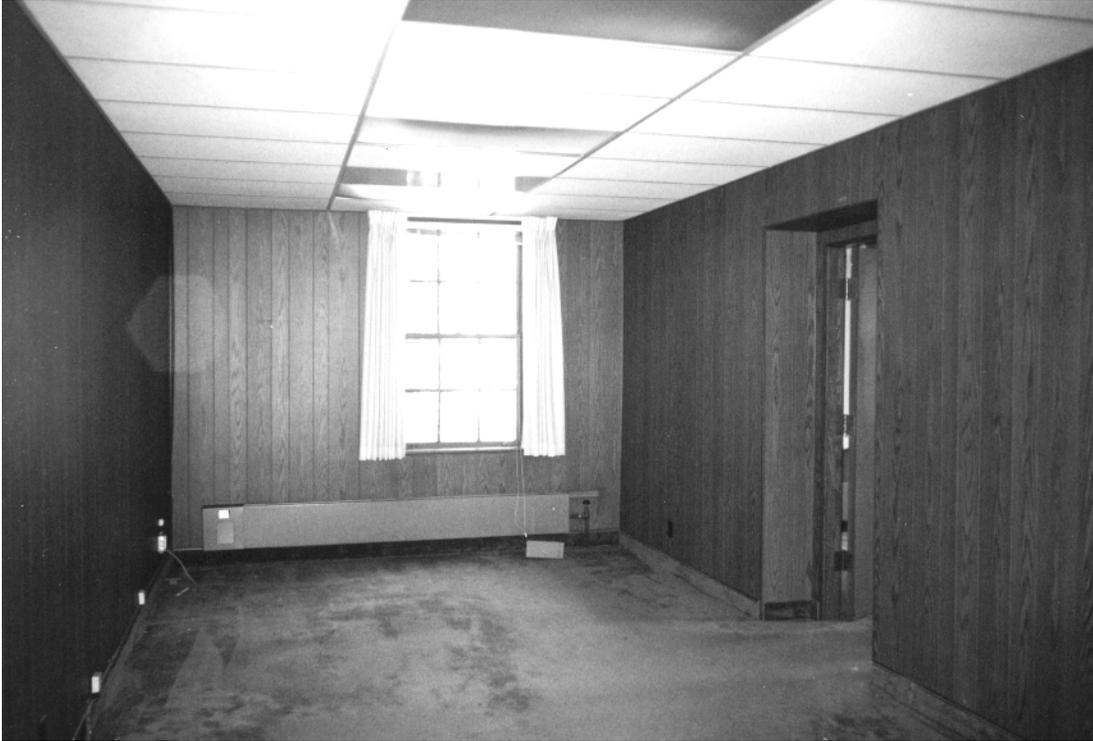
Non-contributing Wall Finish and Ceiling - 1941 Addition
Building 23
Moffett Field
