U.S. Naval Air Station Moffett Field
Building 24 Re-Use Guidelines
Final

prepared for
NASA/Ames Research Center
Moffett Federal Air Field, California

prepared by
Architectural Resources Group
Architects, Planners & Conservators, Inc.
San Francisco, California

June 2002

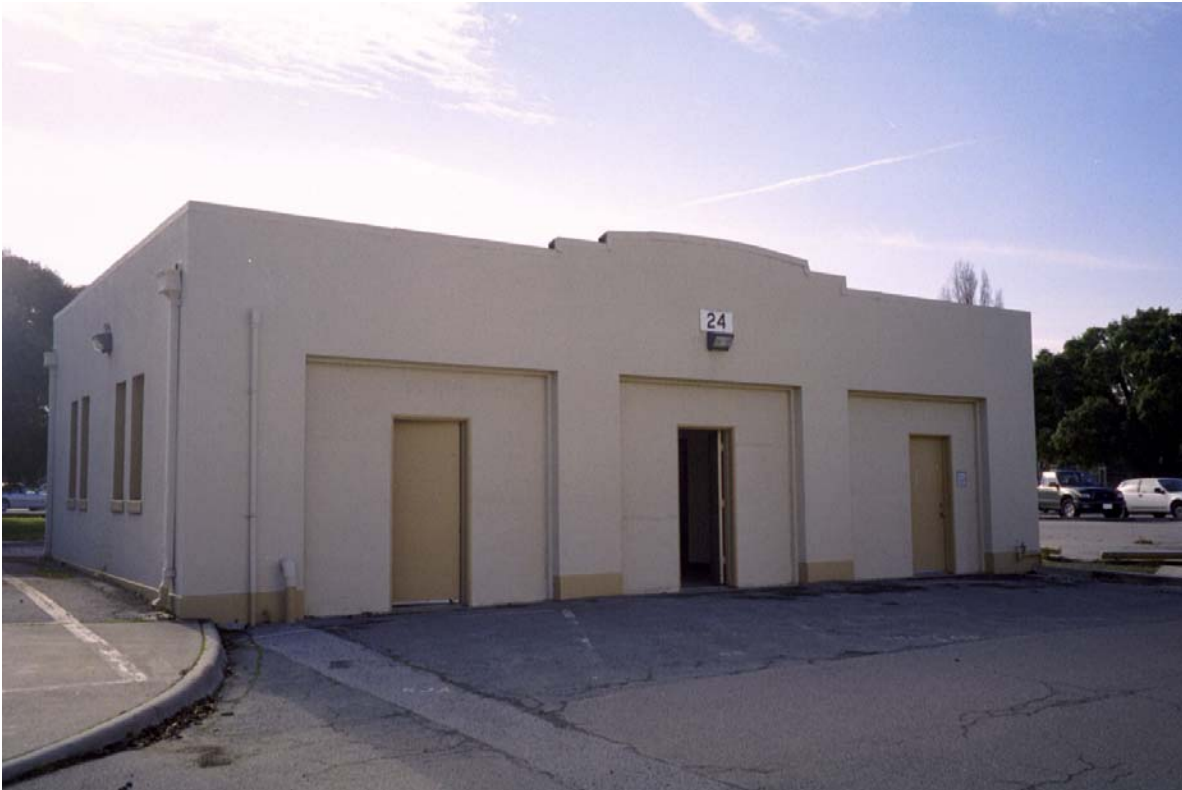
Front Elevation, Building 24
December 13, 2001

The exterior features of the building are simple, utilitarian and include integrally-colored cement plaster, a projecting base, 4 pane horizontal-pivoting windows, and an articulated parapet. The exterior remains mostly as it appeared during the period of significance. With the exception of the removal of the original garage doors and the exterior stucco being painted, there are no other visible exterior alterations.

Buildings 24 is in good physical condition, and the original exterior appearance remains. The construction of more sensitively designed fenestration in the exterior garage door openings is suggested. The exterior appearance is the significant feature of this structure and should be maintained. Its Location contributes to the contextual role as a support structure for Building 23 and in relation to the site and vehicular access. It contributes to the overall historic character of Shenandoah Plaza.

Restoration of the historic exterior color scheme is suggested as a long term goal for the district, along with the other buildings in the district, which are all an integral-colored stucco. This original finish has been painted many times. As it is not known what the original color scheme was, a complete analysis should be performed on the integrally-colored stucco and other exterior components. Consideration should be given to removing paint and restoring the original integrally-colored stucco finish.

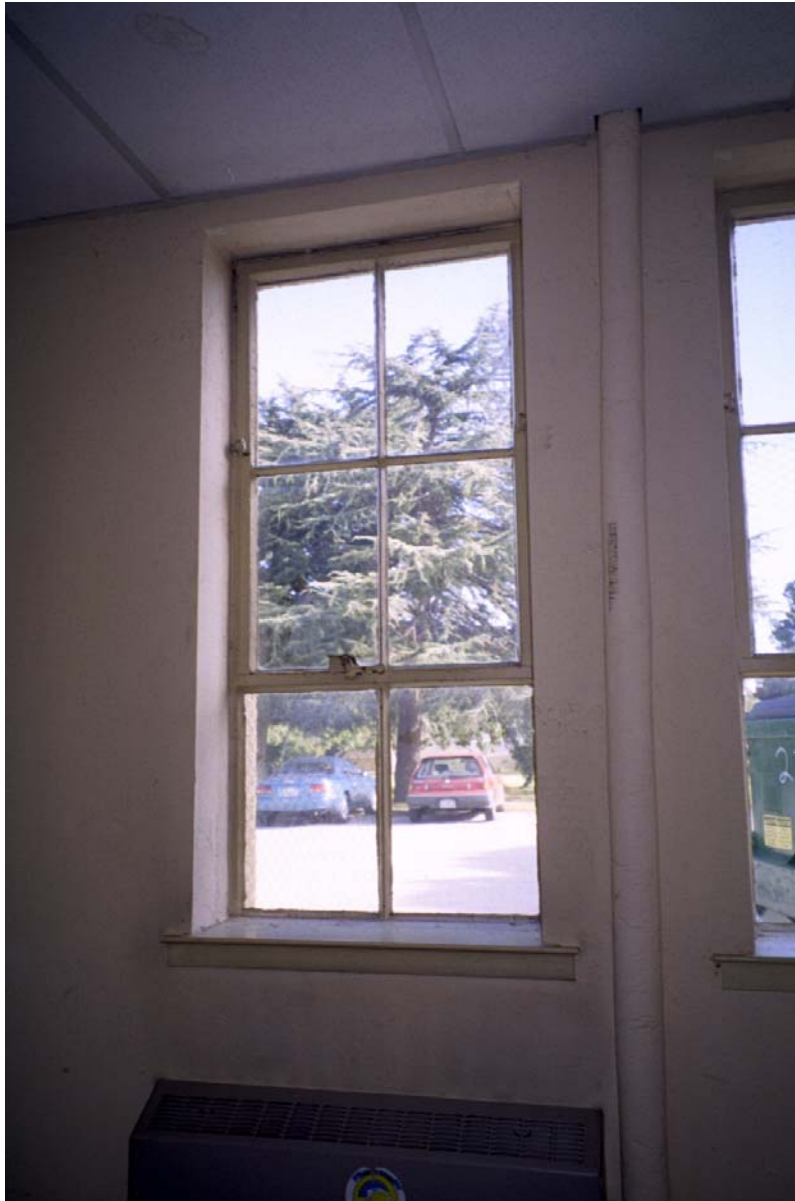
Typical Window, Building 24
December 13, 2001

Building 24 is in good condition overall. The doors and windows are in need of repair. With the exception of limited code compliance issues, and seismic upgrades, the building could be re-occupied with relatively little alteration.

As historic building, Building 24 is exempt from energy code requirements, however measures to reduce energy consumption and provide for user comfort are recommended. These may include ceiling insulation, and exterior wall insulation where the walls are opened during construction. The existing steel sash windows are historic features and they should be repaired and weather-stripped rather than replaced.
