U.S. Naval Air Station Moffett Field
Building 25 Re-Use Guidelines
Final

Moffett Federal Air Field, California
.....

prepared by
Architectural Resources Group
Architects, Planners & Conservators,
Inc.
San Francisco, California

October 2000

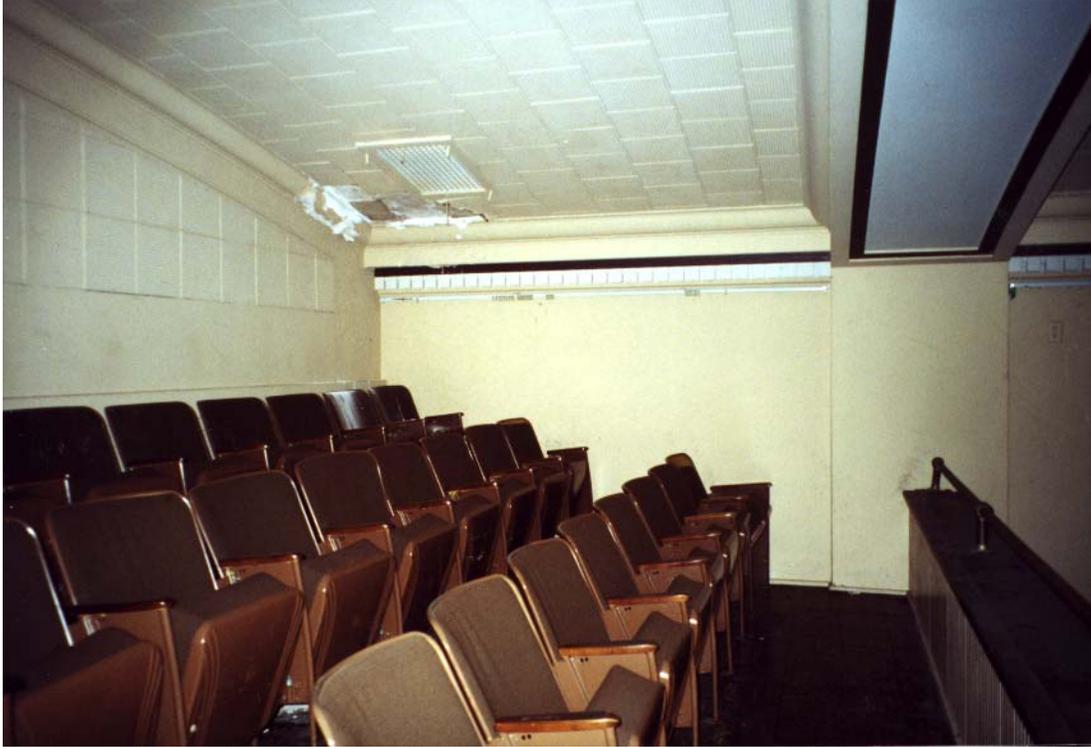
is unclear if any of the seats themselves are original. The width of the rows in the balcony have been enlarged. There is heavy water damage to the plaster walls and ceiling of the auditorium at the southeast and southwest corners. The lobby has had some minor alterations. Paneling has been installed over the original wall surface and doors have been installed between the lobby and the main circulation corridor. The corridors have been significantly altered. On the first floor, doors have been added between the stairways and corridor. It appears as though the historic fabric beyond these doors has been removed and reconstructed. On the second floor the historic fabric is more intact with the exception of the fore-shortening of the eastern end of the corridor. Apparently, the historic doors were relocated to the west of their original location. The most significant alteration occurred to the support spaces. The changes include removal/concealment of historic finished, as well as modifications to the spatial configuration. The porch was once open but has since been enclosed and subdivided.

South West Corner - Auditorium Balcony
Building 25
Moffett Field

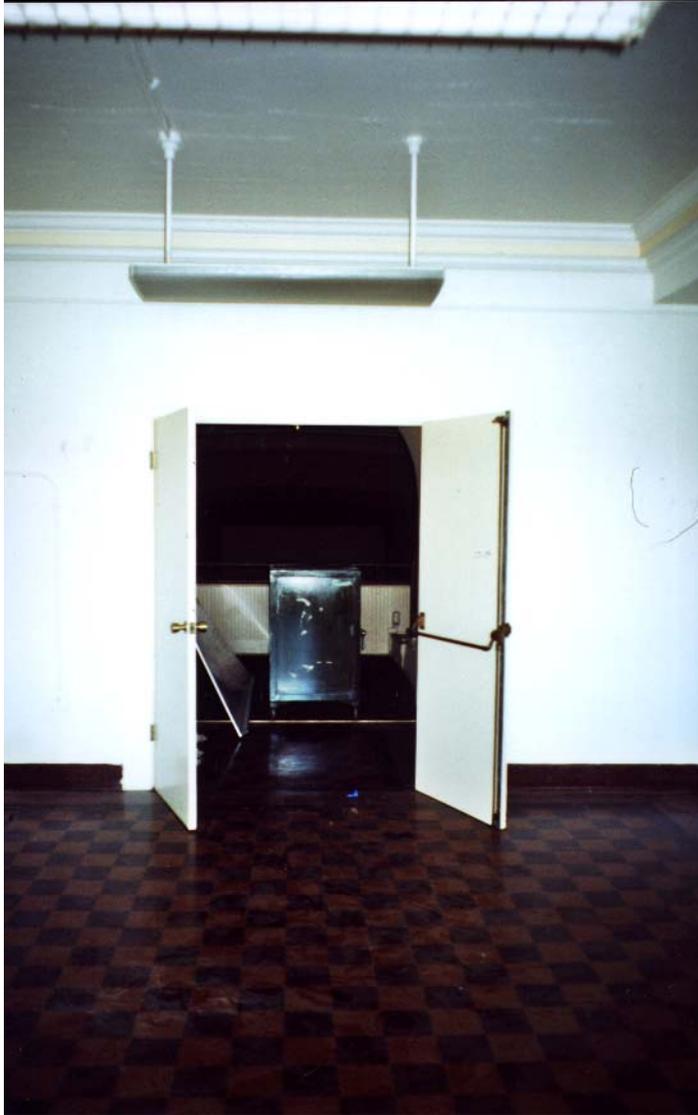
Non-Contributing Doors to Auditorium - Foyer
Building 25
Moffett Field

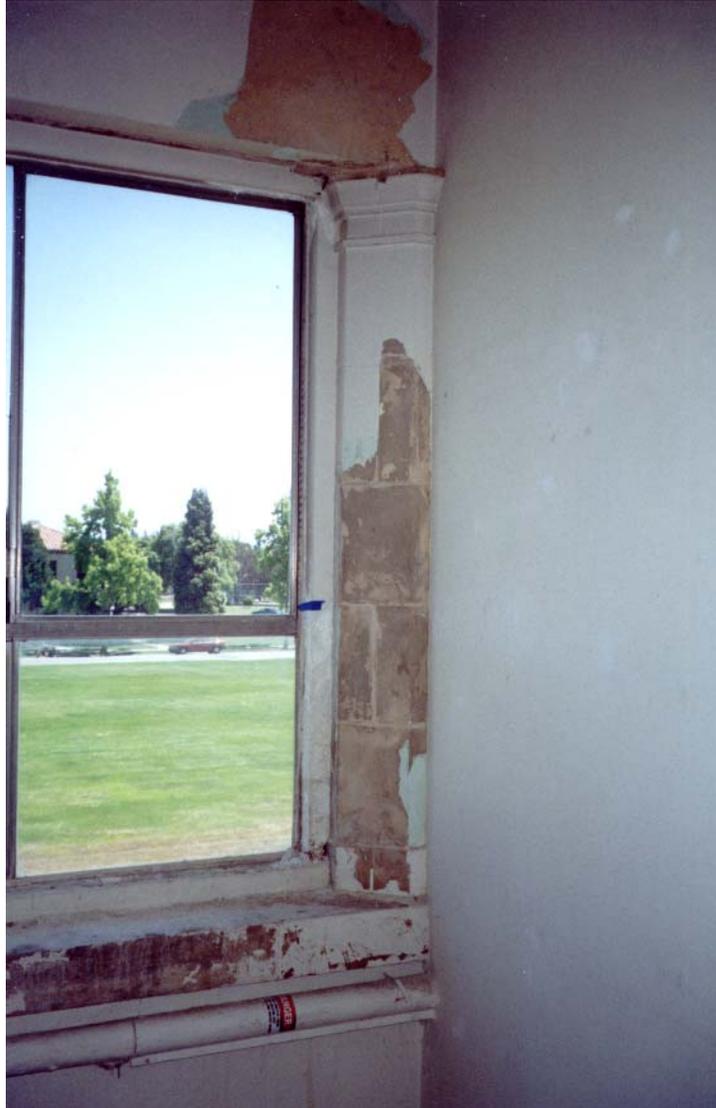
Non Contributing ALuminum WIndow - Porch
Building 25
Moffett Field

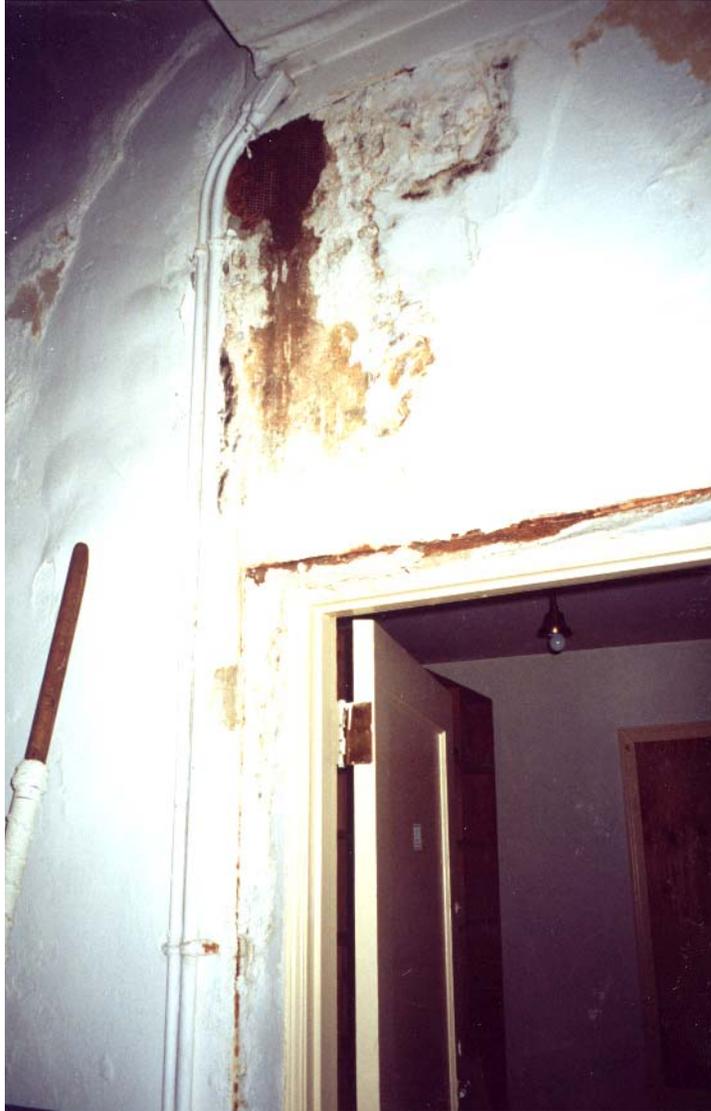
Water Damage - Dressing Rooms
Building 25
Moffett Field
