U.S. Naval Air Station Moffett Field
Building 25 Re-Use Guidelines
Final

Moffett Federal Air Field, California
.....

prepared by
Architectural Resources Group
Architects, Planners & Conservators,
Inc.
San Francisco, California

October 2000

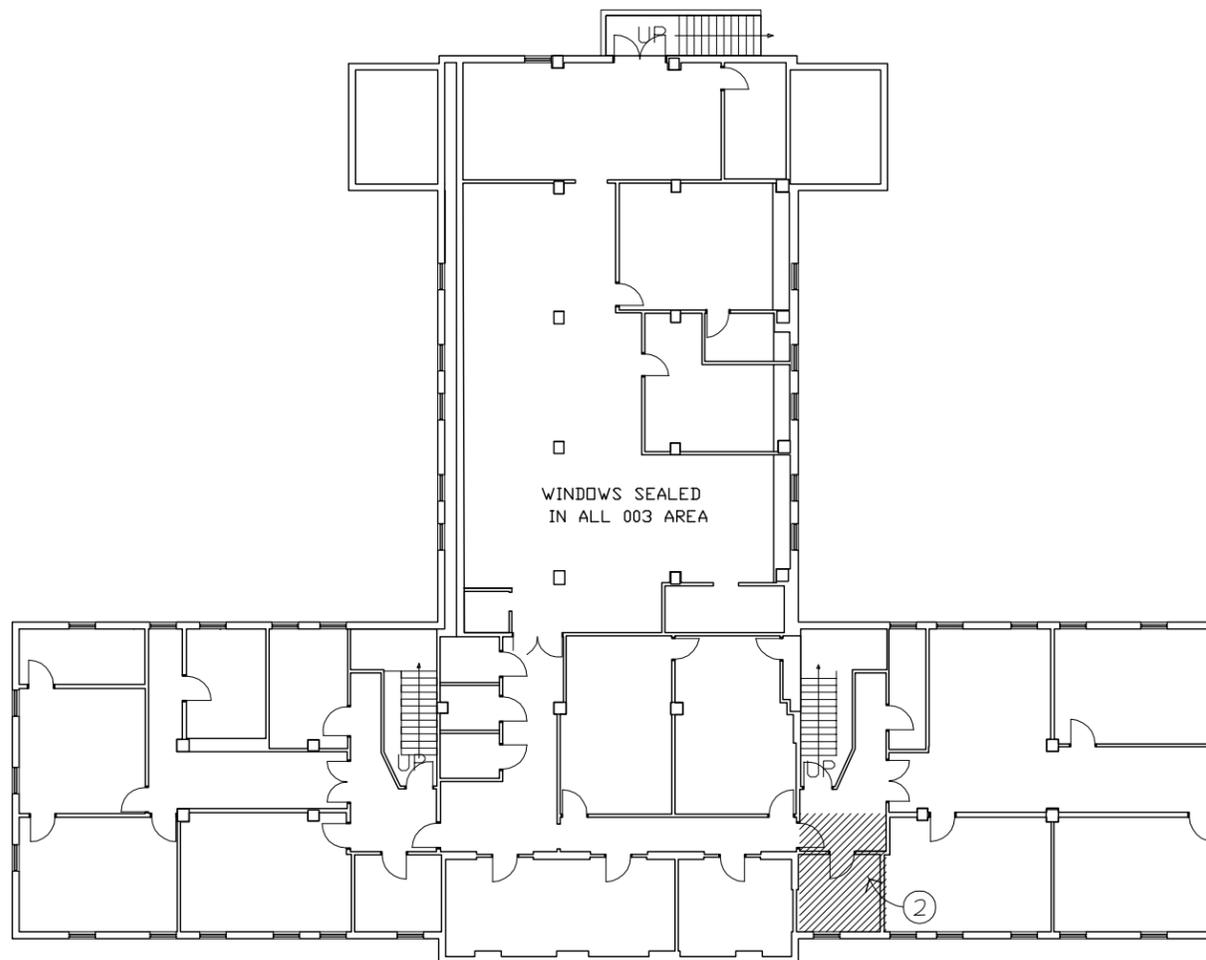
AREAS OF HISTORICAL SIGNIFICANCE
BASEMENT

- ② SUGGESTED AREA FOR NEW ELEVATOR.

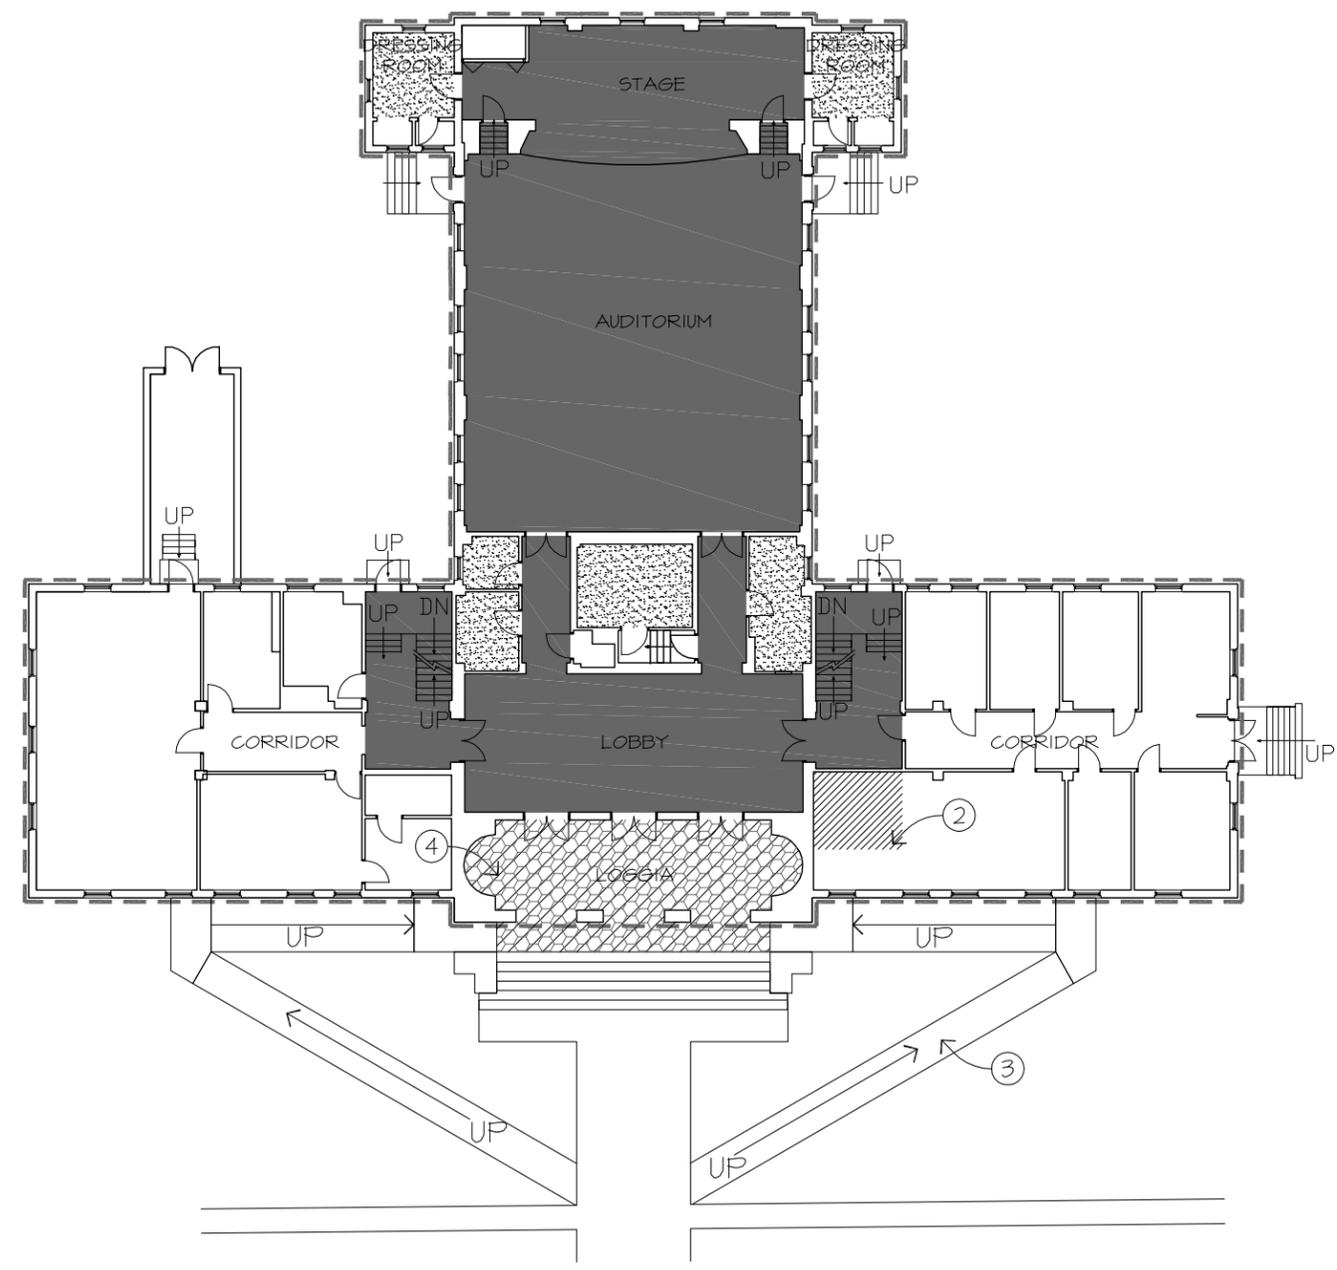
AREAS OF HISTORICAL SIGNIFICANCE
GROUND FLOOR PLAN

- ④ RAISE TERRACE ±6" TO BE LEVEL WITH EXISTING LOBBY FLOOR.

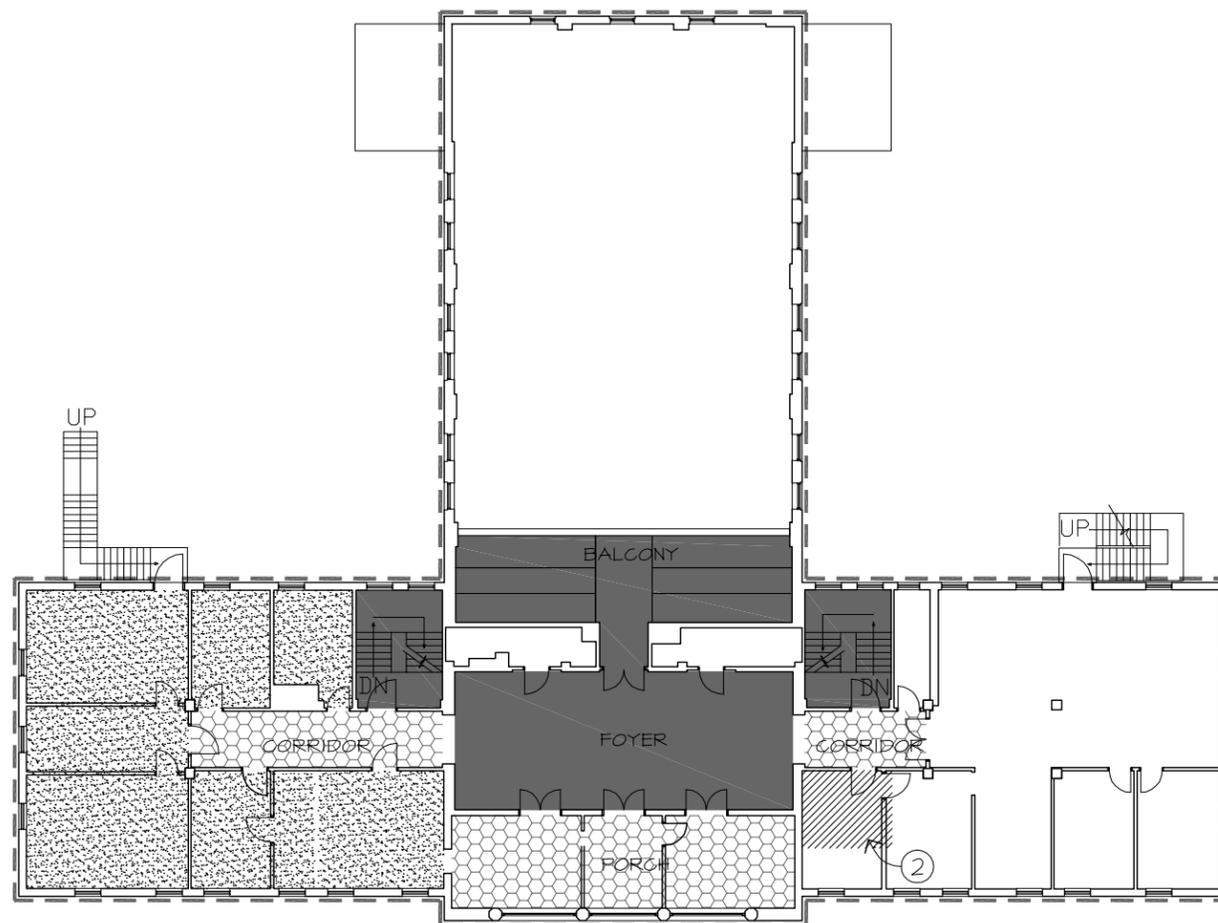
AREAS OF HISTORICAL SIGNIFICANCE
SECOND FLOOR PLAN

- ② SUGGESTED AREA FOR NEW ELEVATOR.

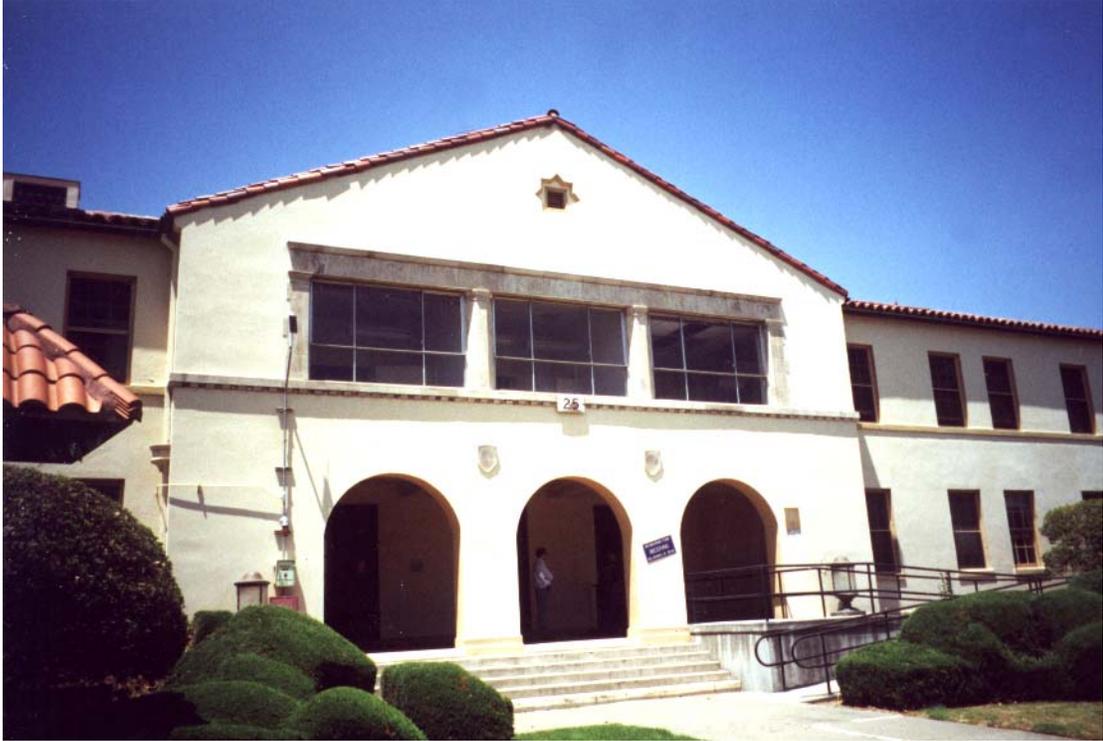
Front Entry
Building 25
Moffett Field

Guardrails: Provide code compliant guardrails at the main entry. Modify existing guardrails at the auditorium exits, the east entrance, and the basement exit stairways.

Stairs (Exterior): Provide code compliant handrails at the front entry. Provide code compliant handrails which are compatible to the existing design at the secondary entrances, and the east entrance. If the existing emergency stairways are left in place, then modify the existing handrails to meet code.

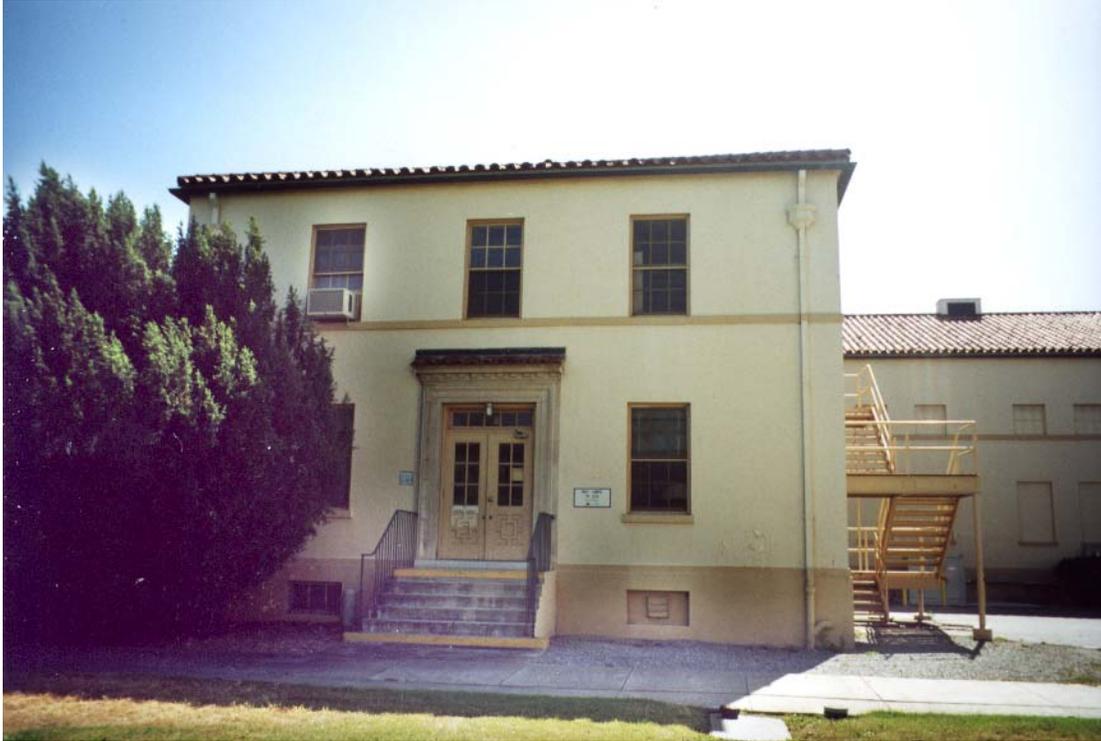
East Entrance
Building 25
Moffett Field

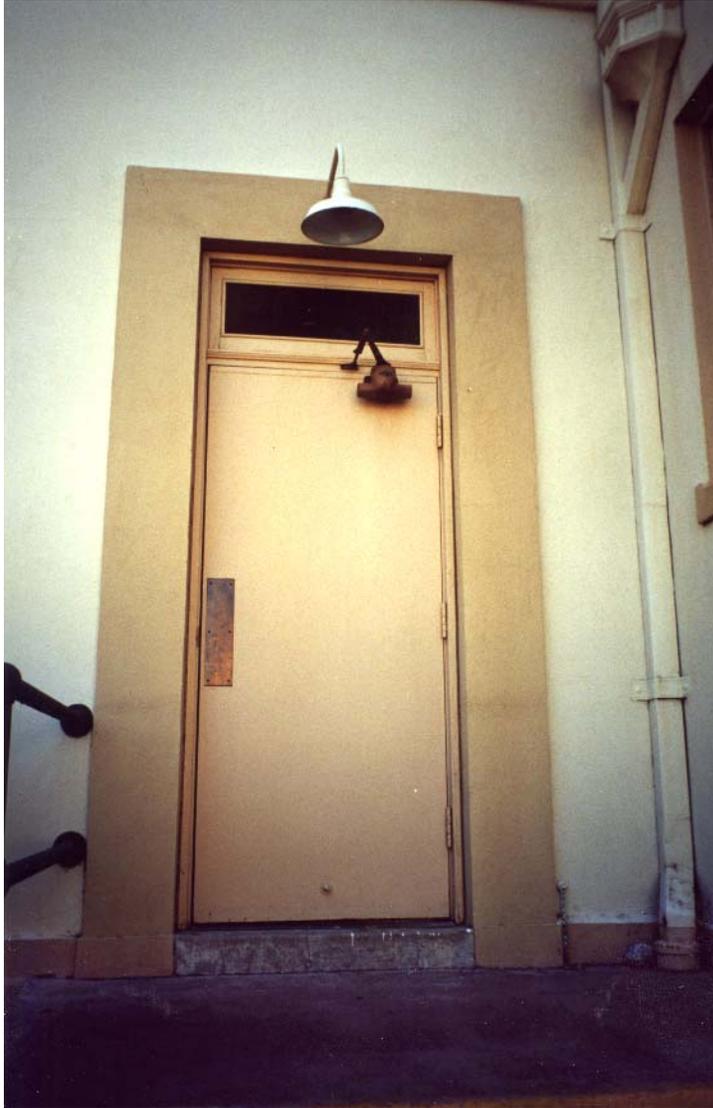
Auditorium Exit
Building 25
Moffett Field
