Re-Use Guidelines

Hangar 2 (Building No. 46)
NASA Ames Research Center
Moffett Field, California

August 30, 2006

Prepared by
PAGE & TURNBULL, INC.
San Francisco, California

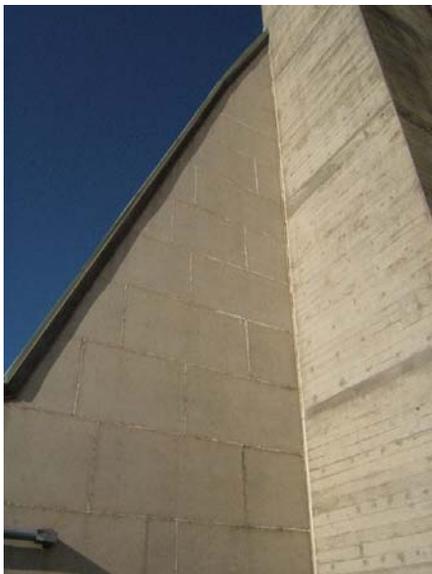
Figure 14. Detail of cement asbestos panels, Hangar 2.

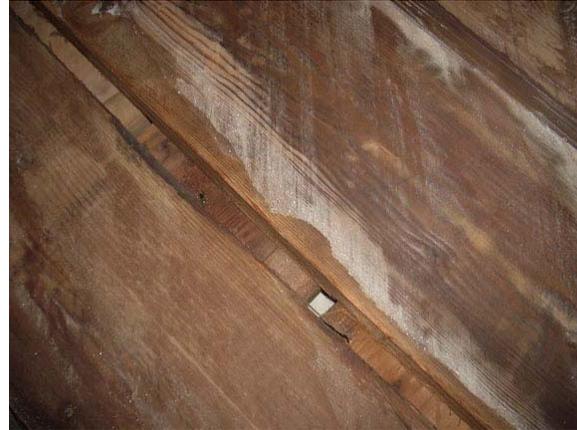
Figure 38. FRT salt deposits on diagonal sheathing of interior of door lintel box girder, north girder, Hangar 2.

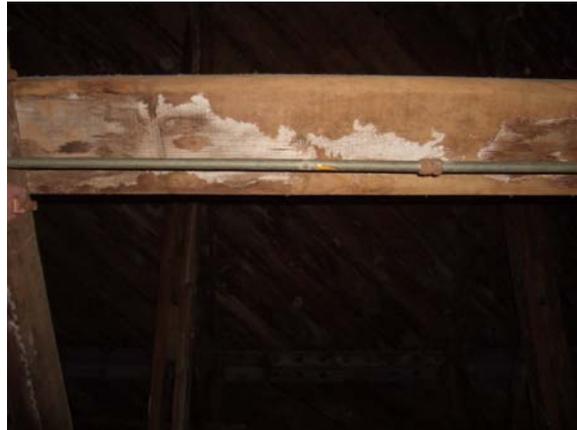
Figure 39. FRT salt deposits on a truss member supporting clamshell roof, north end Hangar 2.

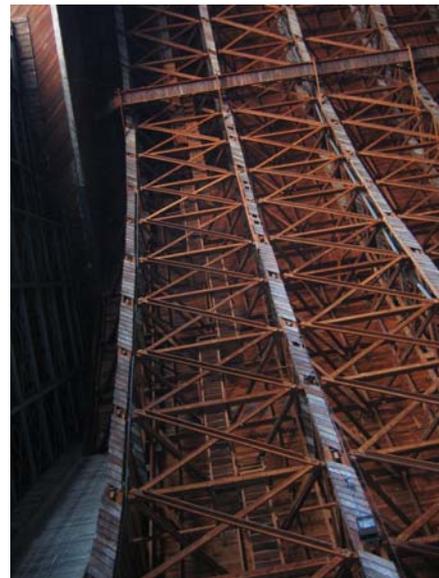
The underside of the catwalks exhibits white stains that appears consistent with the water staining and FRT leaching seen throughout the hangar. Because of safety concerns, the ladders and catwalks were not accessible. It can be argued that they are no longer capable of performing their intended

Figure 43: Braces, ladder and catwalk assembly between Bents #1 & #2, Hangar 2.

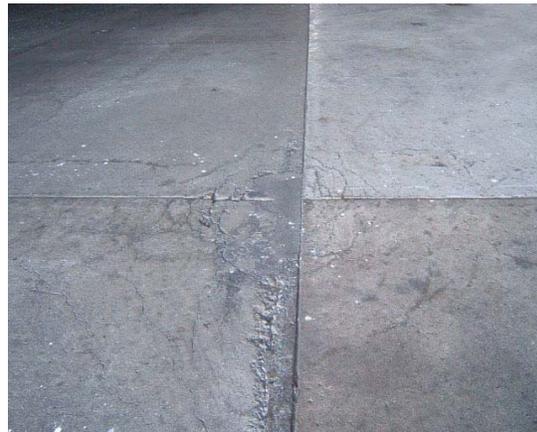
Minor cracking is evident throughout the slab, particularly at the corners of the floor panels where the slab is weakest (**Figure 44**). These cracks are typical for large concrete pours and do not appear to affect the structural performance of the foundation. The slab appears to be intact with no major swells or dips.

Figure 44. Concrete floor slab (typical), Hangar 2 south entry.

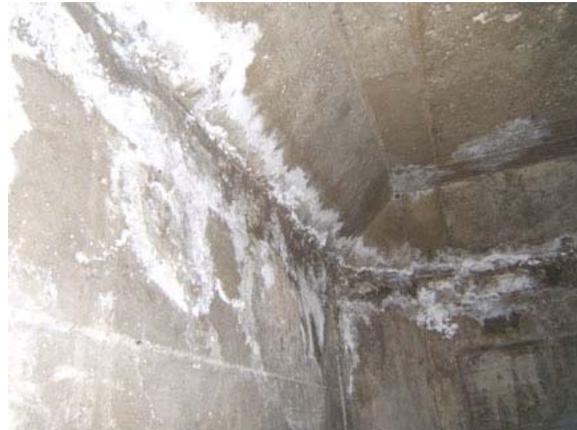
Efflorescence, a deposit of soluble salts and minerals, was noted on the interior of the towers, indicating water transmission through the masonry (**Figure 45**). During the process of water transmittal, salts are hydrated and subsequently moved to the surface. This appears as a white powder and often follows the flow of existing structural cracks. Though this is typically not a problem itself, efflorescence is an indicator of water infiltration that can also cause the corrosion and expansion of embedded steel reinforcement.

Figure 45: Efflorescence on the interior of the door tower, Hangar 2 southeast tower.

The efflorescence at the towers stems from a significant design problem at the junction of the curved roof slope and the concrete door tower. Lack of proper drainage at this point causes water to pool against the concrete wall of the tower. At this juncture, plant life is growing on the roof (**Figure 46**).

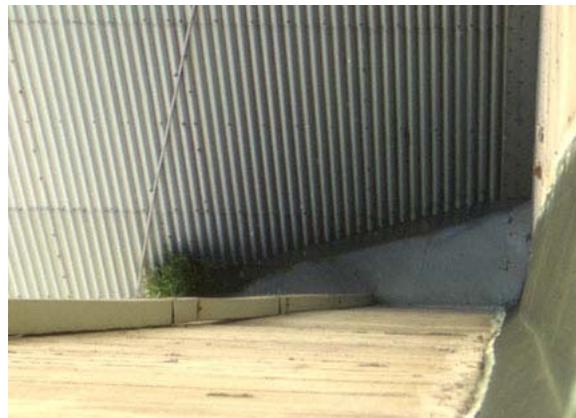
Figure 46. Organic growth found at junction between roof slope and hangar door, Hangar 2 southwest tower junction.

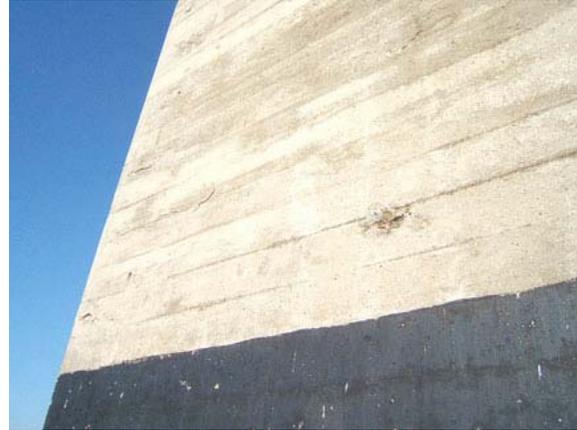
within the tower. The exterior of all towers show minor spalling, particularly at the corners. Shallow placement of reinforcement bars is the probable cause of this condition. The expansion of the corroding steel has caused cracking in the concrete, which has allowed more moisture to intrude into the system. Left unchecked, this cycle will cause the face of the concrete to spall (**Figures 47 & 48**).

Figure 47. Concrete spall on northwest corner tower, Hangar 2.

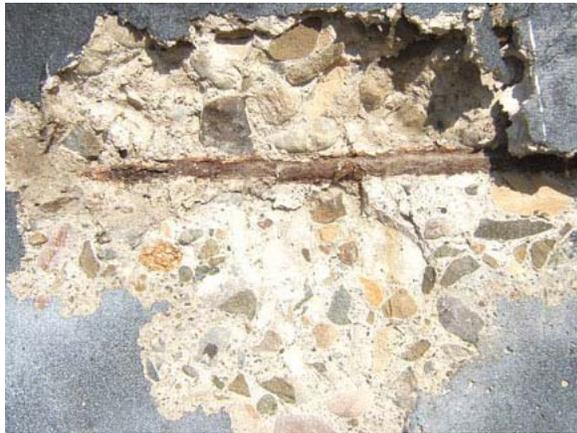
Figure 48. Detail of concrete spall, northwest door tower, Hangar 2.

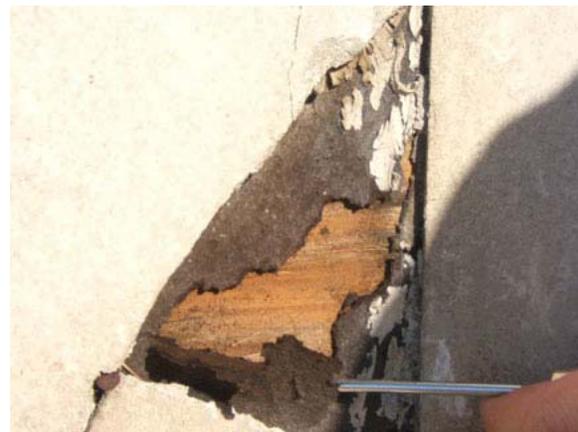
Figure 50. Deteriorated cement asbestos panel showing underlayment of tarpaper and wood substrate, northern corner of the west façade, Hangar 2.

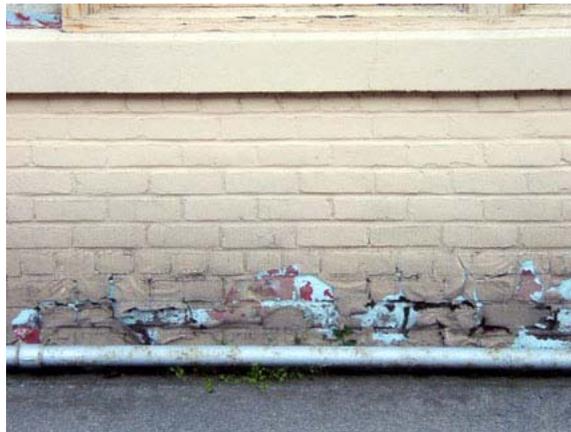
Figure 51. Water table, line of rising damp evaporation causing paint to fail on west façade of Hangar 3,
