Re-Use Guidelines

Hangar 3 (Building No. 47)
NASA Ames Research Center
Moffett Field, California

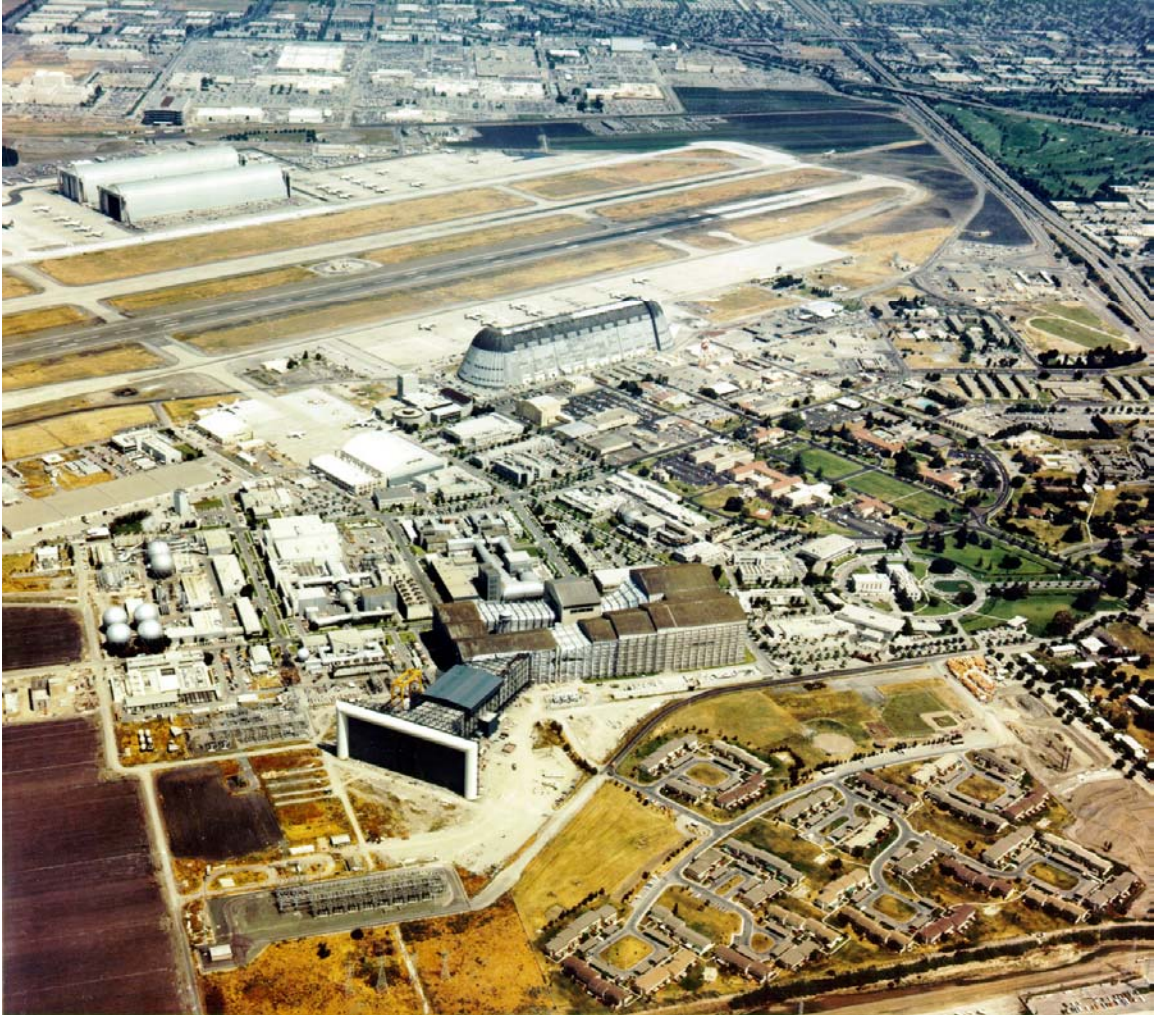
**Figure 1. 1982 Aerial Photograph of Moffett Field and the NASA Ames Research Center.
Source: Moffett Field Historical Museum.**

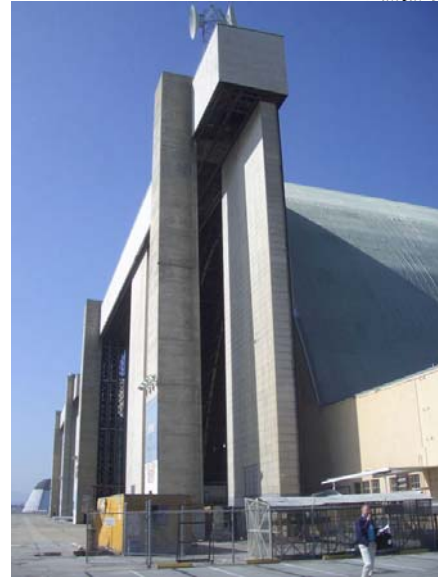
Figure 9. Southeast Corner tower, Hangar 3.

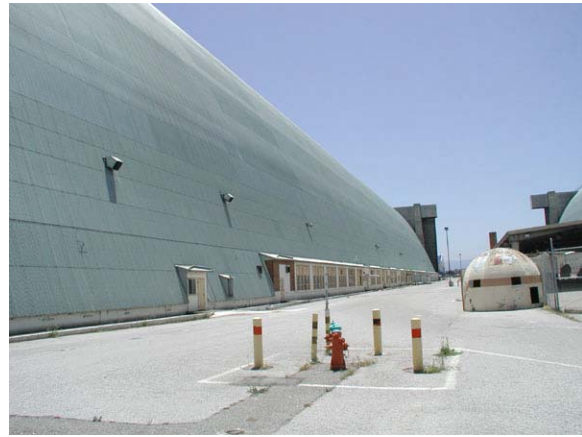
Figure 12. West facade, Hangar 3.

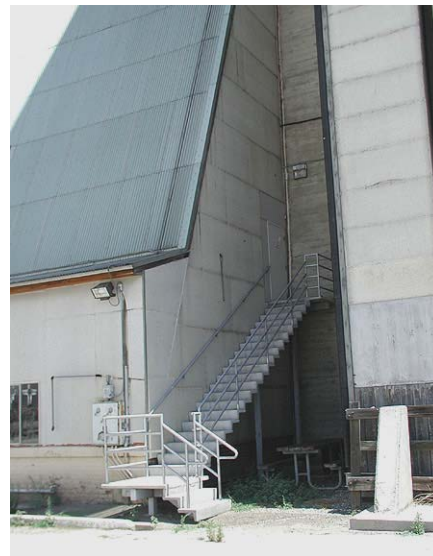
Figure 15. Detail of shed roof connection to parabolic roof, Hangar 2 (Hangar 3 similar).

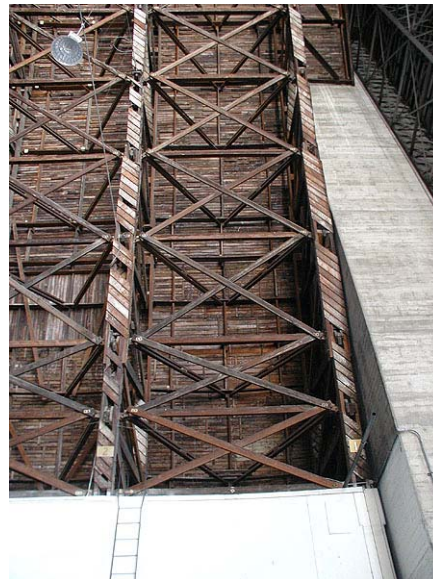
Figure 17. Bents 51 and 50, Hangar 3.

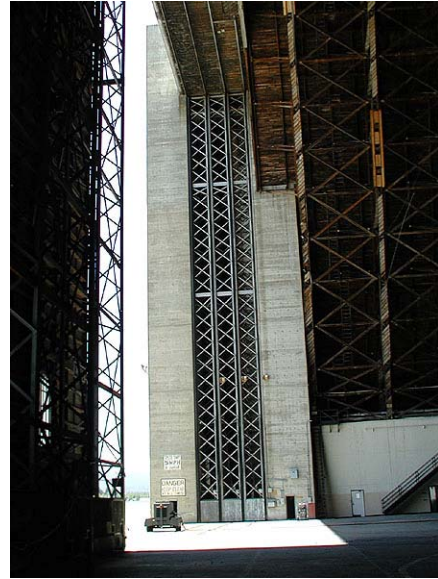
Figure 18. Hangar door, Hangar 3.

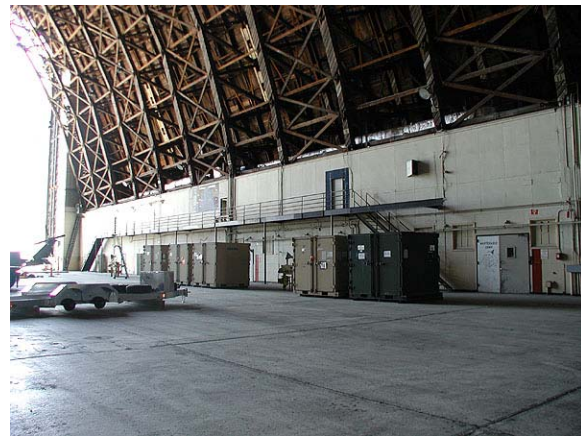
Figure 19. Interior, Hangar 3.

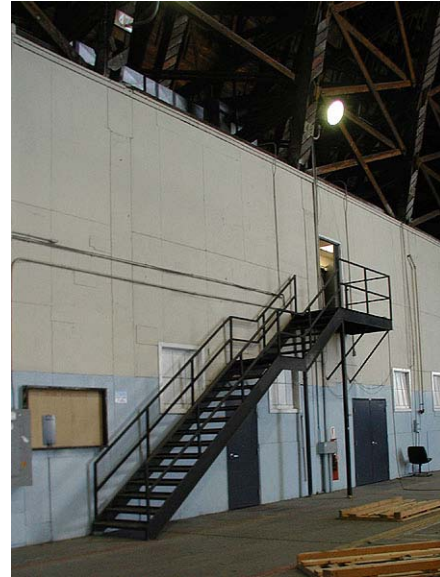
Figure 20. Metal stair (typical), Hangar 3.

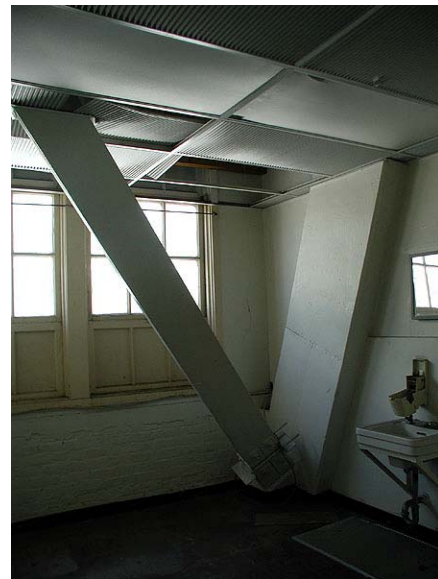
Figure 26. Bent foundations in office/shop areas (typical), Hangar 3.

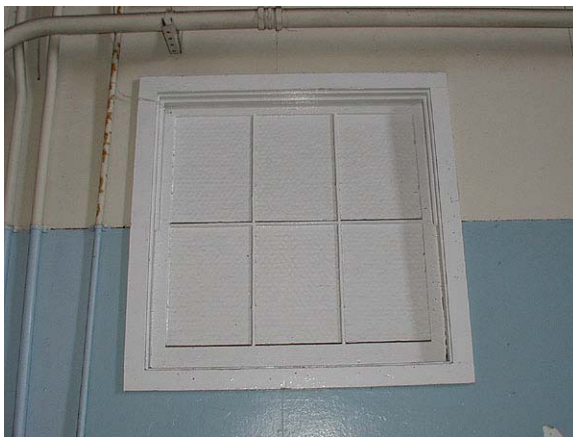
Figure 24. Interior wood-sash window (typical), Hangar 3.

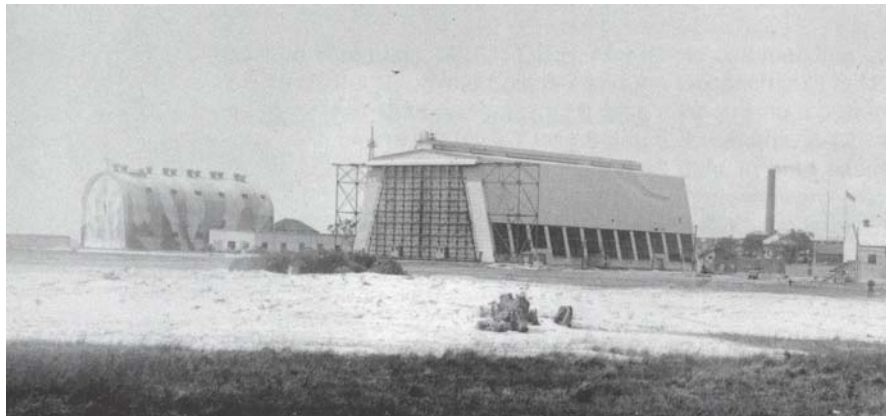
Figure 27. The camouflaged hangar at the background is the Navy's first LTA hangar. Source: James R. Shock, *American Airship Bases & Facilities* (New Smyrna Beach, FL: M & T Printers, 1996) 17.

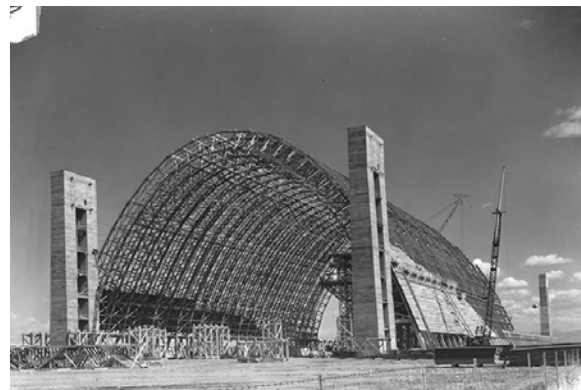
Figure 33. Hangar under construction, 1943.
Source: NASA Ames Image Library Server.

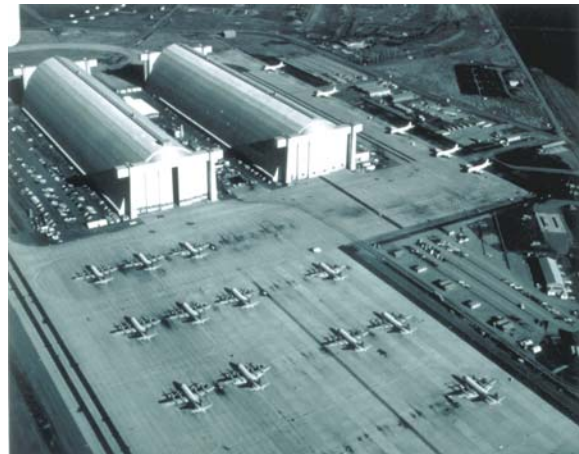
Figure 37. 1968 Aerial view of Hangars 2 and 3. Source: Moffett Field Historical Museum.

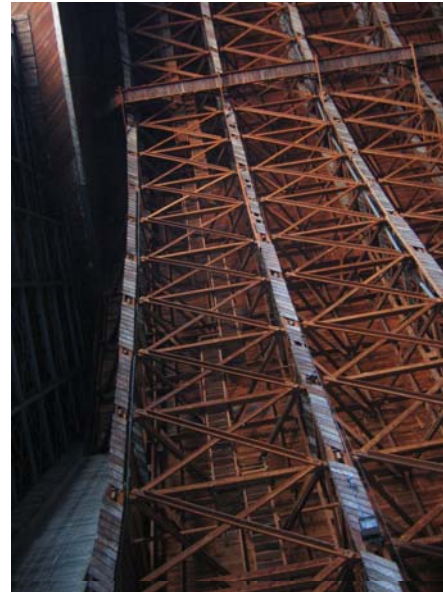
Figure 41 Braces, ladder and catwalk assembly between Bents #1 & #2, Hangar 2 (Hangar 3 similar).

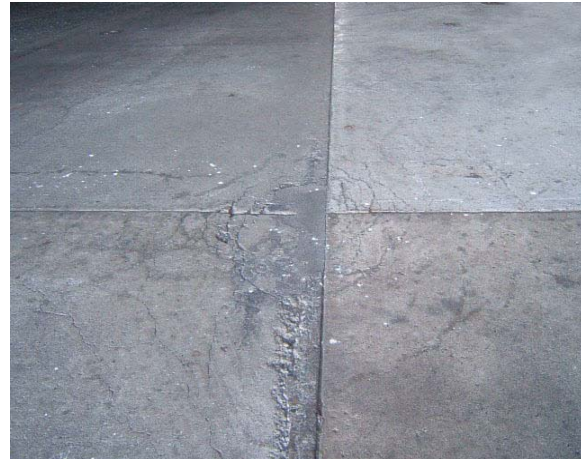
Figure 42 Concrete floor slab (typical), Hangar 2 south entry (Hangar 3 similar).

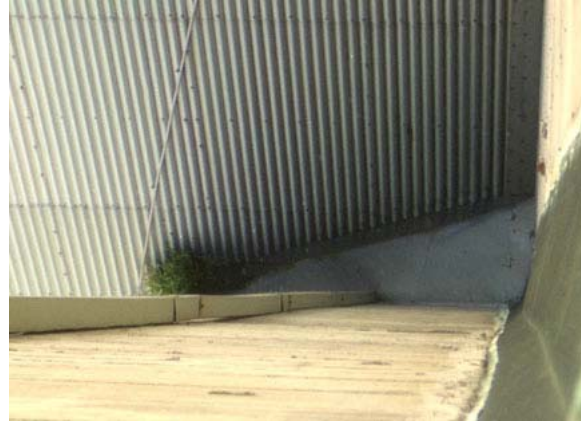
Figure 44 Organic growth found at junction between roof slope and hangar door, Hangar 2 southwest tower (Hangar 3 similar).

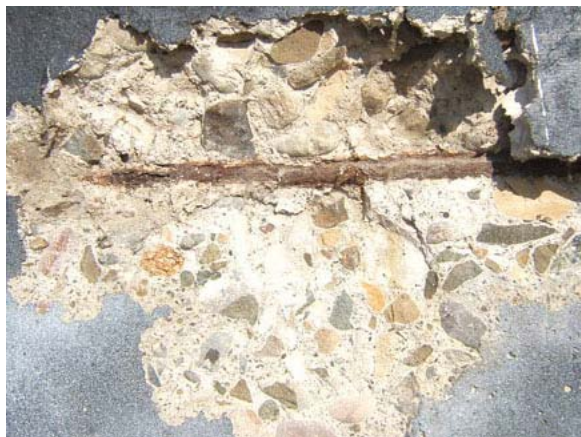
Figure 46. Detail of concrete spall, northwest door tower, Hangar 2 (Hangar 3 similar).

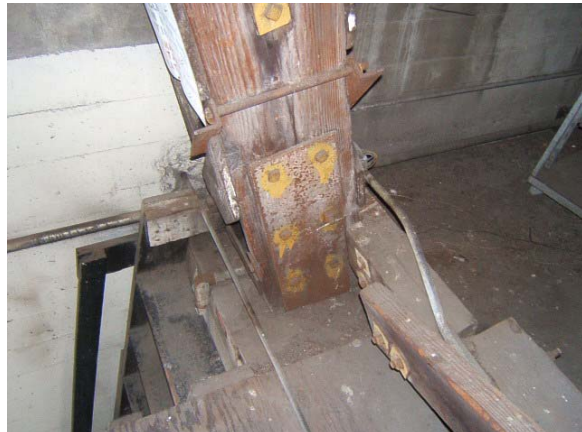
Figure 47: Interface between wood truss and concrete bent, Bent #1, west junction.

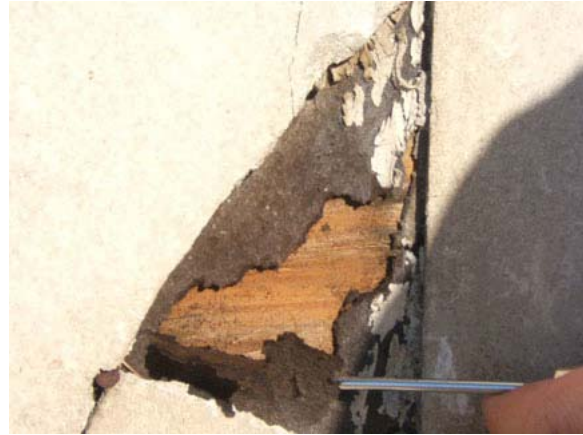
Figure 48. Deteriorated cement asbestos panel showing underlayment of tarpaper and wood substrate, northern corner of the west facade, Hangar 2 (Hangar 3 similar).

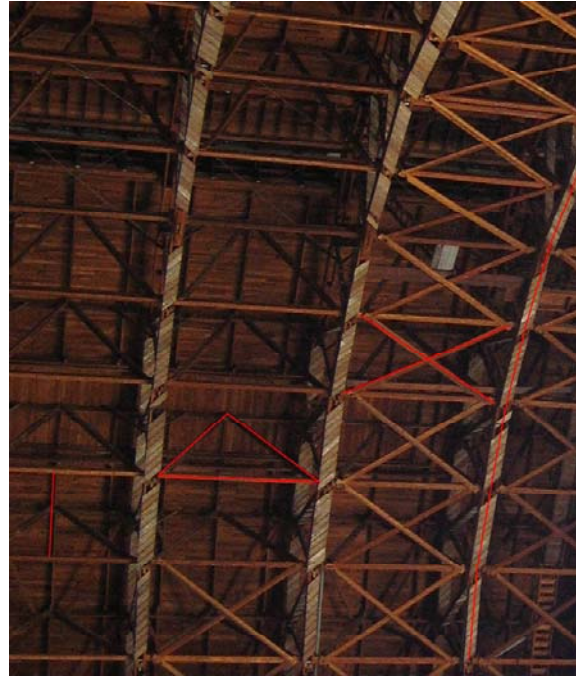
Figure 50. Detail of Structure showing in red, from left to right, purlin, chevron-bracing, X-bracing, and bottom chord of truss. Typical of Hangar 2 and 3.

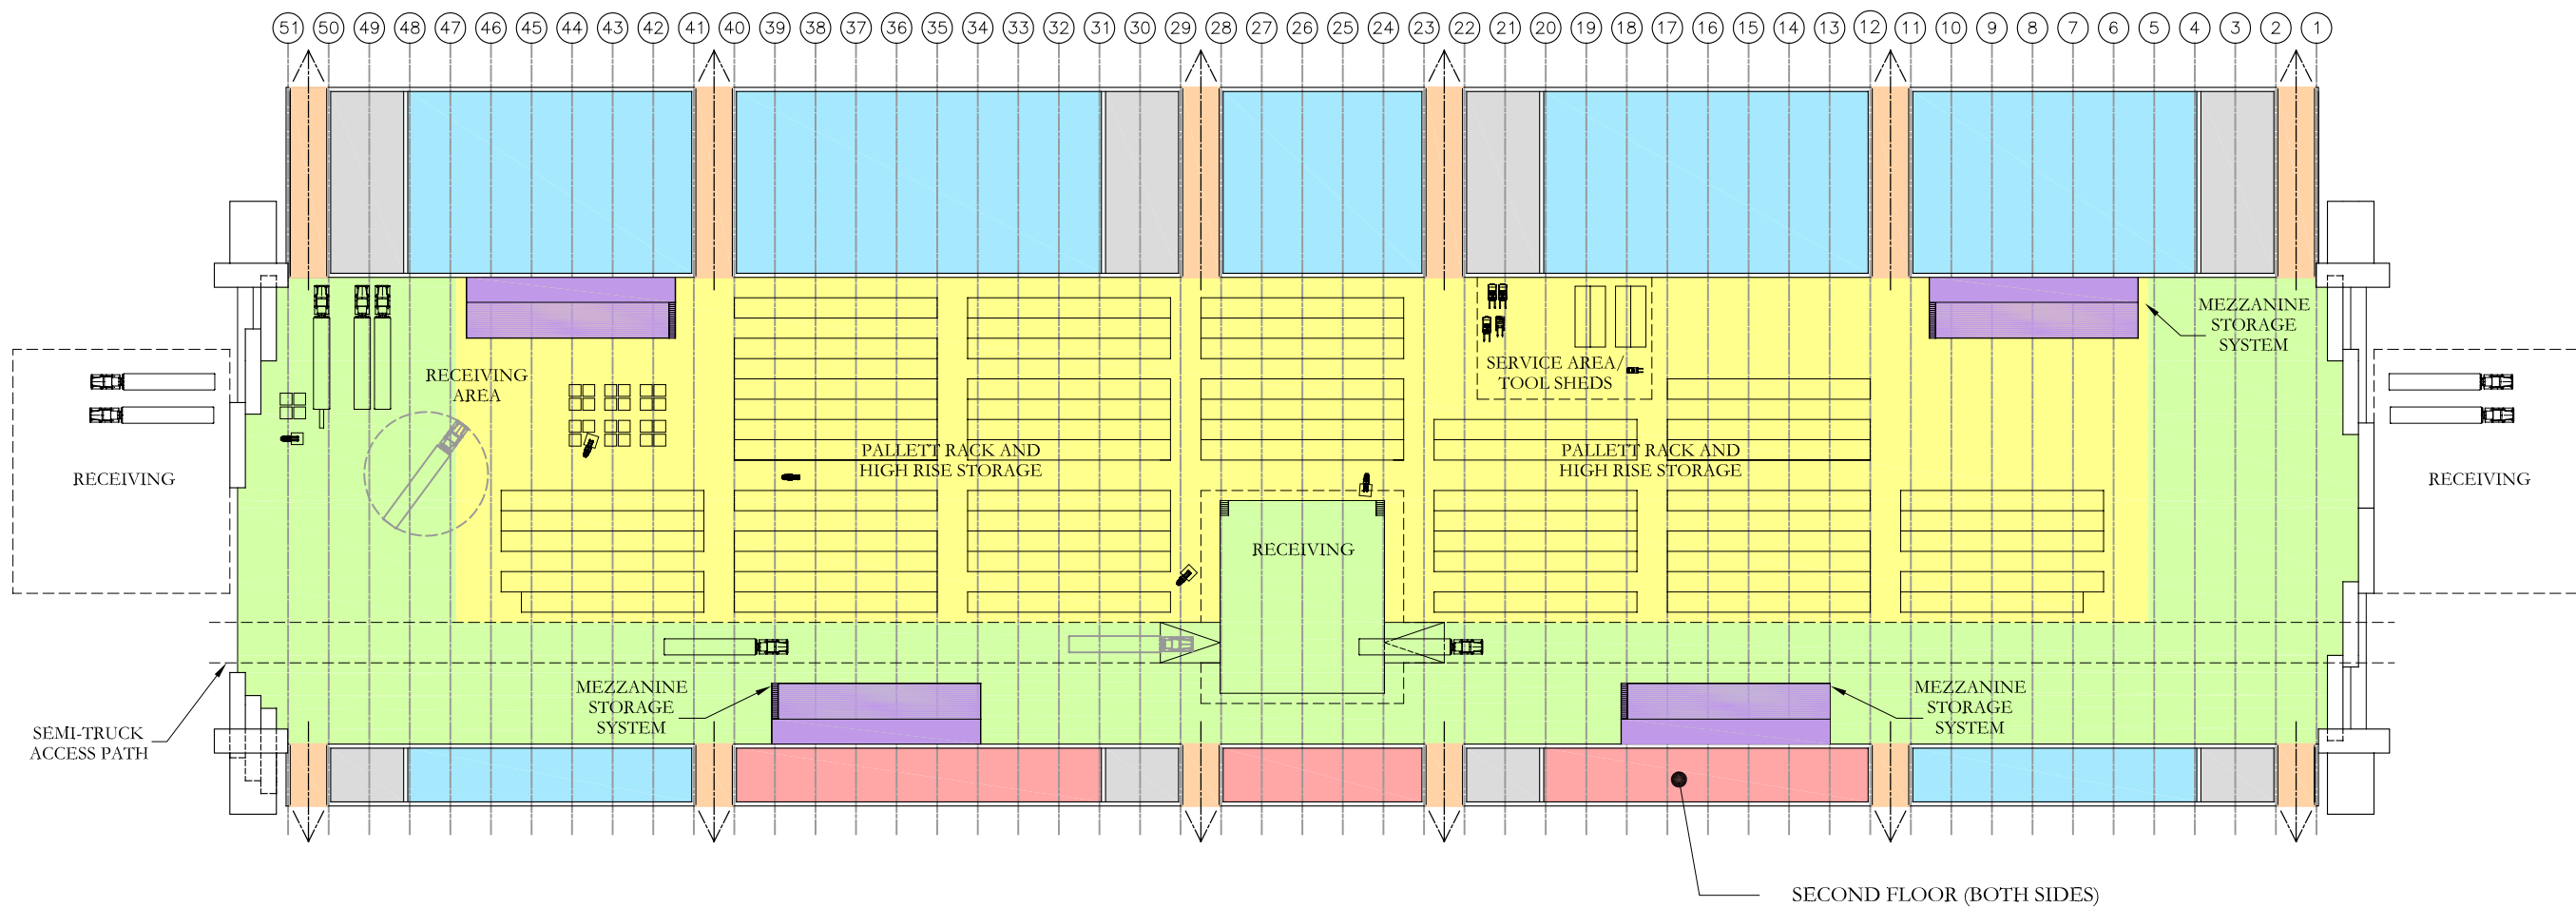
**SCHEME TWO:
FEDERAL EMERGENCY
AND MANAGEMENT AGENCY
STORAGE FACILITY**
