Re-Use Guidelines
Appendices

Hangar 2 (Building No. 46)

NASA Ames Research Center
Moffett Field, California

August 30, 2006

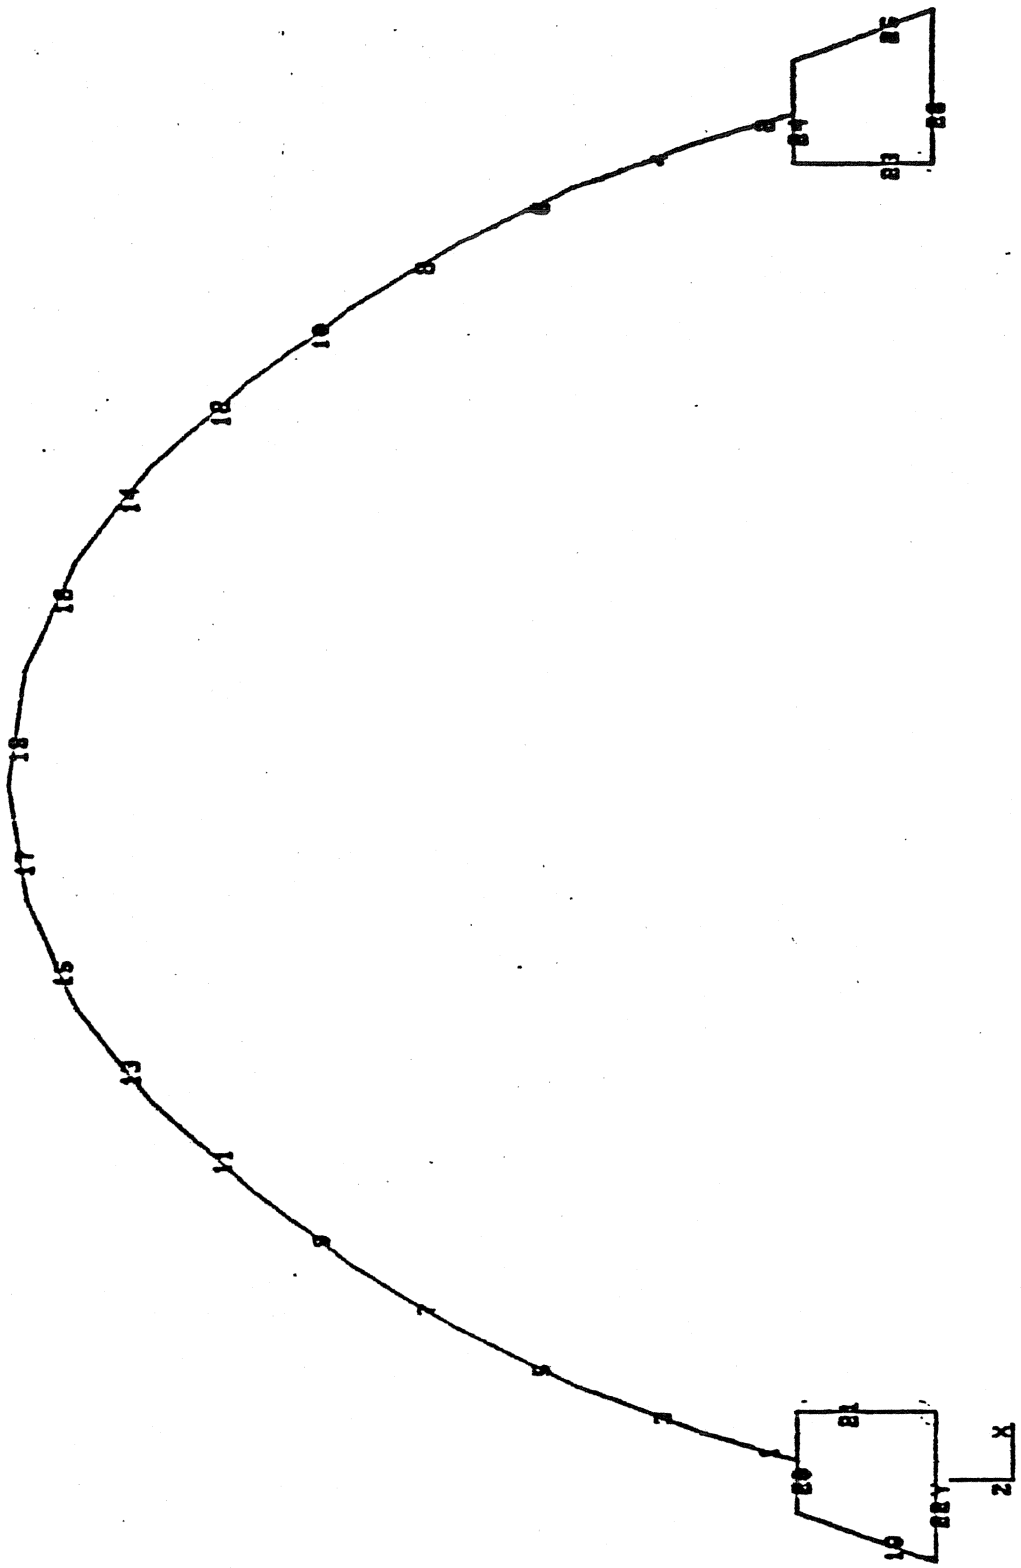
COMPUTER MODEL OF
TYPICAL TRANSVERSE ARCH A 46-5

The main structure of Building 46 was evaluated using Special Provisions for Large Hangars described in Section 1, Part H of this report. A full dynamic modal analysis was performed on the typical transverse arches. To reduce the number of members, the trusses of each arch were modeled as beam members. No simplification was made in modeling the members of the concrete base. Refer to Figure 46-4 for a sketch of the typical transverse arch and to Figure 46-5 for a sketch of the computer model used in analysis. Lumped masses were applied at each node.

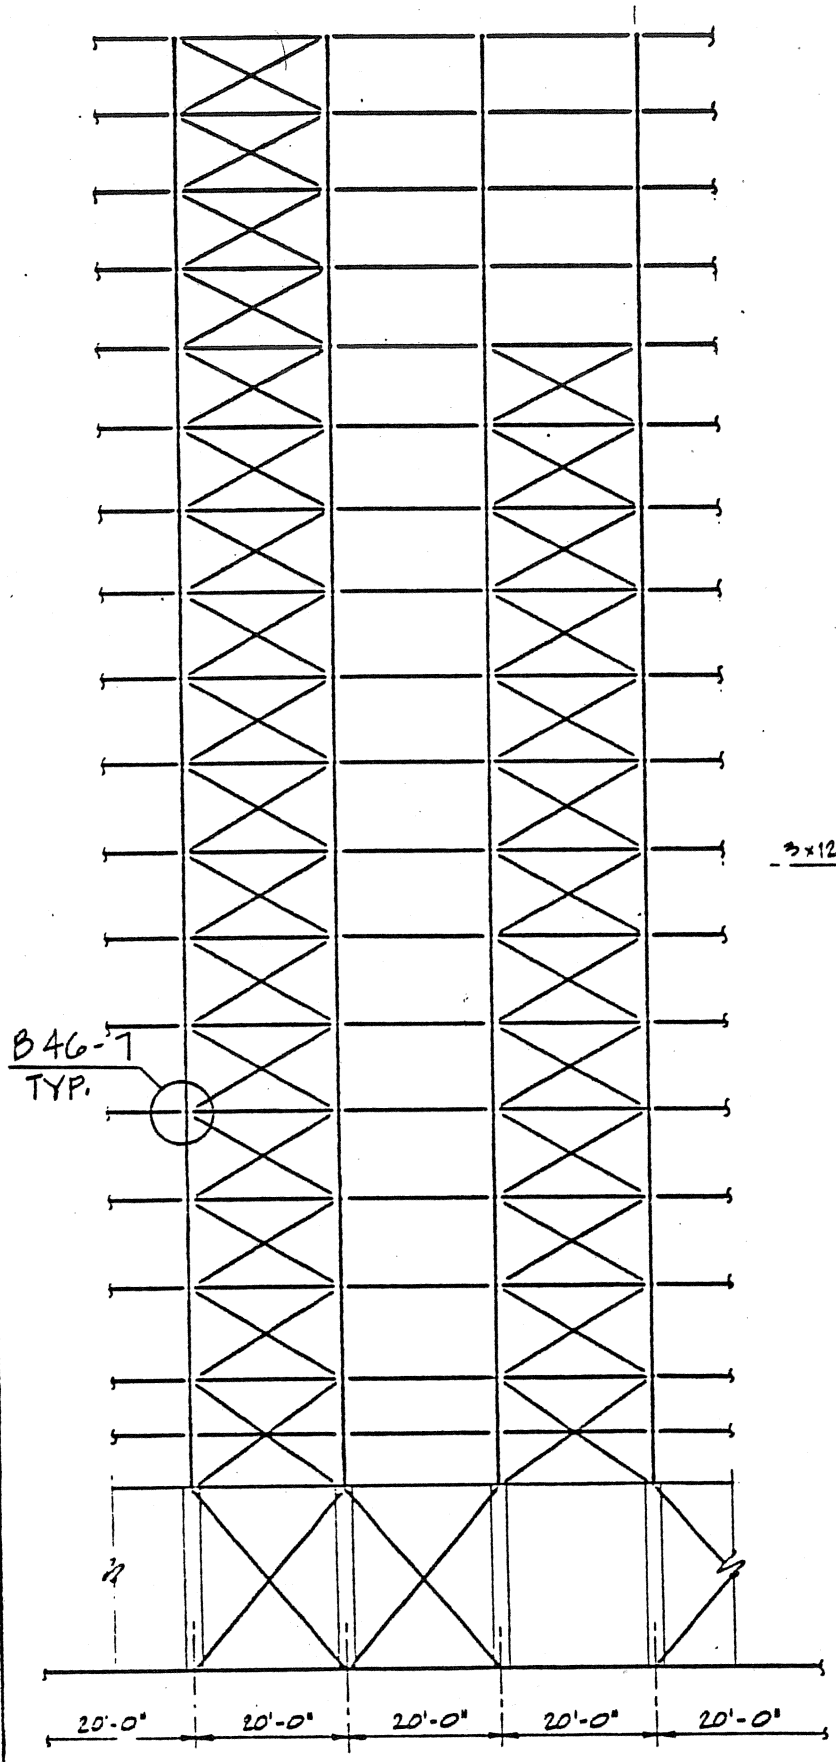
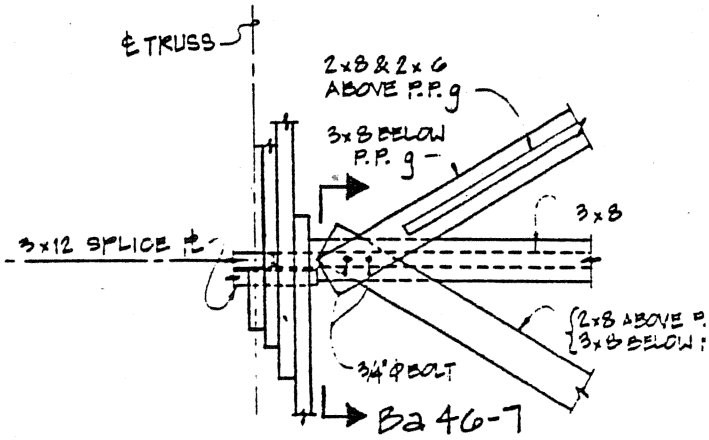
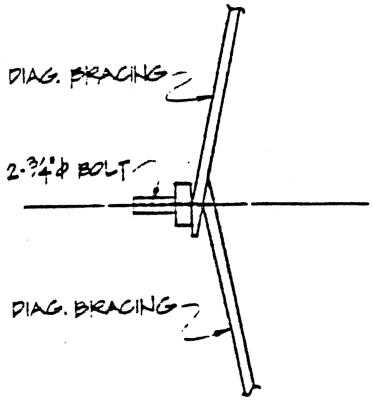
TYPICAL BRACING TRUSS A 46-7

The structural analysis indicates the concrete frames, concrete door towers, and connections of the longitudinal wood bracing are all overstressed. The repair scheme proposed is to strengthen the hangar by infilling the concrete frames with a concrete wall, adding a concrete diaphragm at the top of the frames, strengthening all the overstressed connections, and providing new concrete struts to brace the door towers. The estimated cost for this structural repair scheme is $2,400,000.

LONGITUDINAL TRUSS - ALL CONNECTIONS ARE N.G. TO REPAIR, CUT EXIST DIAG, ADD NEW HORIZ & RECONNECT TO MAIN TRUSS - CONN O.S. @ LEVEL 2 = 1.0 ∴ SIZE CONN FOR LEVEL 2 FORCES AT 2x W.S. ALLOWABLES, ADD NEW DIAG

The structural strengthening estimate is comprised of $1,550,000 for the strengthening of the hangar structure and $850,000 for bracing the door towers. The hangar strengthening estimate includes $1,000,000 for a new shear wall system to resist transverse seismic forces, and $550,000 for repairs to the longitudinal bracing trusses.

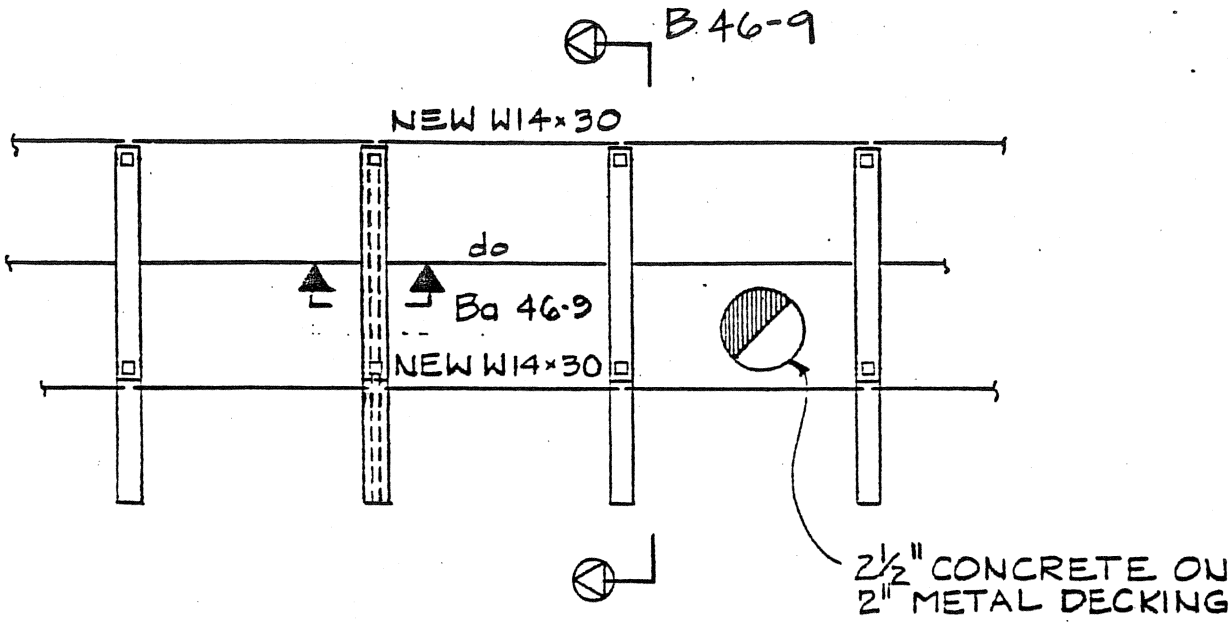
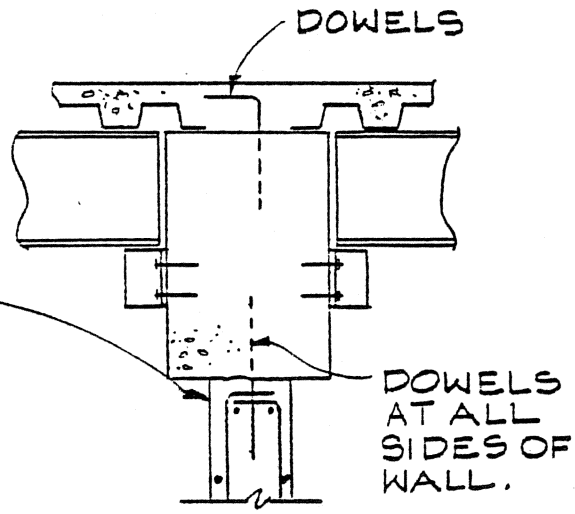
PLAN AT TOP OF CONCRETE BENTS A46-9

TRANSVERSE SEISMIC - EXISTING CONCRETE FRAMES ARE NOT ADEQUATELY REINFORCED TO RESIST SEISMIC FORCES. TRY THE FOLLOWING REPAIR SCHEME:

TITLE TYPICAL CONCRETE BENT REPAIRS			
BLDG NO. 46	BLDG NAME HANGAR 2	BY J.U.	FIGUR 46.
EVALUATION OF SEISMIC VULNERABILITY OF STRUCTURES - NAS MOFFETT FIELD		DATE DEC. 84

1. INFILL EVERY 3RD BENT WITH A NEW CONCRETE SHEAR WALL
2. REINFORCE OR REPLACE EXISTING DIAPHRAGM (K-BRACING) AT TOP OF BENTS TO DELIVER LOAD

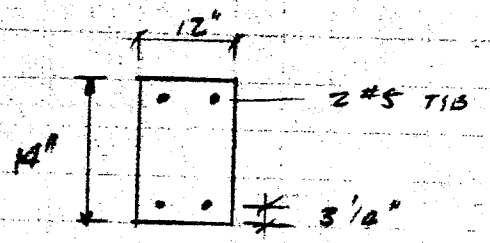
CRACKED SECTION OF GRADE BEAM

REVISE BASE FRAME USING CRACKED SECTION PROP'S

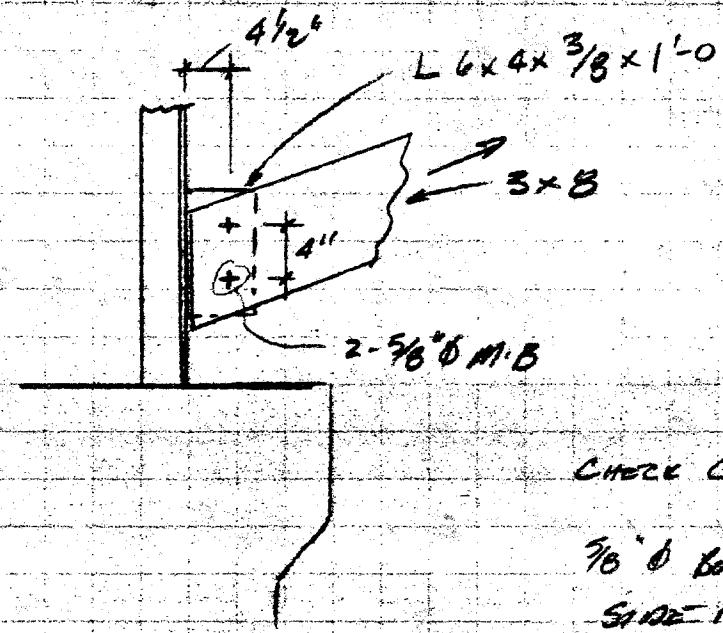
HANGER 2 DIAG CONN @ TOP OF CONCRETE BENTS

ALL CONN. SUSPECT, LONGIT N.G.

$T = \cancel{15.8}^{16.2}$ LEVEL 1

$\frac{V}{2V_{ALL}} = \frac{15.8}{2 \times 2.5} = 3.2$ N.G

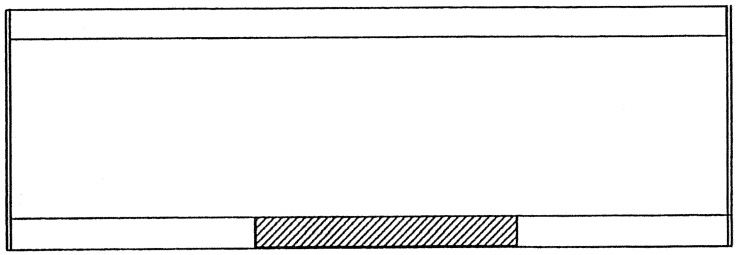
HANGAR 2 PLAN VIEW
SECTION 2

1. THIS AREA EXCEEDS EXIT DISTANCE LIMITS. RECOMMEND FIRE RATING THE EXISTING CORRIDOR WALLS TO INCREASE DISTANCE LIMITS OR PROVIDE A NEW EXIT CORRIDOR IN THIS AREA TO THE OUTSIDE.

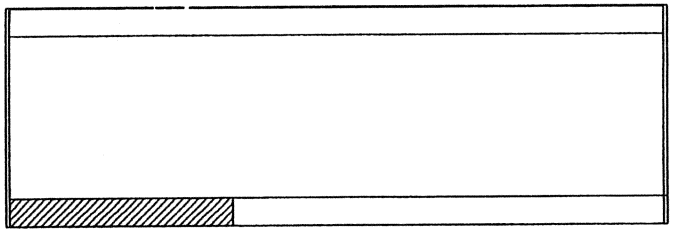
HANGAR 2 PLAN VIEW
SECTION 3

1. THIS AREA EXCEEDS EXIT DISTANCE LIMITS. RECOMMEND FIRE RATING THE EXISTING CORRIDOR WALLS TO INCREASE DISTANCE LIMITS OR PROVIDE A NEW EXIT CORRIDOR IN THIS AREA TO THE OUTSIDE.

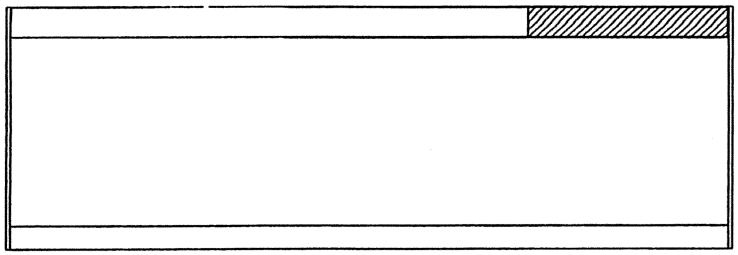
HANGAR 2 PLAN VIEW
SECTION 6

1. THIS AREA NEEDS TWO SEPARATE EXITS DIRECTLY TO THE OUTSIDE. RECOMMEND CONVERTING OFFICE SPACE A & B ABOVE INTO EXIT CORRIDORS TO THE OUTSIDE.

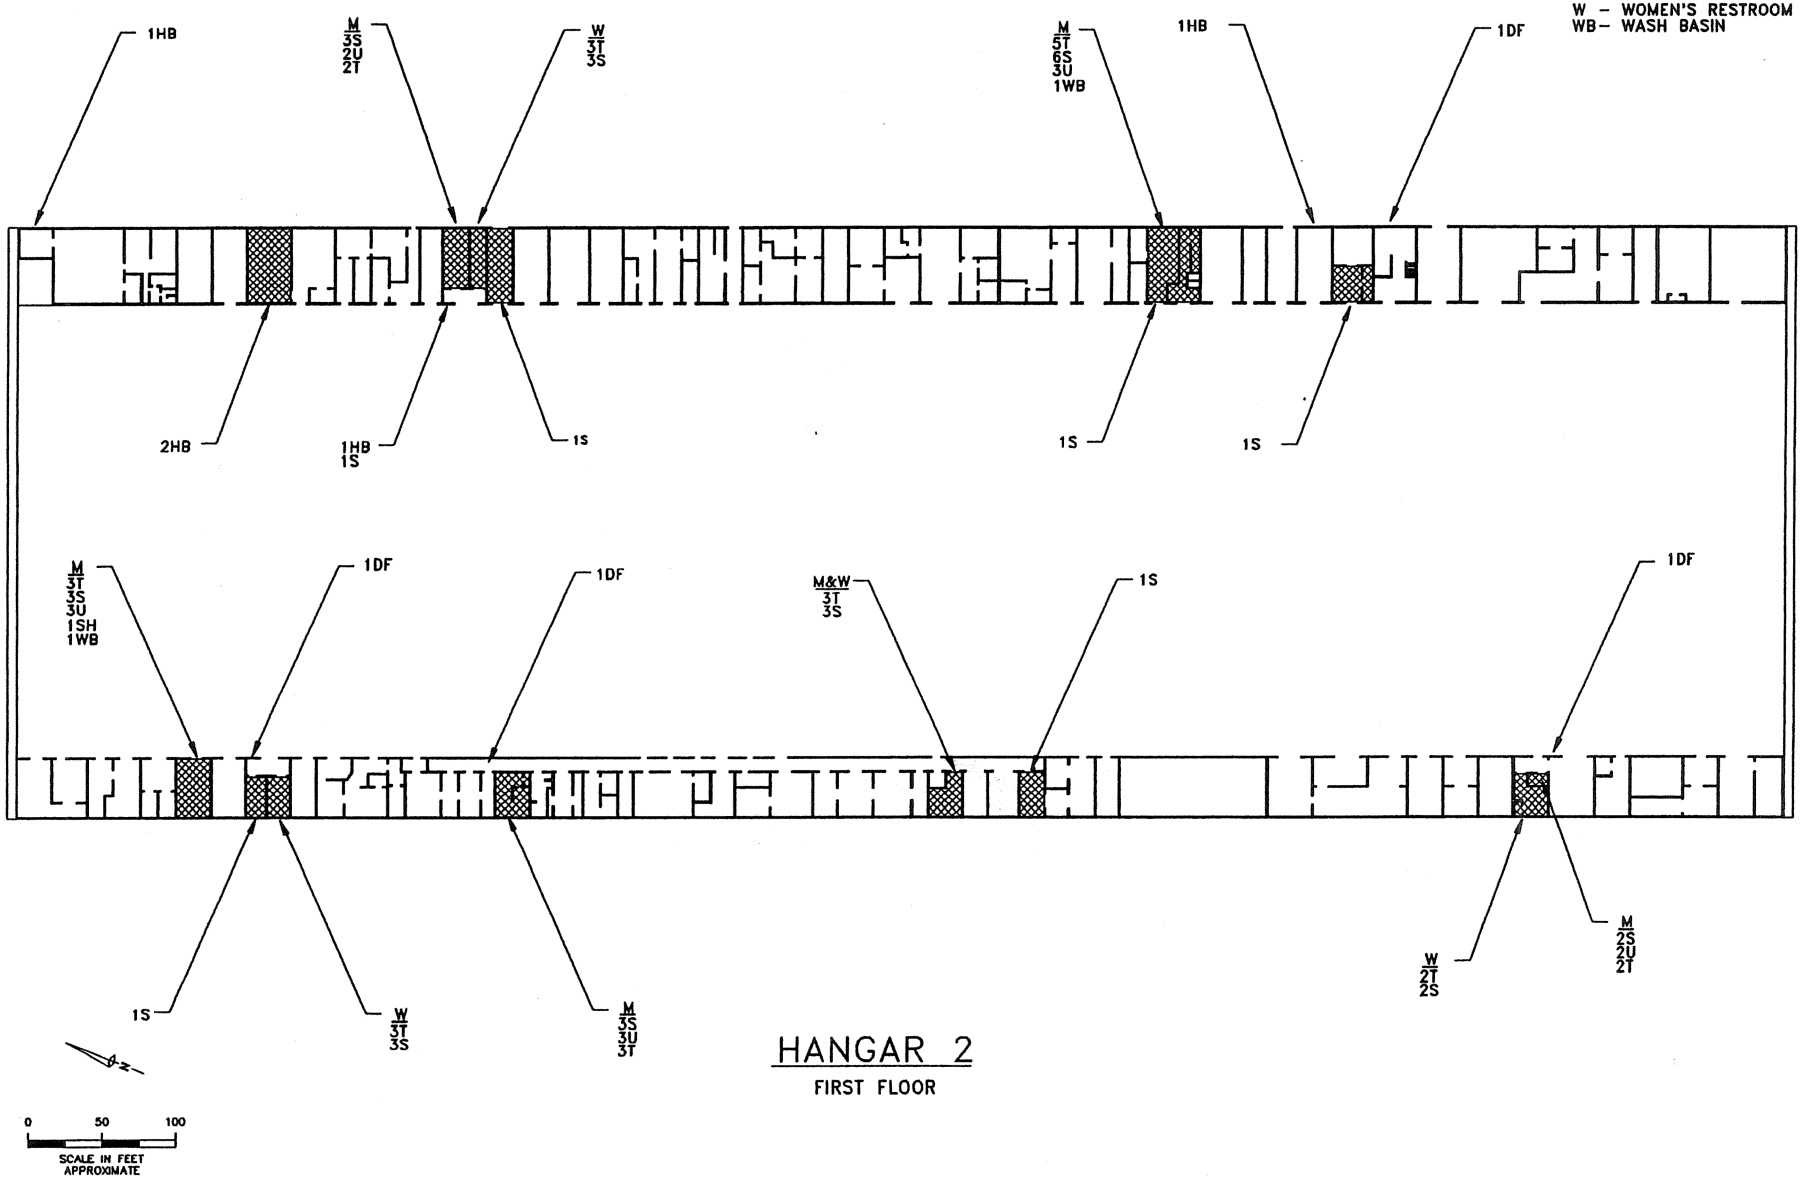
FIGURE 6

The shaded areas in Figures 6 & 7 show the Potable Water Distribution for Hangar 2. Please note that most of these areas are lavatories, locker rooms, or lounges.

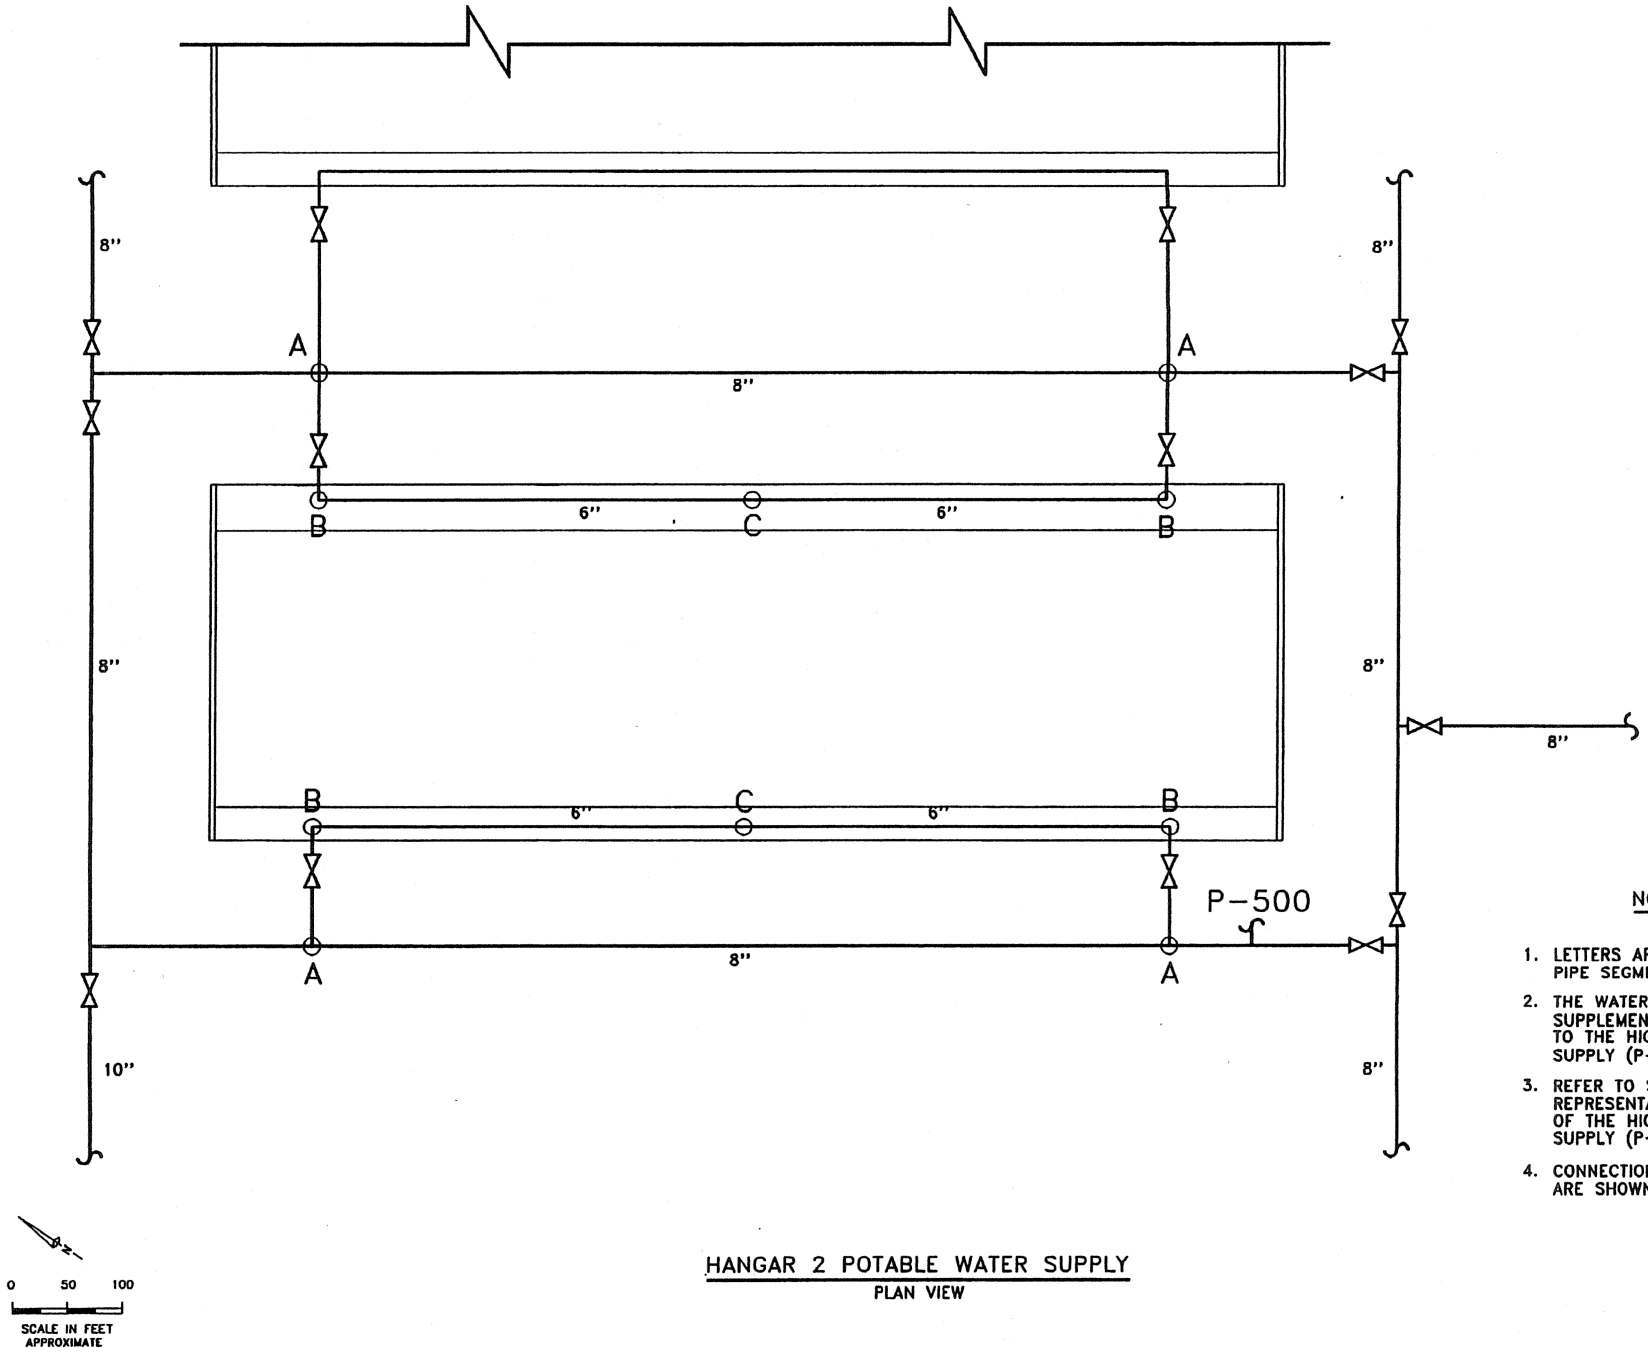
FIGURE 8

Hangar 2 is currently being supplied potable water through 2 - 6" pipes. The pipe entering the building on the East side serves the East side of Hangar 2. Similarly, the pipe entering the West side serves the West side. Both of these pipes are connected (in 2 places each) in parallel to the 8" water main that surrounds the building. (Documents that show the actual locations of these connections were not found.) See Figure 8 for approximate locations. See Figure 9 for an elevation view of the Potable Water distribution.

The Potable Water Supply to Hangar 2 will be analyzed by comparing the two extreme cases. The first analysis assumes that water is only supplied from one connection of each pair and that the piping from the other connection (including its riser) is neglected. This analysis is represented in Figure 8 by the typical pipe segment ABCB. The second analysis assumes equal flow into Hangar 2 through all 4 connections. This analysis is represented in Figure 8 by the typical pipe segment ABC. Both of these analyses compare the current demand on the system (based on a standard public usage rate for each fixture) to the supply capability of the existing piping. Please note that the actual usage may be more or less.

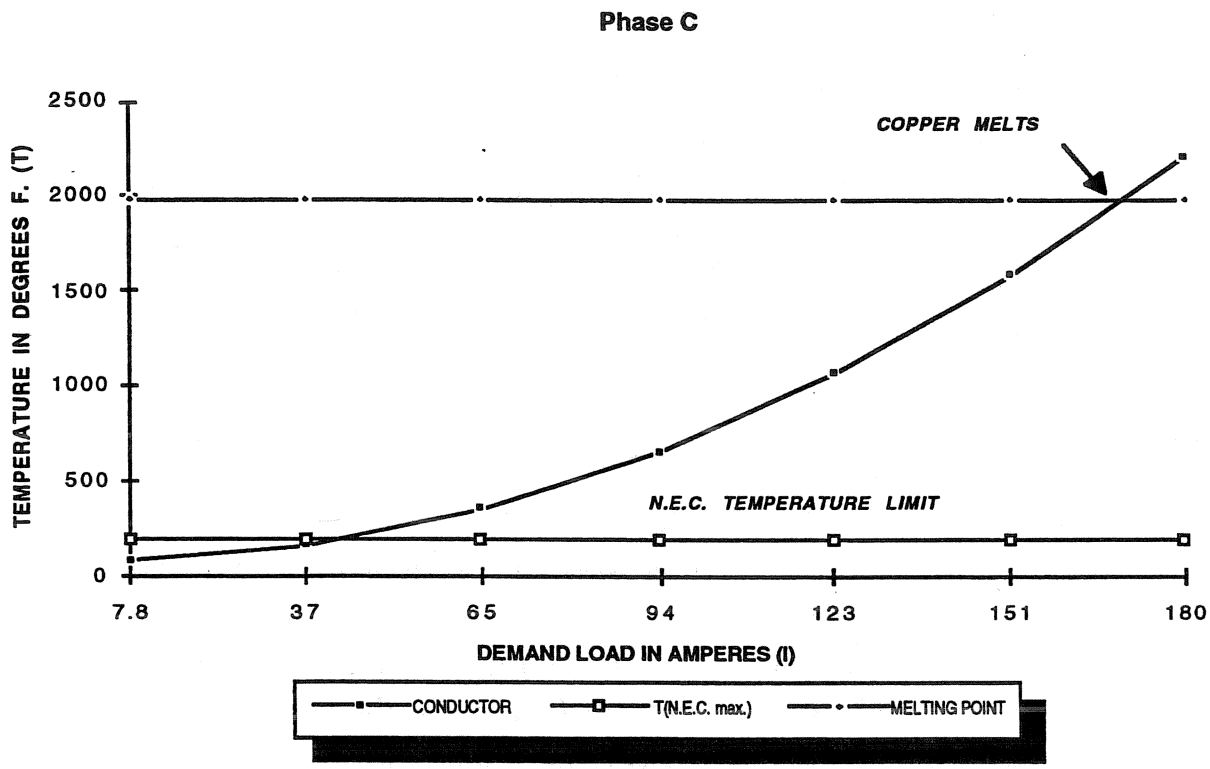
TABLE 7.3

The thermographic scan indicated a thermal anomaly at the vacinity of the 2nd breaker down from the top left hand side (rated at 225 amps) located at the bottom of the switchboard; further research found the surface temperature of the wire insulation to be at 82 degrees F. on all three phases. Phase C was only drawing 7.8 amperes (4 % of design load). Table 7.3 and the accompanying chart depict what the temperature of phase C could be under 100 % of demand load conditions. These numbers could be deceiving; due to the high potential for error attributed to the minimal load and the chance of heat dissipation from the surrounding breakers that are exposed to higher load conditions.

The following Table 7.3 reflects the calculated resultant conditions that could occur if the subject breaker and conductors were exposed to a hypothetical full demand load. Based on the stipulations set forth in Article 210-22 of the National Electrical Code, the calculated full design load of the circuit cannot exceed 180 amperes ($I_{max.}$). At the time of the most recent data acquisition (specified above), the primary load was approximately 7.8 amperes ($I_{rec.}$). This is only 4% of the maximum design load. Hence, if the existing or future Resident Agency(s) were to utilize the full capacity of this circuit (100% of the maximum design load) the temperature of the breaker and conductors could be greater or equal to 2130 degrees F. As depicted in the following graph for Phase C, this temperature exceeds the temperature limit set forth in Article 310 of the N.E.C. by 2014 degrees F. and will seriously damage the breaker, the conductor, and the insulation surrounding them; making a failure condition imminent. The hypotheses stated above is considering the facts that the strength of copper and aluminum decreases significantly, and that these metals are subject to embrittlement after being exposed to temperatures above the N.E.C. limit. Aluminum melts at 1220° F. and Copper melts at 1980° F.

3) Prior to performing the following tasks, attempt to simulate full load conditions and verify the accuracy of the hypothetical data set forth in Table 7.3. If needed, request and implement a power outage to perform the following tasks: Check the condition and cleanliness of the conductors and the 225 ampere breaker (internally, and at the connections); repair/replace as needed.
