Condition Assessment and Rehabilitation Plan Hangar One

for NASA Headquarters and
Ames Research Center, California

Volume 1
Condition Assessment

Hangar One – Ames Research Center, Moffett Field, CA

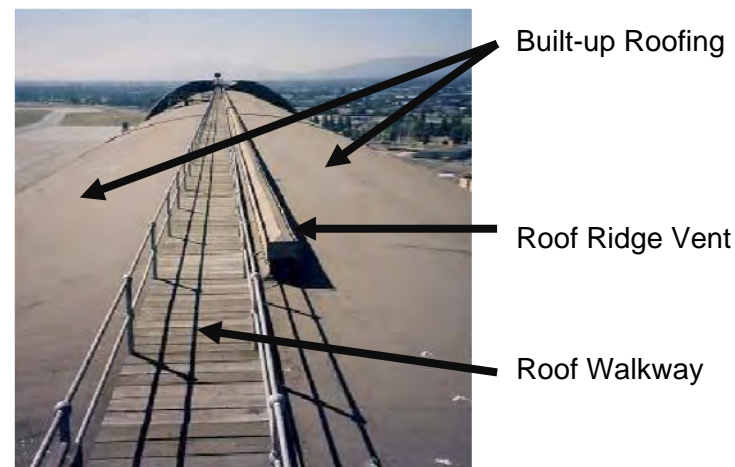
Figure 2. 7

of the hangar structure is a roof ridge vent and a walkway (see figure 2.7) with railings that run the length of the hangar. The walkway is supported by a steel structural frame that is raised above the built-up roof, which passes beneath the walkway. The walkway facilitates access of the hangar roof and also provides access to the roof mounted beacons and obstruction lights. Access to these features shall be maintained at all times for maintenance purposes prior to, during and following the ongoing Navy removal action and will need to be maintained during future rehabilitation efforts. There is also a large holiday star located on top of the hangar that automatically illuminates nightly at certain times of the year.

There are also two dog houses located at the north and south ends of the roof for access to the hangar door pivots and a central access platform where access to the walkway is provided. The current railing configuration on the walkway does not meet OSHA requirements for guardrail height. The existing wood decking of the exterior roof walkway and contaminated wood on the internal catwalks will be removed with the ongoing Navy removal action. The railings and steel structure will remain.

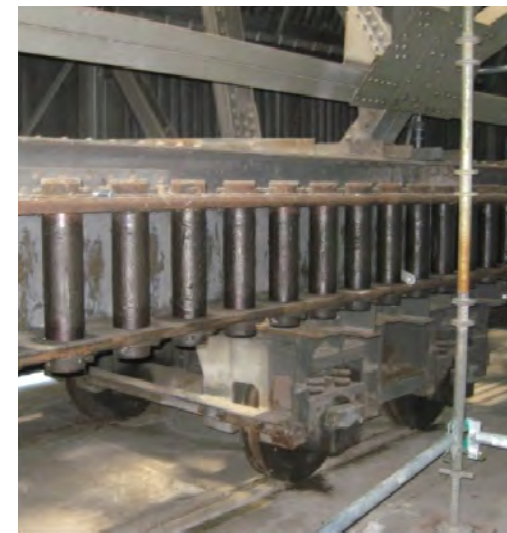
Figure 2.13

Each hangar door leaf sits on nine trucks (see figure 2.13) that consist of support for the door leaf and a series of wheels that roll on tracks that are mounted within the concrete hangar floor slab. These tracks extend beyond the building enclosure and allow the hangar door leaves to roll into their fully open position. At the end of each set of tracks is a door stop that would protect the hangar from the doors opening too far. The wheel and trucks appear to be in relatively decent shape based on visual inspection but because they have not been operational for many years they would require maintenance and cleaning in order to bring them to a fully functional state of operations. These motors may need electrical components replaced as well in order to meet current regulations.

As part of the Navy’s removal action they will be draining oil from the trucks and providing overall thorough cleaning of all mechanisms. Some items may not be able to be thoroughly cleaned due to inability to completely disassemble some pieces or difficult locations of equipment. A site

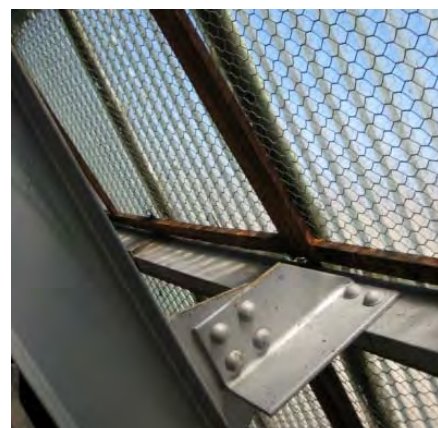
Figure 2.21

The corrugated windows represent one of the important features contributing to the historic value of the exterior of the hangar. Chicken wire panels with wooden frames have been installed at the interior of the windows (see figure 2.21) in isolated locations in order to minimize the potential for broken pieces of the glass to fall to the hangar floor below.

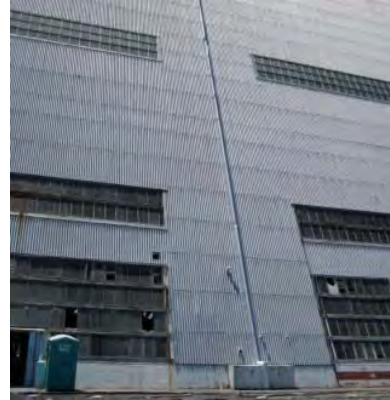
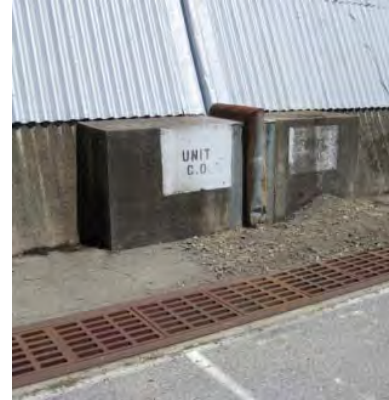
Figure 2.27

There are two major building expansion joints located in Hangar One. These are located at structural grids 4/5 and 10/11. At these locations, two sets of trusses are provided approximately 4 feet apart from each other to allow for movement of the structure. The metal wall panels and built-up roofing stop at the expansion joint and copper/steel flashing details are provided to allow for movement to

occur while keeping moisture from getting inside the hangar. The expansion joints continue across the concrete foundation walls at the base of the hangar exterior (see figure 2.28). The expansion joints augment the thermal expansion capabilities of the metal panel bolt/clip system, which were designed to flex with the movement of the panels.

The expansion joints are in relatively good condition. At the metal siding areas the joint covers have received minor denting. These joint covers have received the various coatings over time and do not have any visible corrosion or deterioration. The metal covers at the concrete base have received more damage over time and are dented and rusted. They will require replacement as part of any future rehabilitation of the hangar exterior.

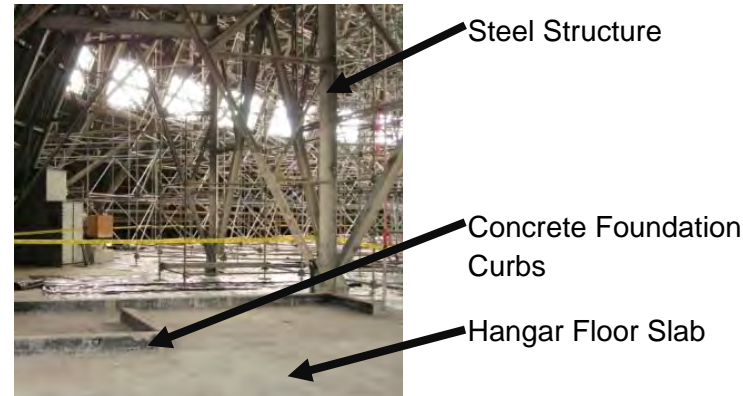
Figure 2.32

Based on interior construction and structures that were added for the various occupants of the hangar there are concrete foundation curbs at various locations in the hangar (see figure 2.32). The removal of these curbs is not presently part of the Navy removal action but the curbs would have to be removed as part of any future improvements. Refer also to the structural condition assessment for additional concrete slab information. Two locations of concrete slab within the hangar have been noted during the Navy removal action where the concrete is deteriorating. One location existed prior to the removal action. A third area within the hangar was identified as a potential void space beneath the concrete slab that may have been created during a water main break. The water main break was repaired by NASA and occurred prior to the removal action.

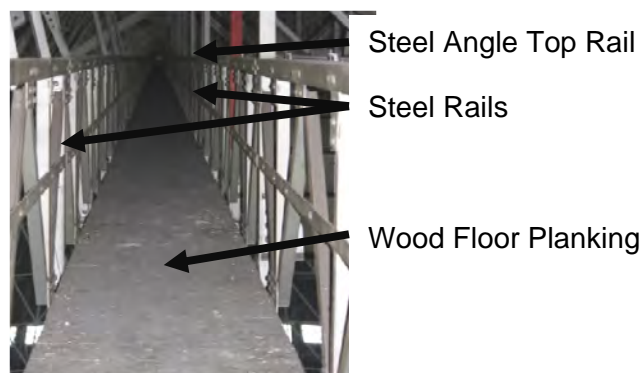
Figure 2.33

A series of stairs, ladders and catwalks provides access between the hangar ground floor and the upper portion of the hangar interior, including access to the outer portions of the roof. The current configuration of railings, specifically the height and/or shape of railings does not comply with OSHA requirements. The stair railings are

As part of the ongoing Navy removal action the wood floor planking of the catwalks is being removed as it has absorbed contaminants. The steel components will be left in place and future use will dictate the replacement requirements.

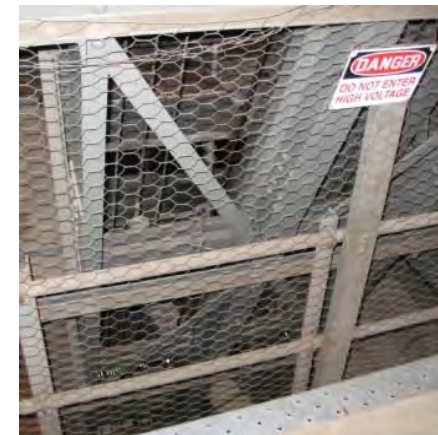
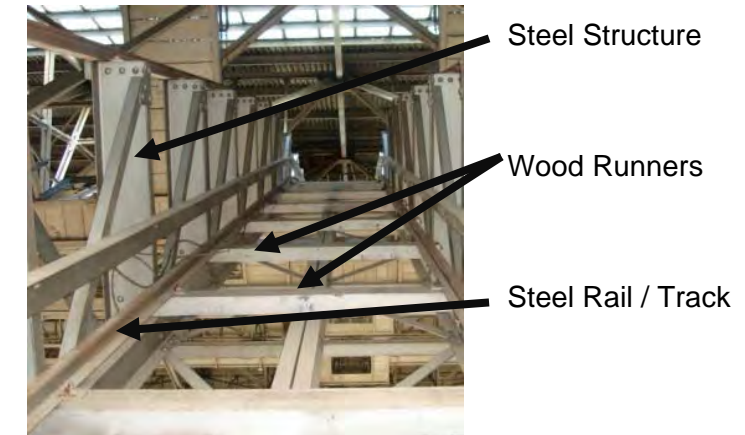
The steel elevator rails are welded to steel angles which are in turn welded to the steel hangar superstructure. There are wood runners spaced periodically (see figures 2.34 and 2.35) that have similar contaminants as the metal panels. These wood runners are being removed as a part of the ongoing Navy removal action. An engineering analysis by Will Design in April 2011 has verified that removal of these wood runners would not adversely impact the steel rail connection to the hangar structure from a vertical load standpoint.

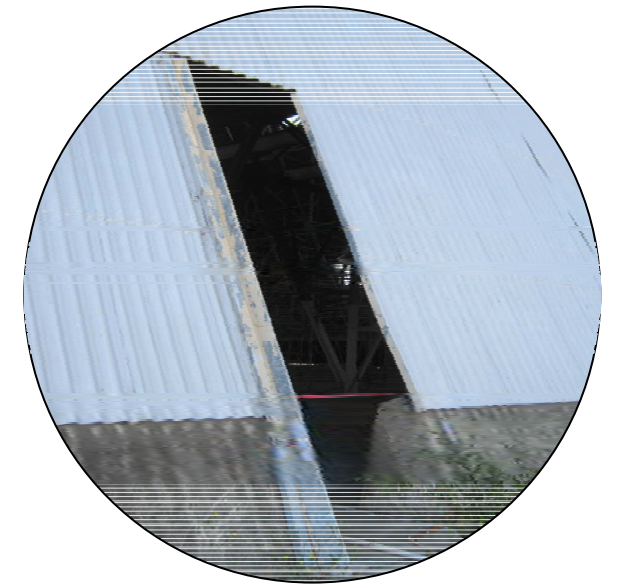
Figure 3-17: New Opening

The concrete perimeter walls also appear to be in good condition. No concrete decay was noted during the site visit. The new doors in the hangar wall were saw cut through the concrete. The saw cut portion may need to be replaced for historical reasons.

The one tall new opening in the east side of the hangar will need to be repaired. At this location, a wind girt was completely severed to accommodate the new opening. That wind girt will need to be replaced with a modern steel member similar to the original member. The location of the girt is shown in Figure 3-27. The figure shows the steel member at the top of concrete wall which was cut and will need to be replaced. The girt is directly above the opening shown in the figure.

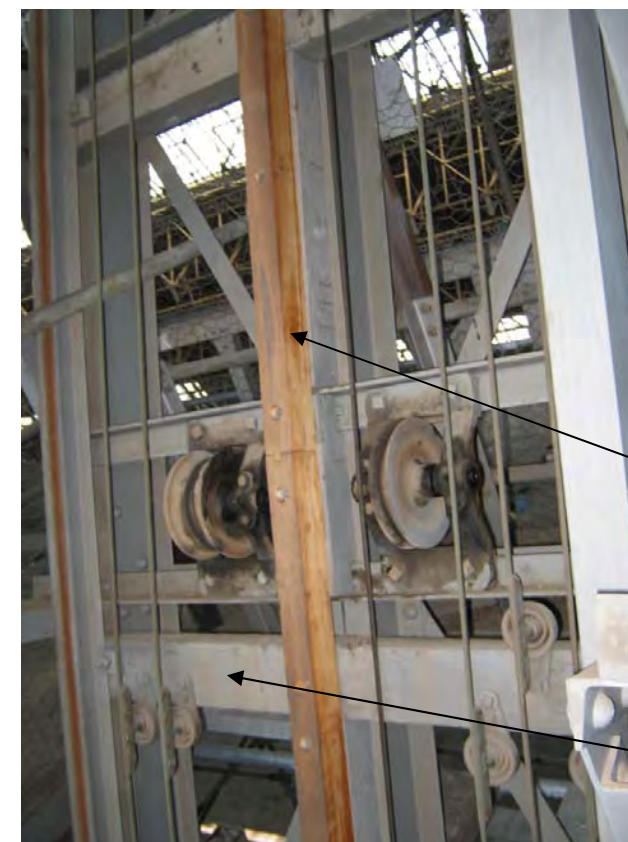
The elevator system uses redwood ties to support the rails and a redwood center rail that apparently guides the elevator cab. The wood members at the elevators would need to be replaced if the elevators are to be made functional again.

Wood Center Rail

Wood Tie Supporting Rails

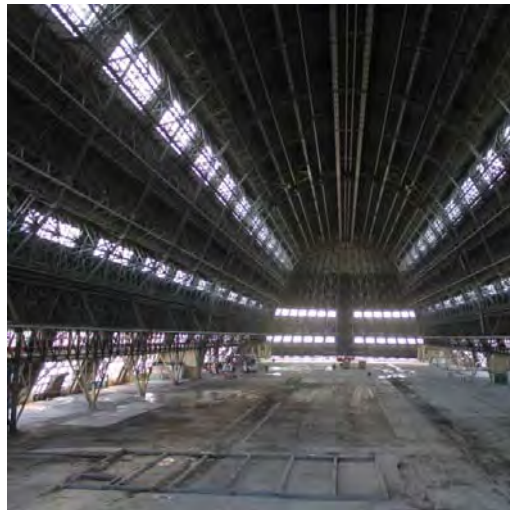
Figure 6.11

The existing hangar floor slab is less than ideally smooth. It is rough, and uneven in various locations that will make it an area of future modifications, depending on future tenants requirements. The floor slab also contains multiple locations of existing concrete curbs that served as foundations for previous interior construction that has since been removed from the facility as part of the Navy demolition contract. These curbs will require future removal to facilitate re-use of the interior of the hangar. There also are small areas of topping slabs that previously provided smooth floor slabs within various interior spaces. These topping slabs will likely need to be removed to meet future tenant needs. Additionally, the existing 8" deep hangar slab was originally designed for use with a 'lighter than air' aircraft. Because of this, the floor slab load capacity might not be suitable for heavy loading and traffic.

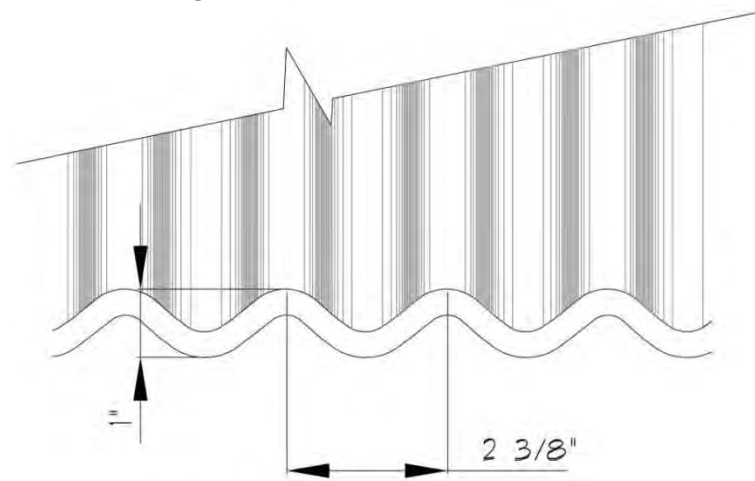
Figure 6.15

The existing windows, in particular the corrugated glass, are an important historic preservation feature of the existing hangar. Ideally the existing windows and frames would be salvaged and re-used. However, due to the poor existing state of the glazing and steel frames they are being removed as part of the Navy's removal action. Left in place are the steel support members that connect between the steel structure and the window frames. As part of the re-skinning project of the hangar new steel window frames and glazing will need to be provided to the requirements noted herein.

Existing 1/2 " thick Historic Corrugated Window

The most simple, preferable and recommended replacement for the windows is to replace the frames and glazing, in-kind, to match the detailing and attachment of the original construction. Readily available wired, corrugated glass to match the existing construction is difficult to find in the United States and difficult to find

without custom manufacturing from international sources. The recommendations of this Rehabilitation Plan are to require that custom manufactured wired glazing be provided to match the corrugated and flat glass window panels. Refer to the AECOM As-Built Drawings M001-1100-A7.01 through M001-1100-A7.22 for additional information.

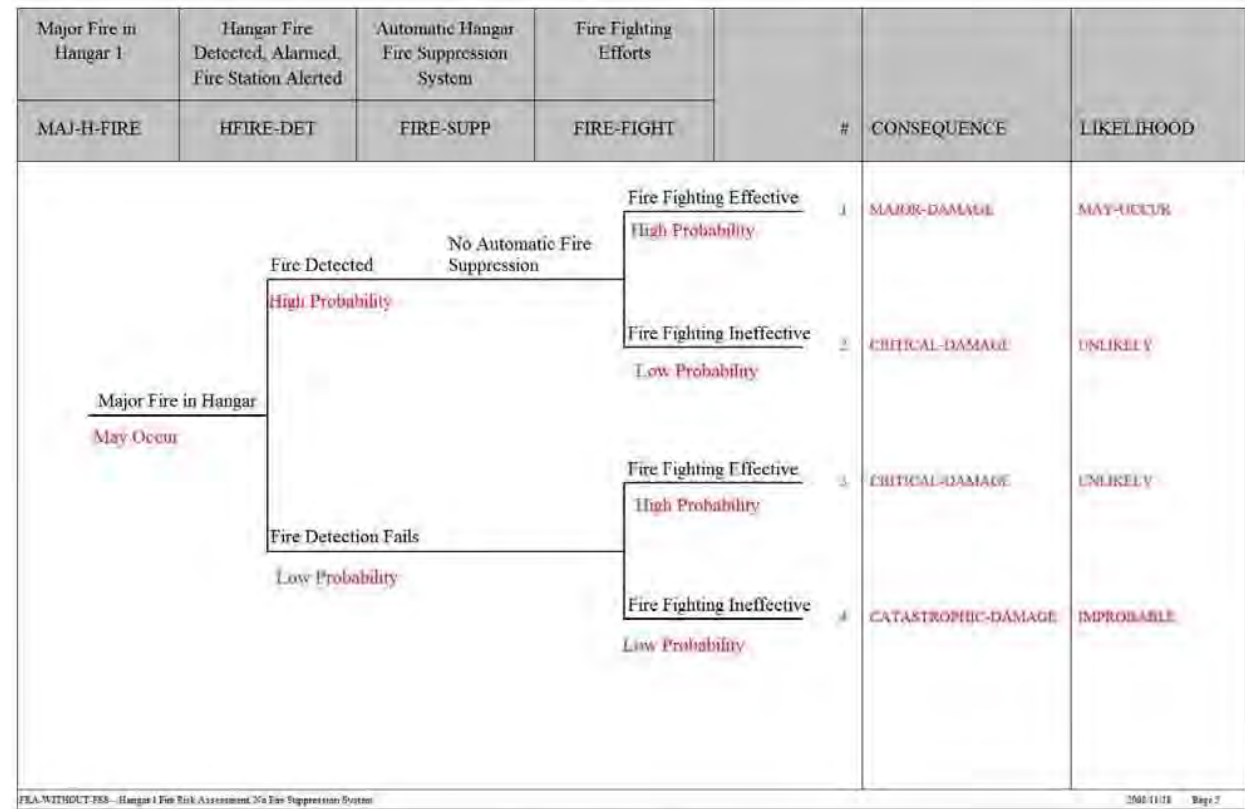
Figure 3: Event Tree for Fire Risk in Hangar 1 *without* any Special Hazard Fire Suppression System

The event tree in Figure 3 represents event sequences that could lead to fire damage in Hangar 1 and whose worst-case likelihood of occurrence has been judged to be as: “May Occur” in the life of the hangar.

At the third branch: if the fire is detected the alarm is set-off and the NASA/Ames Emergency Dispatch Center is notified. Since the NASA/Ames fire station is very close to Hangar 1, the response - *if* NASA/Ames Fire Department resources are in quarters and not assigned to another emergency incident - should be immediate and the team assessed that fire fighting should be effective (event sequence #1, Figure 3) with a high probability occurrence; and only with a low probability that fire fighting be ineffective (event sequence #2, Figure 3).

A major fire occurrence with effective firefighting (event sequence #1, Figure 3) was assessed to result in “Major damage” as a consequence with likelihood that it “May Occur” in the life of the hangar. A major fire with ineffective firefighting (event sequence #2, Figure 3) was assessed to result in “Critical Damage” as a consequence with a likelihood of “Unlikely” to occur in the life of the hangar. If the fire is not detected automatically, it eventually will get detected by personnel and the fire station notified. However, the notification is relatively late in this case (as compared to when the fire is automatically detected and the fire station is automatically notified). So in this case late effective firefighting results in “Critical Damage” (event sequence #3, Figure 3). Otherwise ineffective firefighting (event sequence #4, Figure 3) would result in “Catastrophic Damage” to hangar, which was judged to have an “Improbable” likelihood of occurrence in the life of the hangar.

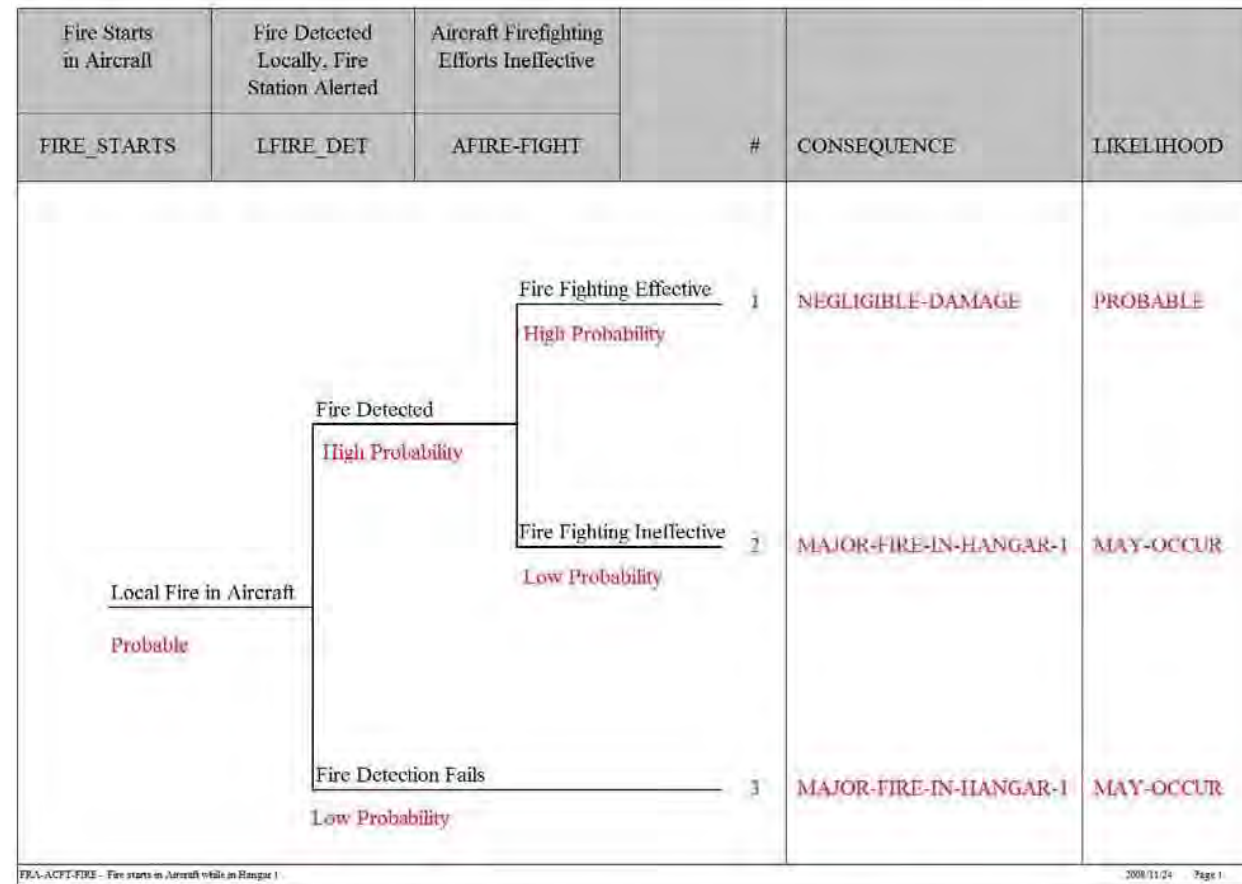
Figure 8: Event Tree for Aircraft Initiated New Hangar 1 Fire Risk

The initiating event is that a local fire starts in an aircraft that is stored in the hangar. This is assessed to be “Probable” in the life of the hangar. Local fire detection occurs with a high probability. When detected, the NASA/Ames Emergency Dispatch Center is alerted. If the local fire fighting is effective, it results in sequence #1 with a “Minor Damage” consequence and a “Probable” likelihood in the life of the hangar. Event sequence #1 occurs whether or not there is a Special Hazard Fire Suppression System and this risk is shown in the risk assessment matrix of Figure 1.

Event sequence #2 occurs if local fire fighting is ineffective and it results in a “Major fire in Hangar 1.” Event sequence #3 occurs if the fire is not detected in time so that it results in a “Major fire in Hangar 1.” These two event sequences shows that an aircraft related fire initiating event can spread and become a “Major fire in Hangar 1” with a “May Occur” likelihood in the life of hangar. These sequences feed the initiating event in event trees of Figures 3 and 5. These results partly justify the likelihood assessment of “May Occur” for the initiating event in “Fire Risk in Hangar 1 *without* any Special Hazard Fire Suppression System” (Figure 3) and “Fire Risk in Hangar 1 *with* a Special Hazard Fire Suppression System” (Figure 5).

Note that the event tree of Figure 8 does not include the NASA/Ames Fire Department's effectiveness in fighting the fire — they are included in the event trees of Figures 3 and 5.

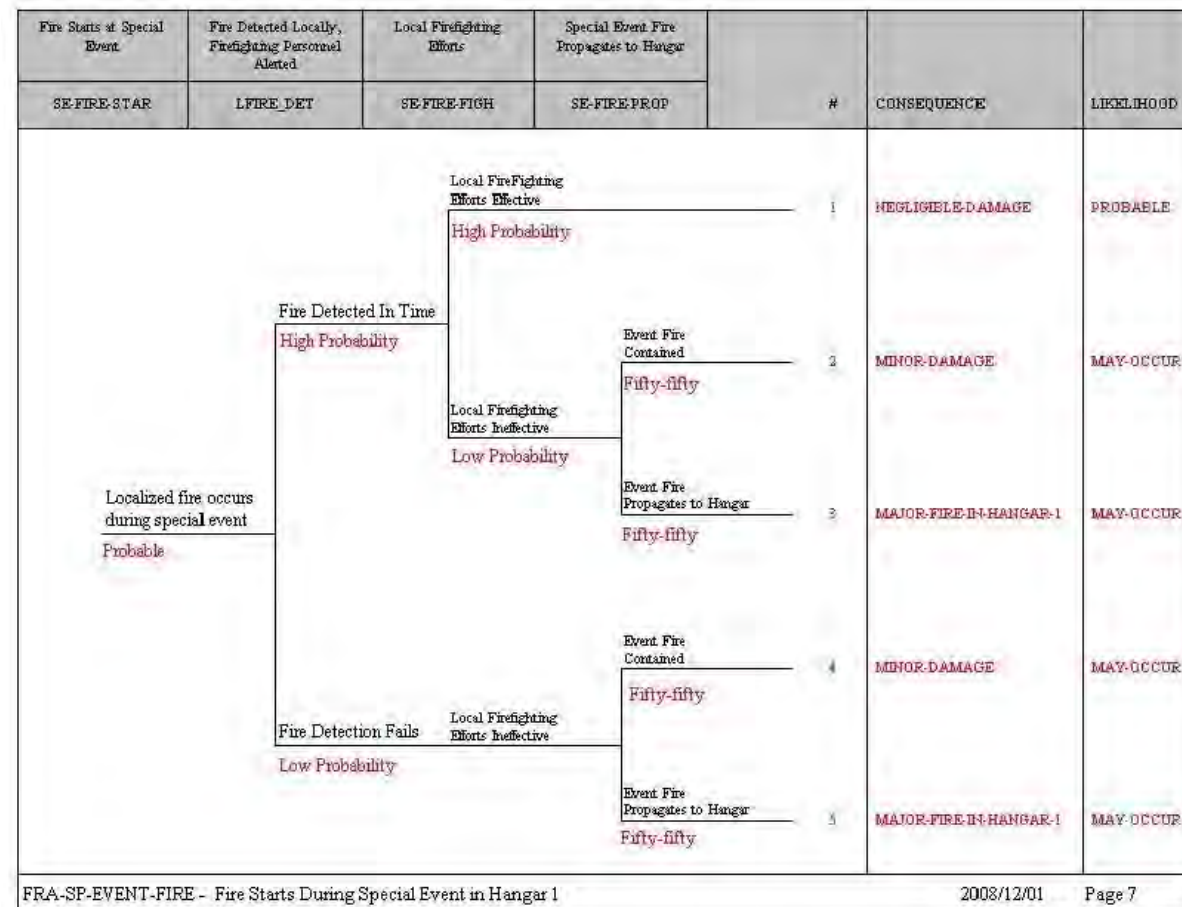
Figure 10: Event Tree for Special Event Initiated Hangar 1 Fire Risk

The initiating event of the Figure 10 event tree is that a localized small fire that occurs during the course of the special event. Due to the nature of special events, there can be multiple ignition

Local fire detection occurs with a high probability. When detected, the NASA/Ames Emergency Dispatch Center is alerted. In addition, the local personnel have access to and use the available fire suppression systems. If the local fire fighting is effective (sequence #1, Figure 10), it was judged to result in a “Negligible Damage” consequence and a “Probable” likelihood in the life of the hangar.

If local firefighting is ineffective there is a chance (assessed as fifty-fifty) that the fire will not spread to the rest of the hangar (sequence #2, Figure 10). The fire may lack sufficient combustible materials, or have barriers or have separation. This scenario was judged to have a “Minor damage” consequence and a “May occur” likelihood in the life of the hangar. Conversely, if fire spreads to nearby to aircraft/airship/hangar combustible material it could result in a “Major fire in Hangar 1” (sequence #3, Figure 10). This risk of this scenario (sequence #3), could be reduced to a lower likelihood if there are sufficient firebreaks between the special event location and the aircraft/airship/hangar, but the fifty-fifty chance is a conservative assumption.

If the fire is not detected in time, (and event with low probability of occurrence), then there is no local fire fighting. The fire either spreads in Hangar 1 or is contained on a fifty-fifty chance. The former leads to a “Major fire in Hangar 1” with “May occur” likelihood in the life of the hangar (sequence #5, Figure 10); while the latter leads to “Minor damage” with “May occur” likelihood (sequence #4, Figure 10).

Event sequences #3 and #5 represent the worst-case and feed the initiating event in higher level event trees of Figures 3 and 5. These results show that the likelihood assessment of “May Occur” for the initiating event in “Fire Risk in Hangar 1 Without any Special Hazard Fire Suppression System” (Figure 3) and “Fire Risk in Hangar 1 With a Special Hazard Fire Suppression System” (Figure 5) are a result of aircraft initiated fires and special event fires.

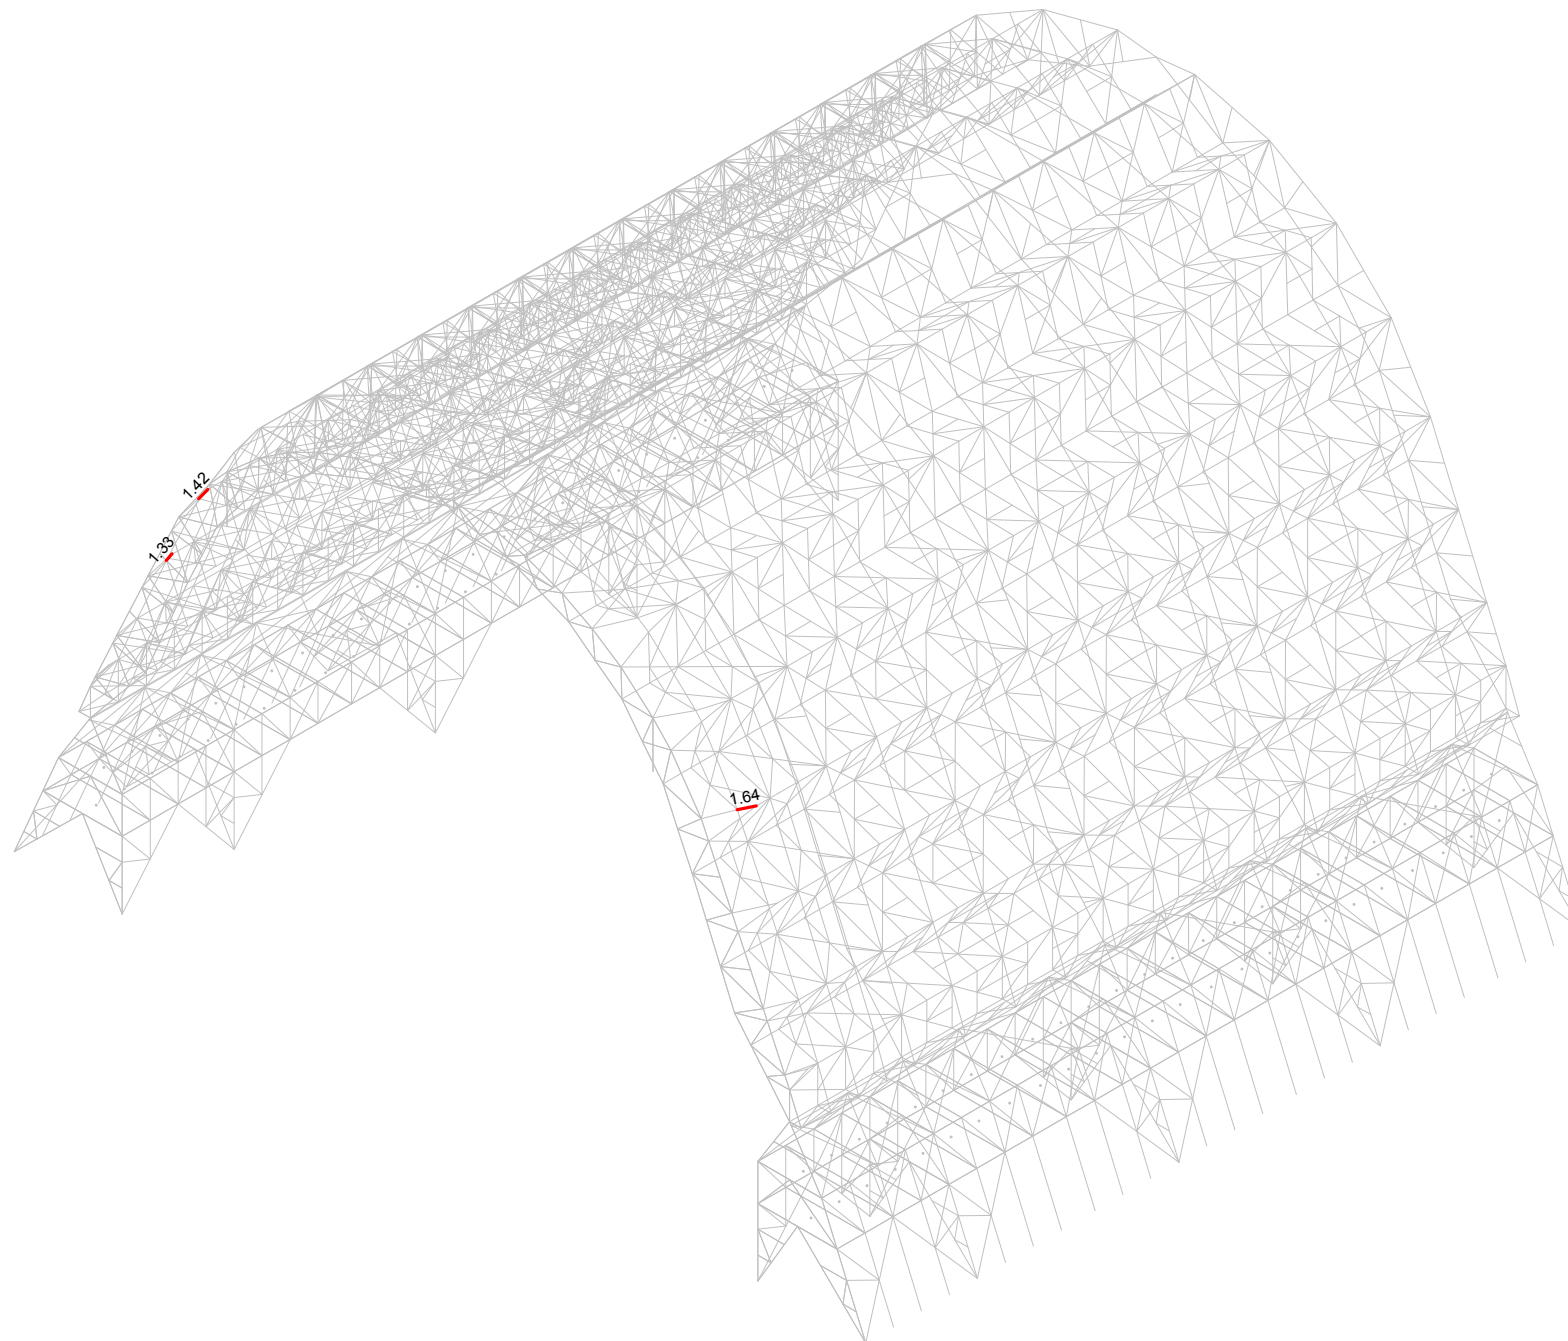
ExelTech	Hangar 1 South Section End Section Above A-Frame Wind Category II Unity	SK - 2
AJC		Nov 2, 2011 at 9:48 AM
1123		Hangar End_Site Arches and above A Frames_20111030.r3d

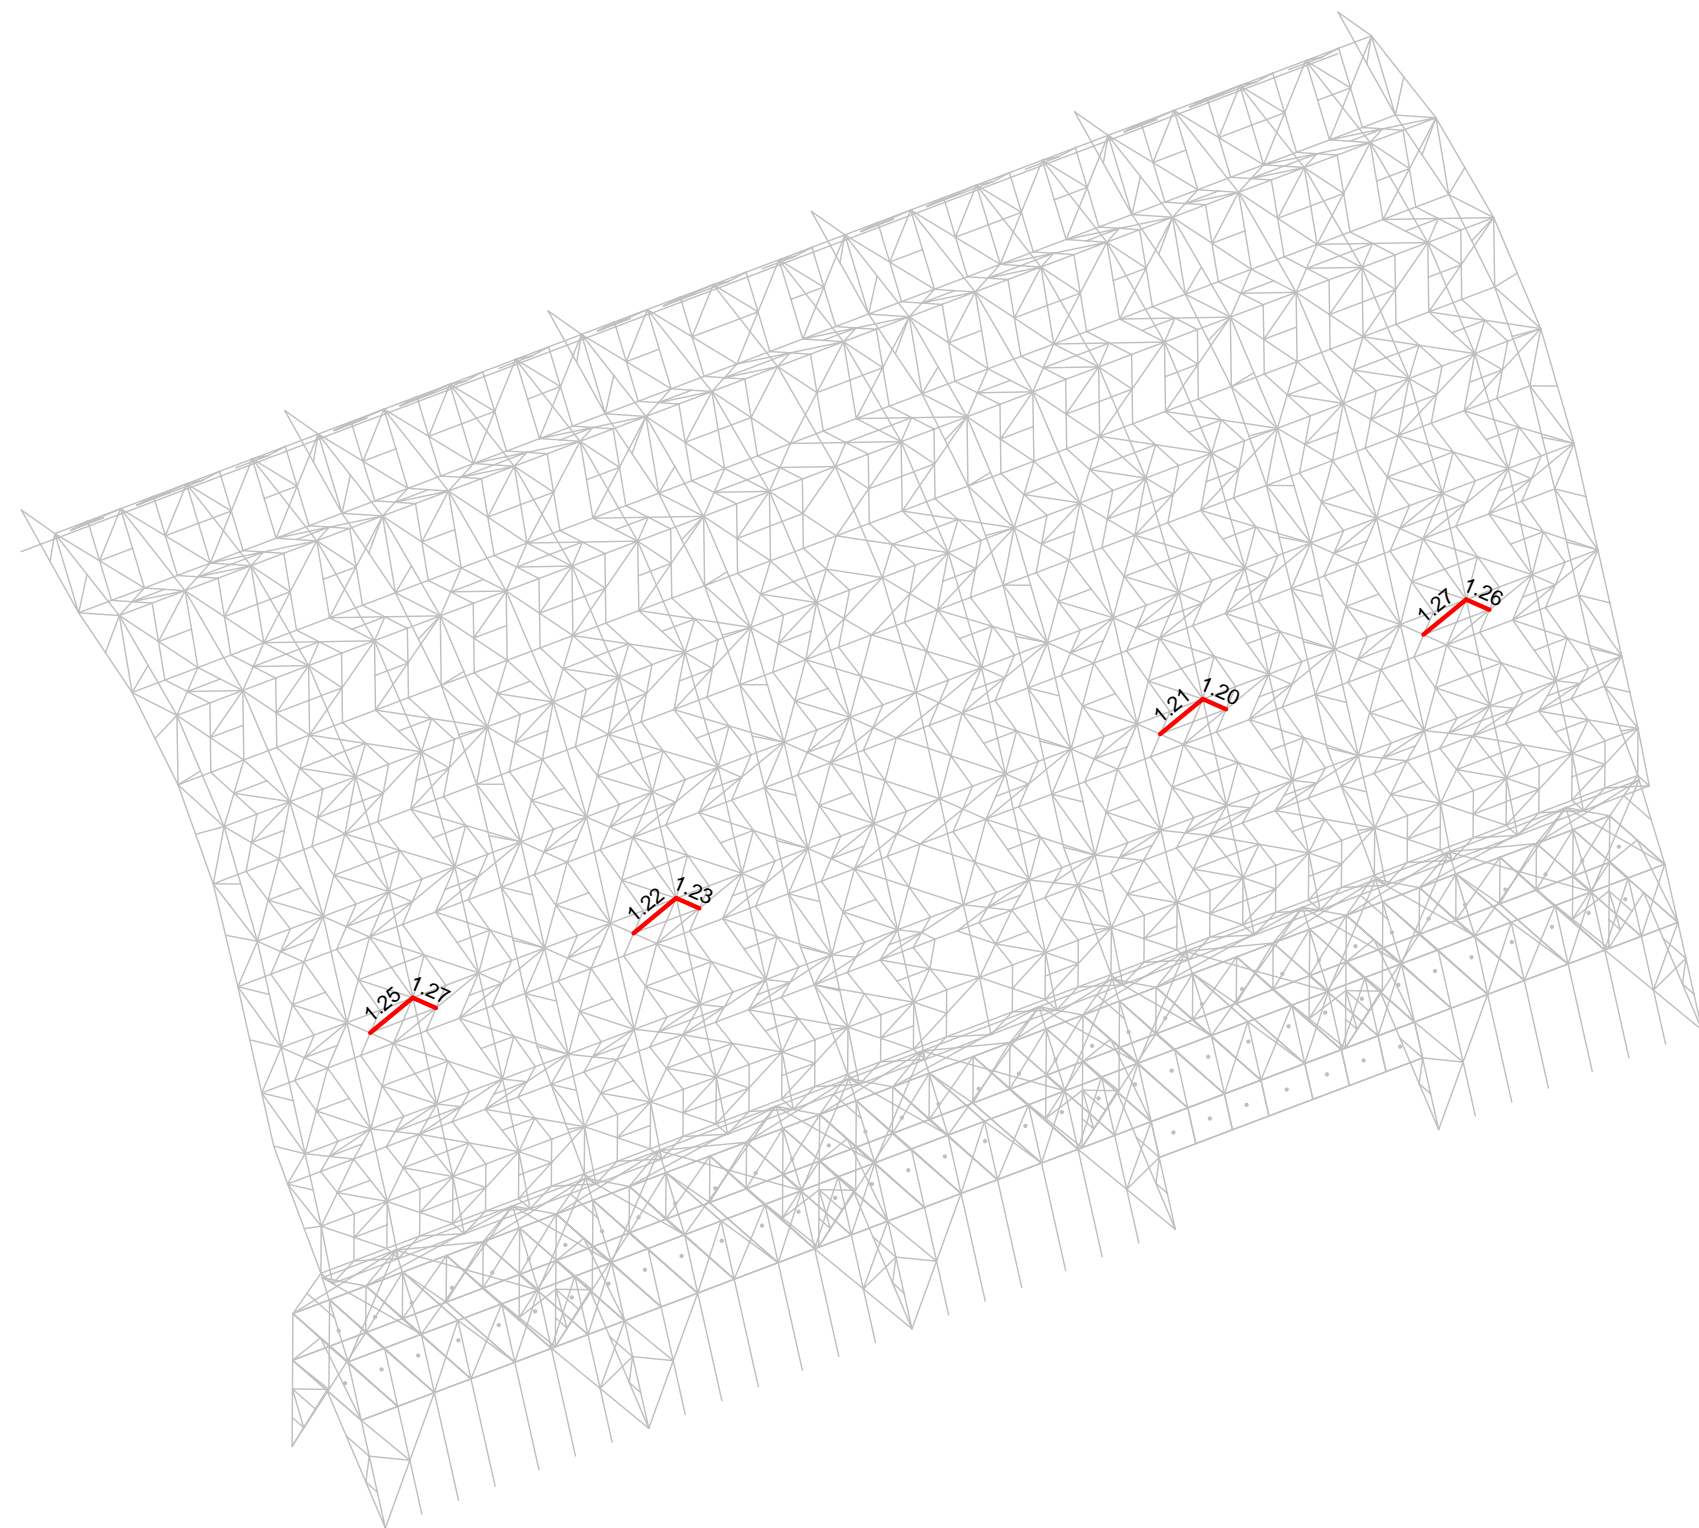
ExelTech	Hangar 1 - Middle Section (Original) Iso Middle Wind Category II - Arches & Above A-Frame - Member_Unity	SK - 5
AJC		Oct 7, 2011 at 12:15 AM
1123		Hangar Middle_Site Class D_Original_Reduced Load 20110930_RISA.r3d

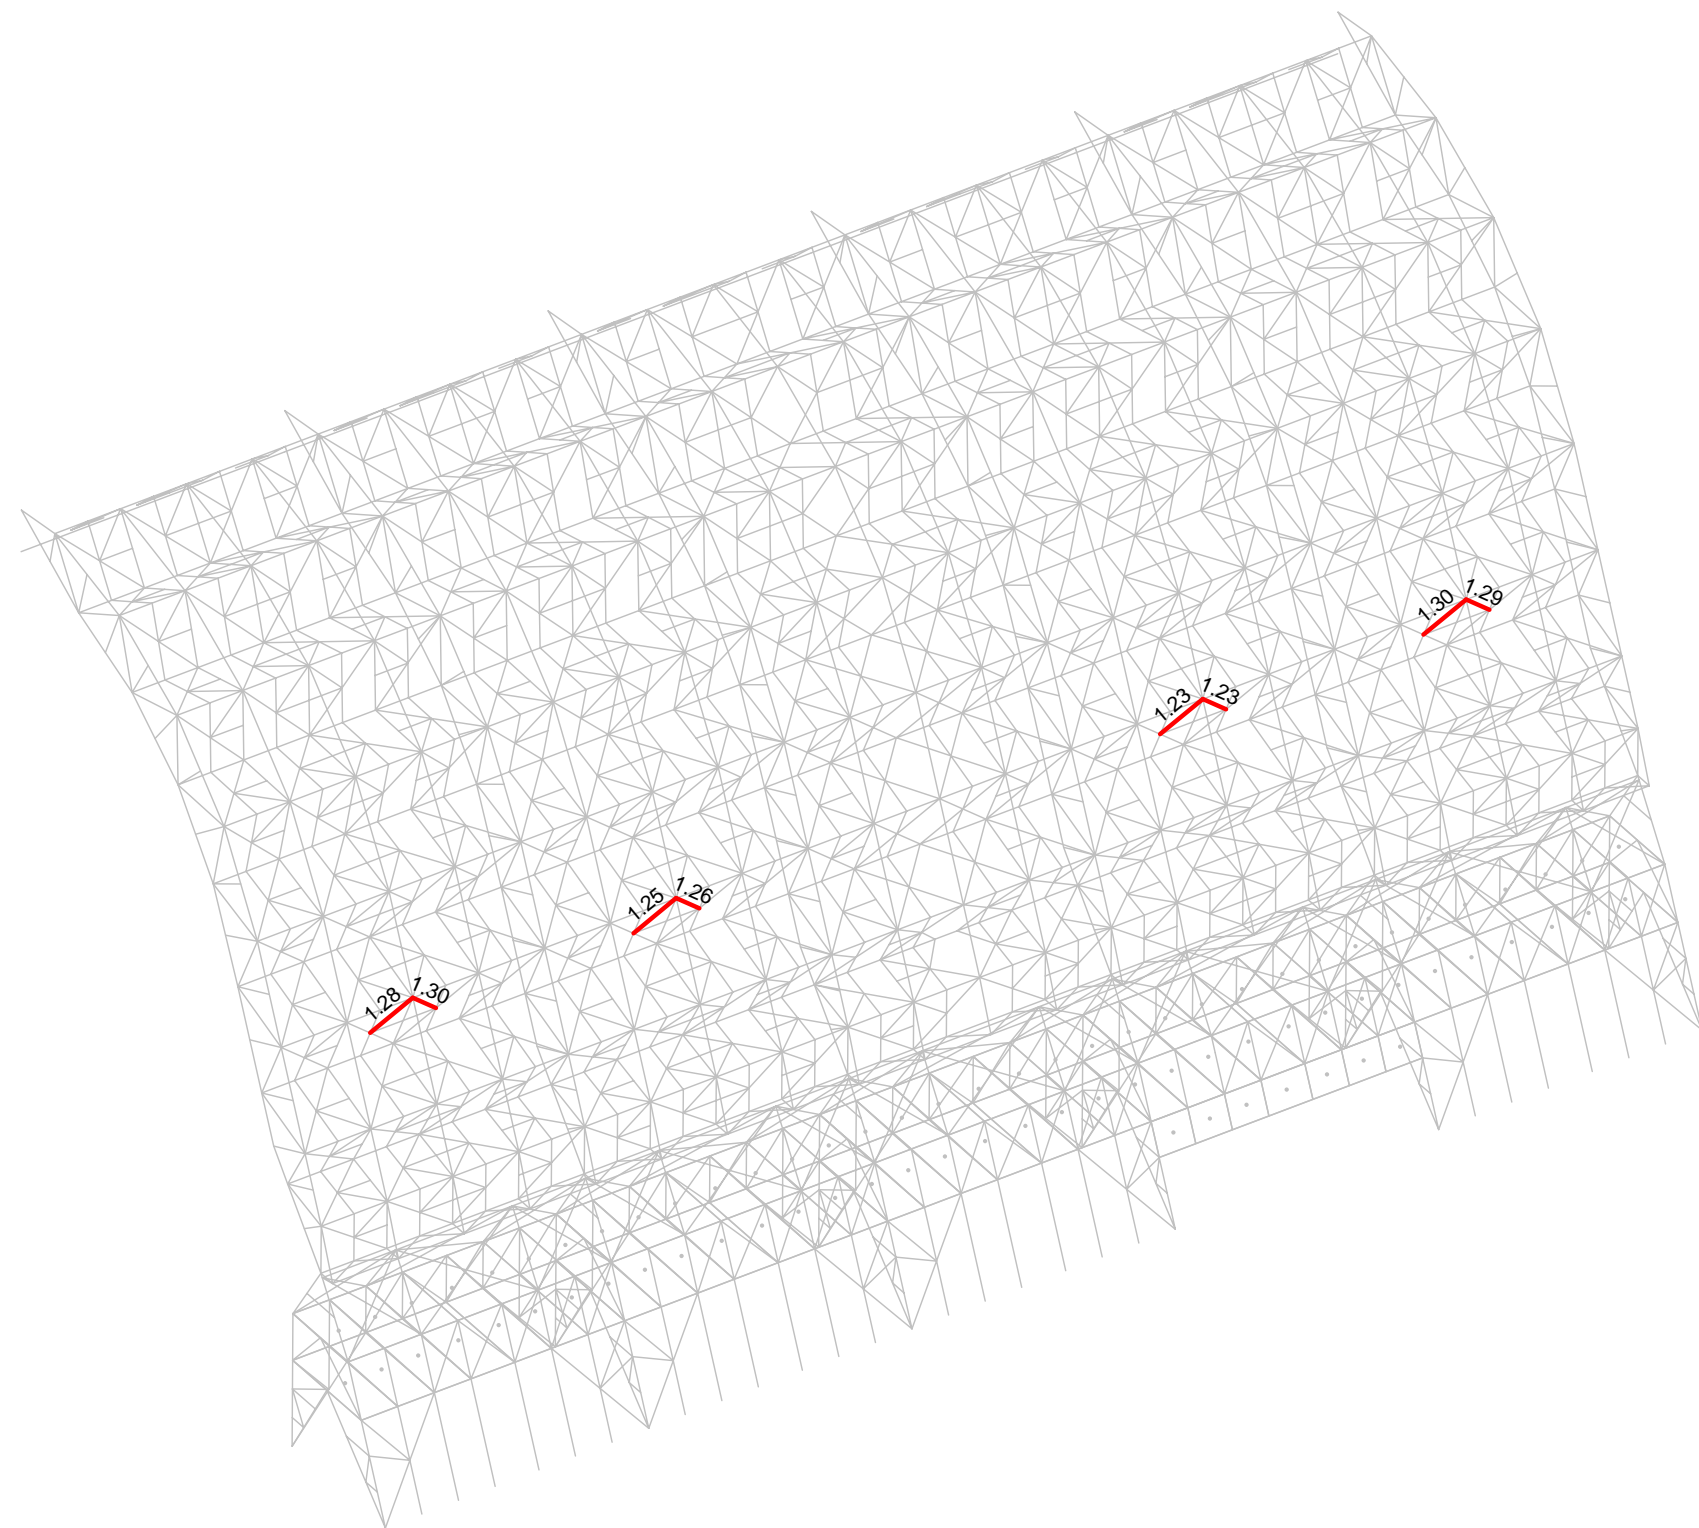
ExelTech	Hangar 1 - Middle Section (Original) Iso Middle Wind Category III - Arches & Above A-Frame - Member_Unity	SK - 2
AJC		Oct 7, 2011 at 12:06 AM
1123		Hangar Middle_Site Class D_Original_Reduced Load 20110930_RISA.r3d
