U.S. Naval Air Station Moffett Field
Building 25 Re-Use Guidelines
Final

Moffett Federal Air Field, California
.....

prepared by
Architectural Resources Group
Architects, Planners & Conservators,
Inc.
San Francisco, California

October 2000

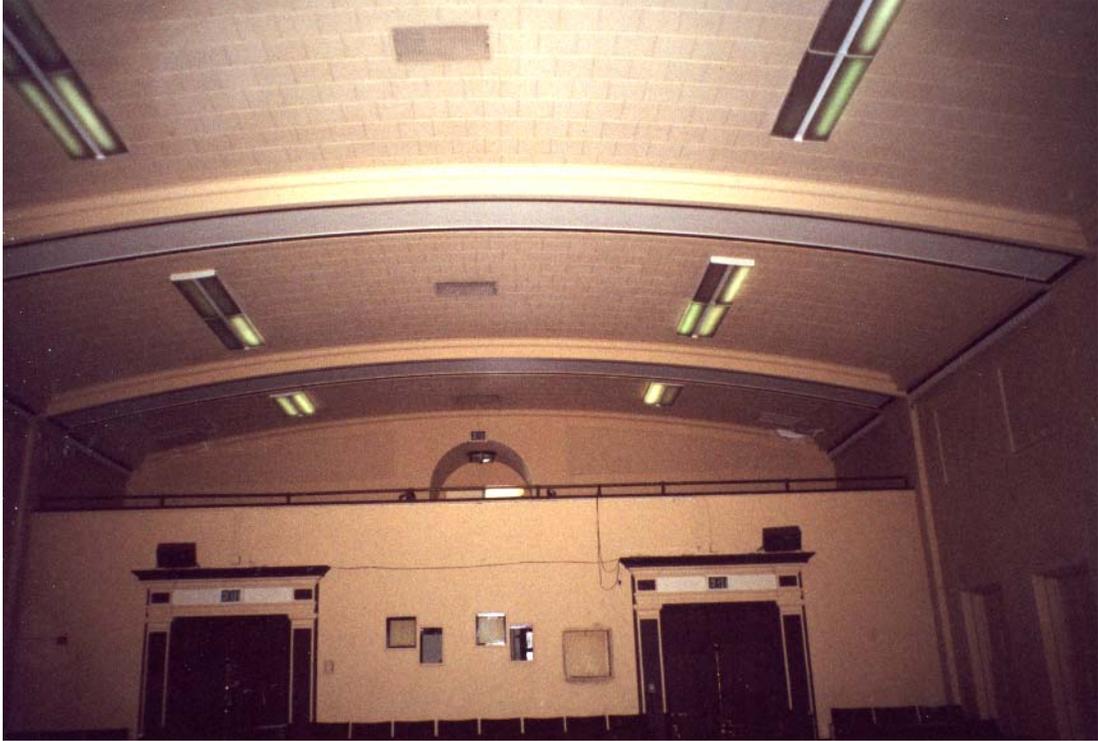
Rear Wall - Auditorium
Building 25
Moffett Field

is unclear if any of the seats themselves are original. The width of the rows in the balcony have been enlarged. There is heavy water damage to the plaster walls and ceiling of the auditorium at the southeast and southwest corners. The lobby has had some minor alterations. Paneling has been installed over the original wall surface and doors have been installed between the lobby and the main circulation corridor. The corridors have been significantly altered. On the first floor, doors have been added between the stairways and corridor. It appears as though the historic fabric beyond these doors has been removed and reconstructed. On the second floor the historic fabric is more intact with the exception of the fore-shortening of the eastern end of the corridor. Apparently, the historic doors were relocated to the west of their original location. The most significant alteration occurred to the support spaces. The changes include removal/concealment of historic finished, as well as modifications to the spatial configuration. The porch was once open but has since been enclosed and subdivided.

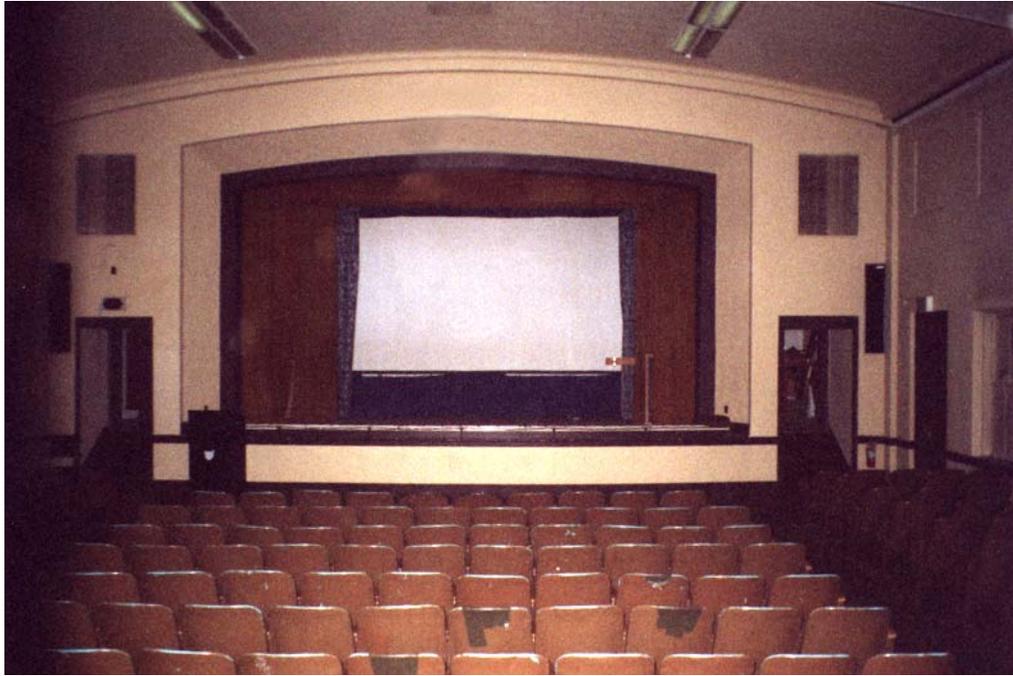
Auditorium Stage
Building 25
Moffett Field

Stage: Further evaluation is needed to determine possible deficiencies in this area.

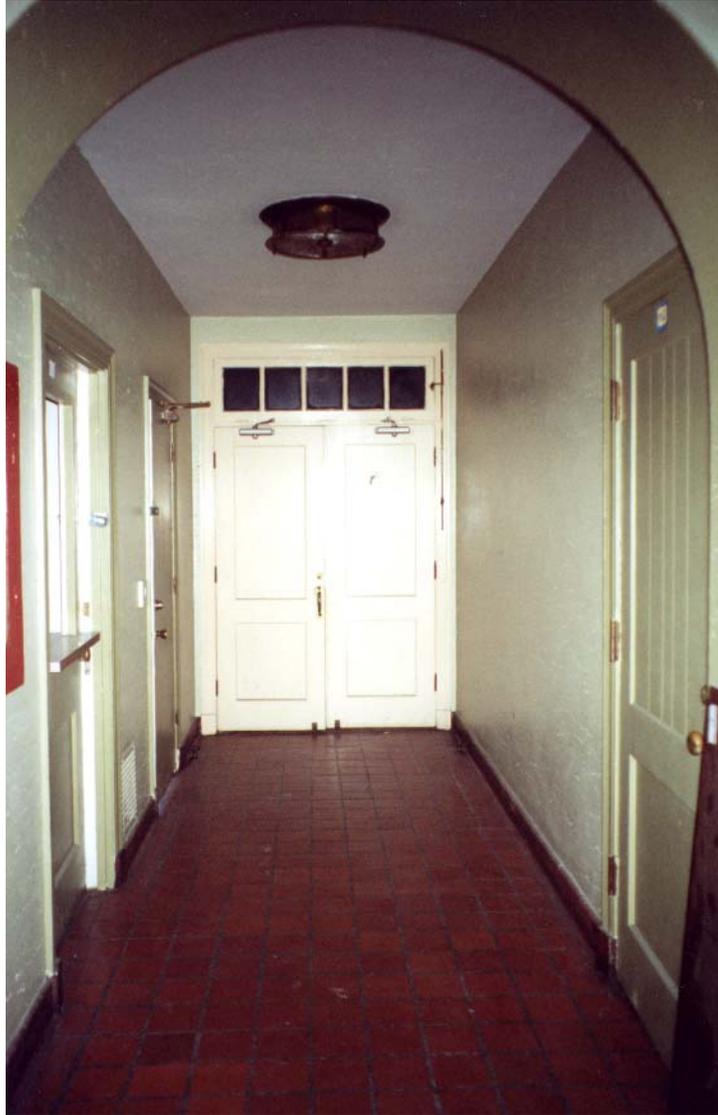
Corridor - Second Floor
Building 25
Moffett Field

Dead-end Corridors: On the west wing of the second floor, removal of the non-contributing emergency exit stairs leaves the existing corridor to this wing as a dead-end corridor in excess of 20’. Rectifying this deficiency will require some reconfiguration of the doors to the rooms.
