Re-Use Guidelines

Hangar 2 (Building No. 46)
NASA Ames Research Center
Moffett Field, California

August 30, 2006

Prepared by
PAGE & TURNBULL, INC.
San Francisco, California

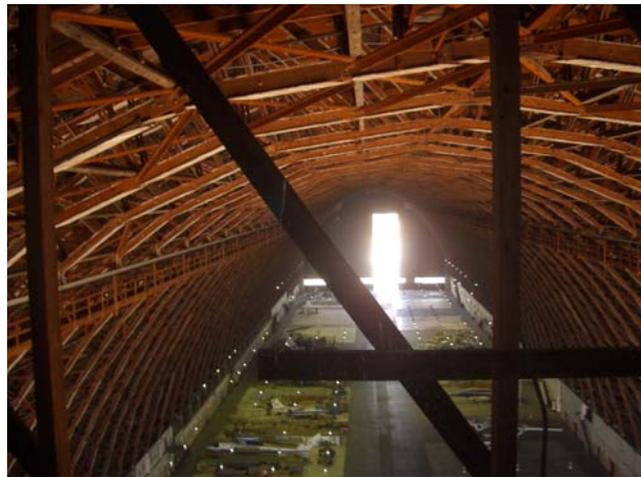
Figure 40. Upper arc of truss assembly, south end, Hangar 2.

Wood is the primary building material used in the construction of Hangar 2 and is most evident in the monumental truss system **(Figure 40)**. It is also used in the less apparent roof diaphragm, framing of the door lintels, and in the construction of the support structures such as the catwalks, ladders and the framing of the Radar House on the roof. The interior office and shop spaces are wood framed and the flooring and decking on top of the second story office spaces are sheathed with tongue & groove planks. Each of the distinct wood assemblies will be described in the following sections.

creosote-treated outer layer, the trusses appeared to be in fair condition. Every truss appeared to be intact, no significant out-of-plane movement was noted, and no significant cracking, rot or loss of subcomponents was observed. It was not possible to assess the metal split ring connectors within the truss assemblies. Visible metal subcomponents, such as the gusset plates and bolts connectors were exhibiting rust.

The wooden subcomponents, such as the X-bracing, appeared to be in place and functioning and showing few visible signs of deterioration, such as cracking of the wood or staining. White-painted battens, two inches wide, are attached across the upper and lower faces of the paired rafters to strengthen the chord assembly.³⁶ Some of these battens have deteriorated or are missing from the truss assembly.

- Consult with a Structural Engineer regarding the integrity of the interface between the wood trusses and the concrete bents. In particular, examine the number of bolts used to attach these two materials and the condition of the metal.

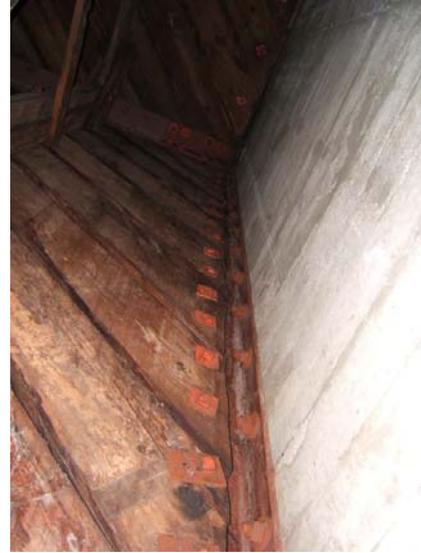
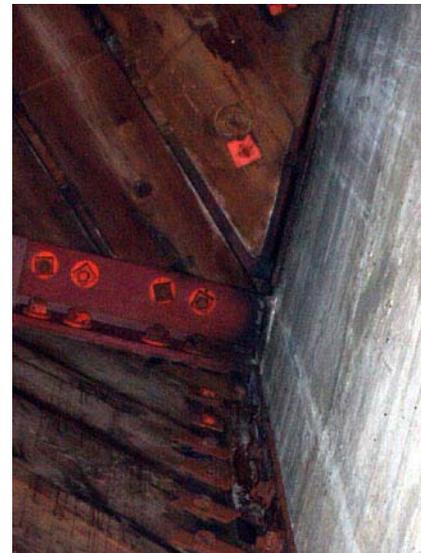
Figure 41. Angle iron union of box girder and corner tower, Hangar 2, interior of box girder northeast corner girder.

Figure 42. Detail of angle iron at juncture between box girder and corner tower, Hangar 2, interior of box girder, northeast corner.

The lintel between the door towers is hollow. It is framed with a double-height truss system. The walls and ceiling are clad with 2 in. tongue and groove diagonal sheathing. The floor of the door girder is approximately 8 in. thick and composed of three layers of planking. Salt deposits were found on all the surfaces of the truss members inside the box girder. A steel angle iron connector unites the wood walls of the lintel to the interior concrete walls of the door towers and the steel and bolts are badly corroded, further suggesting the presence of water in the space (**Figures 41 & 42**).

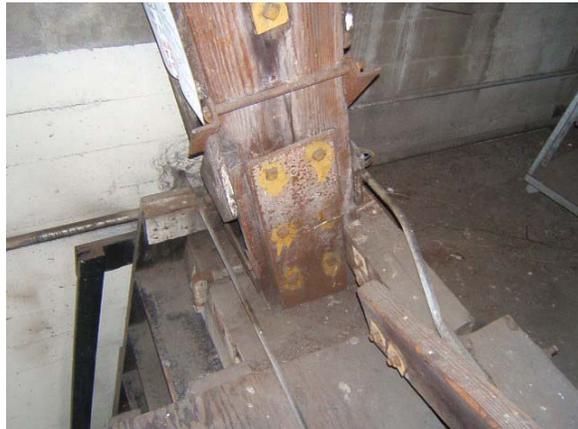
There is rusting and salt damage on the connection plates between the wooden truss members and concrete bents (**Figure 49**). A structural engineer should assess the number of bolts connecting the wood trusses together and the trusses to the concrete bents. The connectors are, at best, in Fair condition. They are showing the early signs of wear, as evidenced by the rust, and require routine maintenance.
