Memorandum

To: Jonathan Ikan, Cultural Resources Manager, NASA Ames Research Center
CC: Kathy Kwon, AECOM
Subject: Continuing Section 106 Consultation on Building 19 First Floor Renovation, NASA Ames Research Center, Moffett Field, Santa Clara County, California (OHP NASA_2022_0923_001)
From: Trina Meiser, Senior Architectural Historian
Heather Miller, Architectural Historian
Date: August 1, 2023

Section 106 Supplemental Memorandum
Building 19 First Floor Renovation

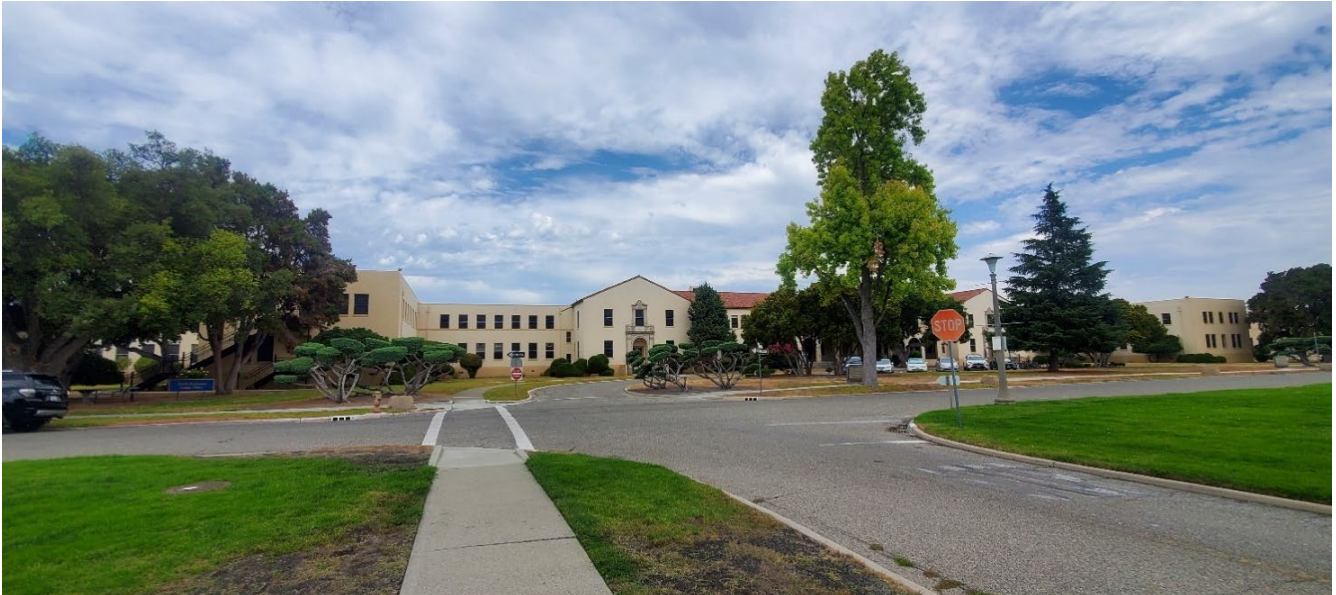
Photograph 1. Building 19 façade (south elevation), view facing north. The red tile roof section is the original 1933-constructed building and Conference Room 1218 is located behind the stop sign.

Building 19 is a two-story building with a south-facing façade, complex plan, frame construction, stucco siding, and a central low-pitched Spanish tile gabled roof (**Photograph 1**). The original portion of the building was constructed in 1933 and has a E-shaped plan with a primary gabled roof system covered in Spanish tile and Spanish Colonial Revival-style features, such as a prominent arcaded loggia in the first story of the façade (south elevation) and elaborate, molded ornaments at the main entrances. A one- and two-story, flat-roofed section was constructed at the rear of the building in 1933 as part of the original design, between the two gabled roof wings.

Substantial International-style wings were added to the east and west ends of the building in 1952, more than doubling the building's footprint. The façade of the original building was extended with perpendicular wings on either side (**Photograph 6**; see **Photograph 1**). The two-story wings have flat roofs with low parapets, stucco exterior walls, and symmetrical rows of fenestration containing metal double-hung sash windows in each story. The building was originally constructed as Bachelor Enlisted Quarters, but the interior has been highly modified and is currently used for offices. The west wing contains the NASA Exchange Lodge hotel.

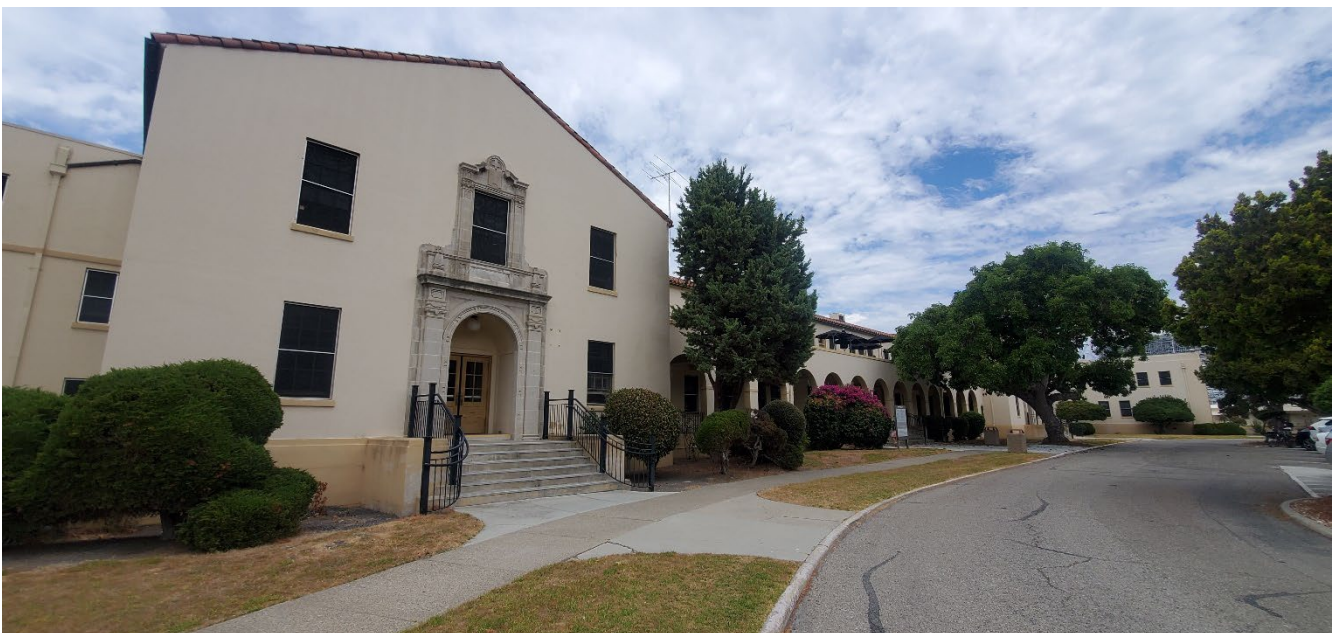
Photograph 2. Building 19 façade (south elevation) showing arcaded loggia in the first story between the two shallow gable roof projections. Western projection in foreground on left and eastern projection obscured by tree in background at center-right, view facing northeast.

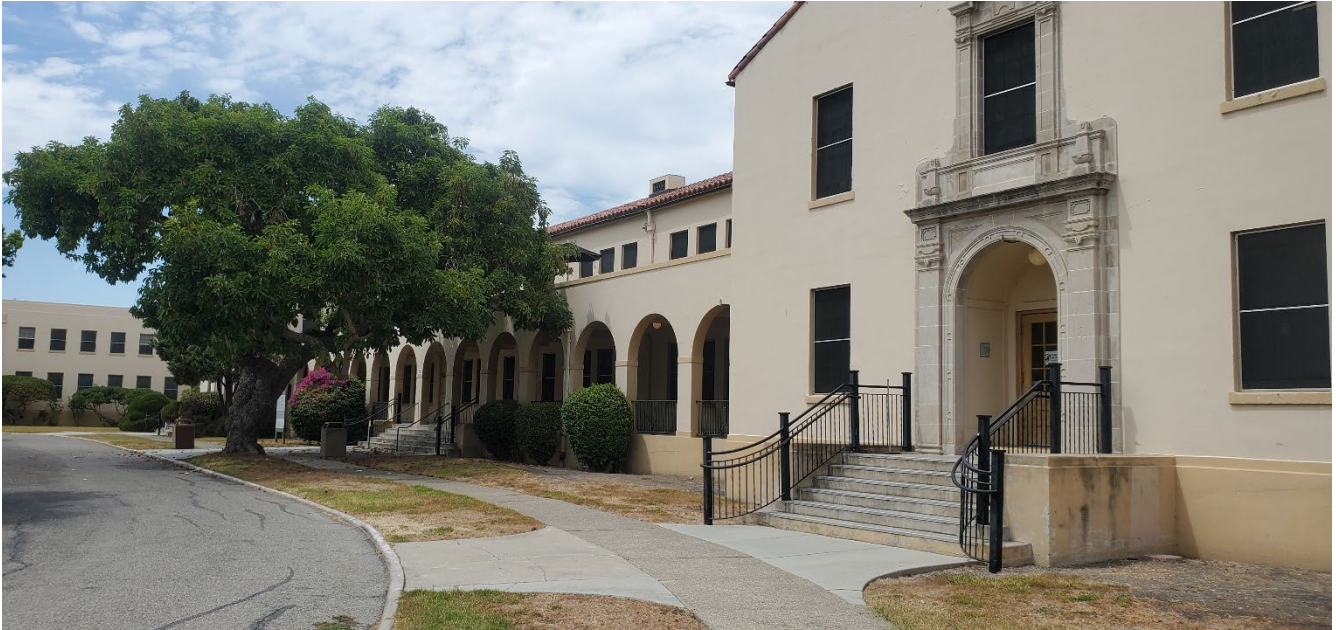
Photograph 3. Building 19 façade (south elevation) showing arcaded loggia in the story between the two shallow gable roof projections. Eastern projection in foreground on right and western projection obscured by tree in background at center-left, view facing northwest.

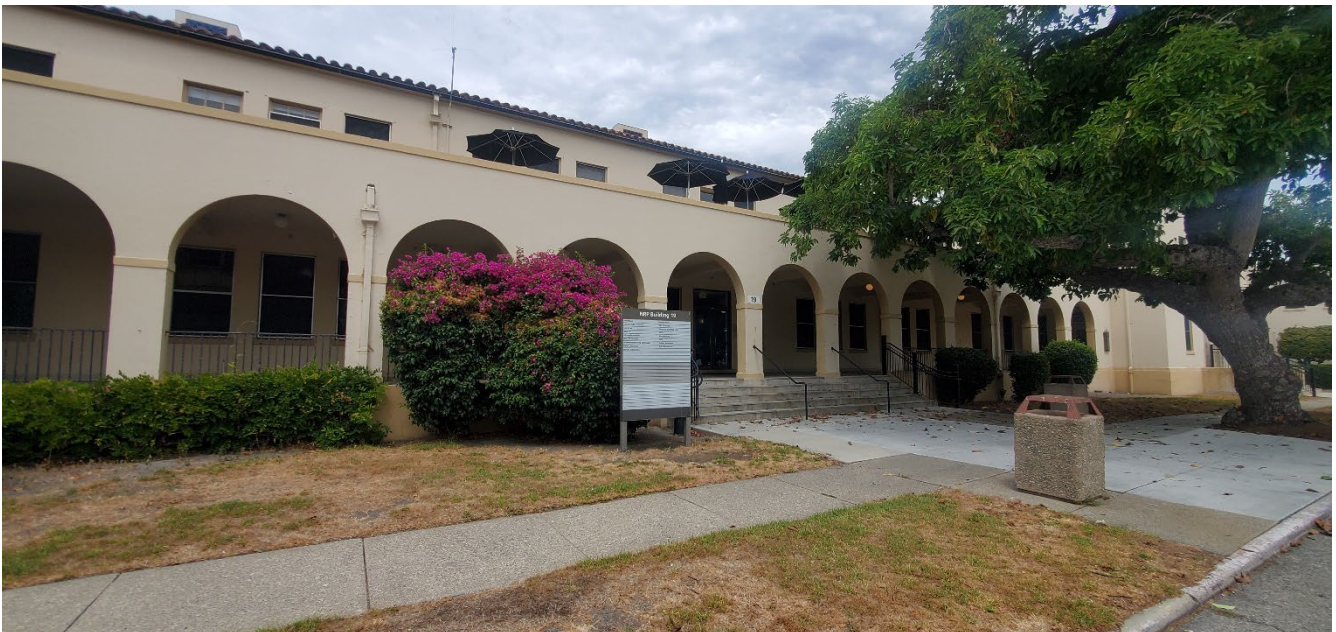
Photograph 4. Building 19 façade (south elevation) showing arcaded loggia in the first story, with eastern projection on far right, view facing northeast.

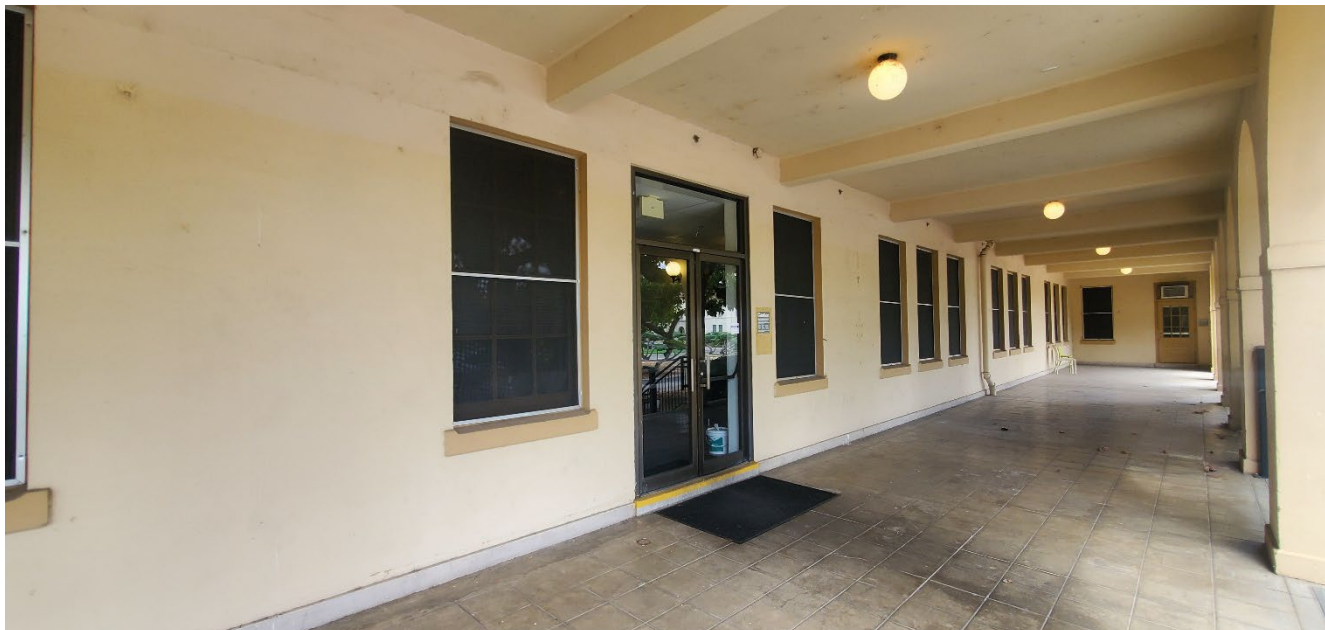
Photograph 5. Building 19 façade (south elevation) showing Conference Room 1218 at east end of arcaded loggia in the first story (far right) inside the eastern projection, view facing east.

entrances into the first floor of the gable-roofed projections are on secondary elevations and covered by the arcaded loggia. The secondary entry into the eastern projection provides access to Conference Room 1218, the subject of this project revision (**Photograph 5**). This entry consists of a multi-light, wood frame door with a transom infilled with an air conditioning unit and plywood. North of the door is a multi-light, wood-framed window.

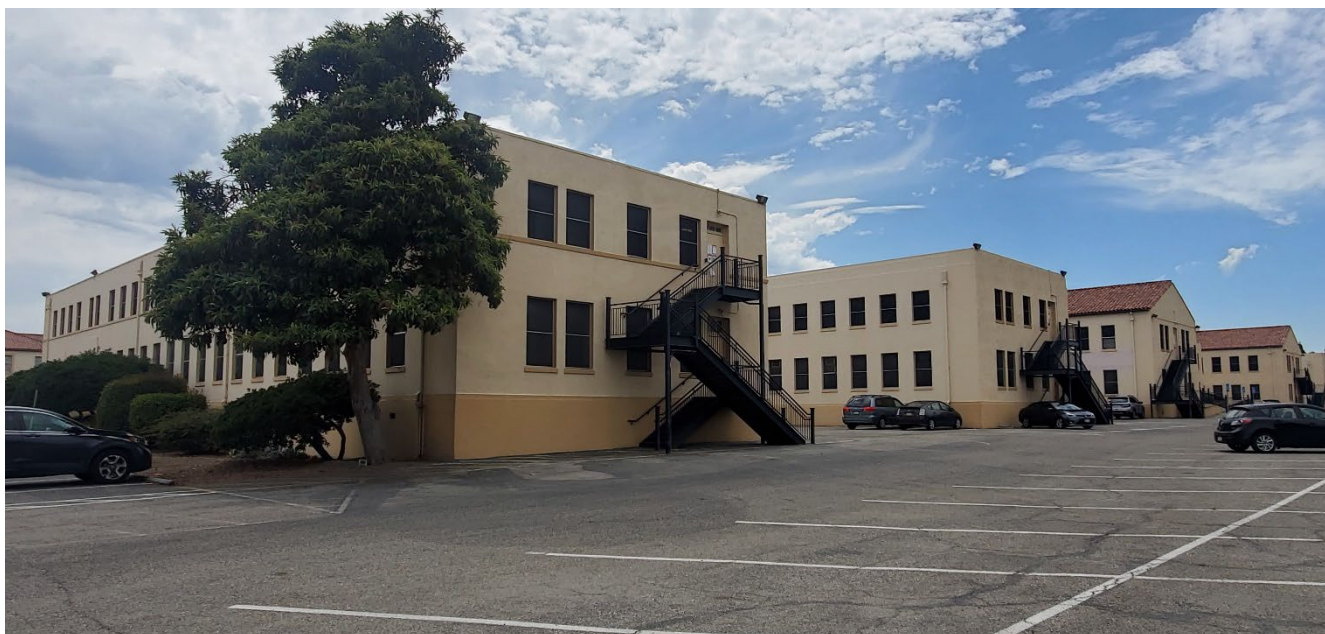
Photograph 6. Building 19 rear, north elevation, 1952-constructed eastern wing additions in foreground, view facing west. The red tile roof sections are part of the original 1933 building.

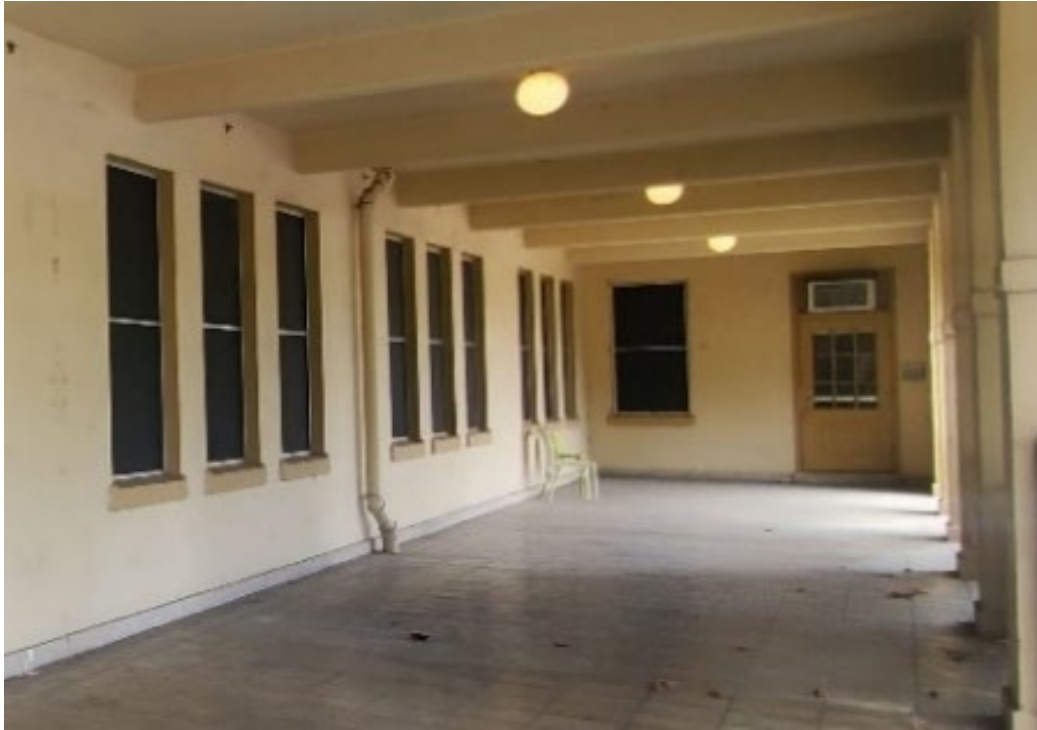
Photograph 7. Conference Room 1218 window and entrance at east end of arcaded loggia in the first story (far right) inside the eastern projection, view facing east.

Double hung metal sash windows with screens – The project would demolish the double hung metal sash window immediately north of the exterior entry door into Conference Room 1218 on the façade (south) and the opening would be infilled with reinforced concrete (Photographs 7 and 8). The removal of one of the more than 200 windows in the building would not substantially change the character of the historic windows throughout the building.

Metal door with glazing and metal transom at south elevation – The revised project would re-install glass in the transom above the exterior entry door into Conference Room 1218, which currently lacks glazing and is infilled with plywood and an external AC unit (Photograph 7). Re-installation of glass in the transom would return the exterior entry to the original configuration and appearance.

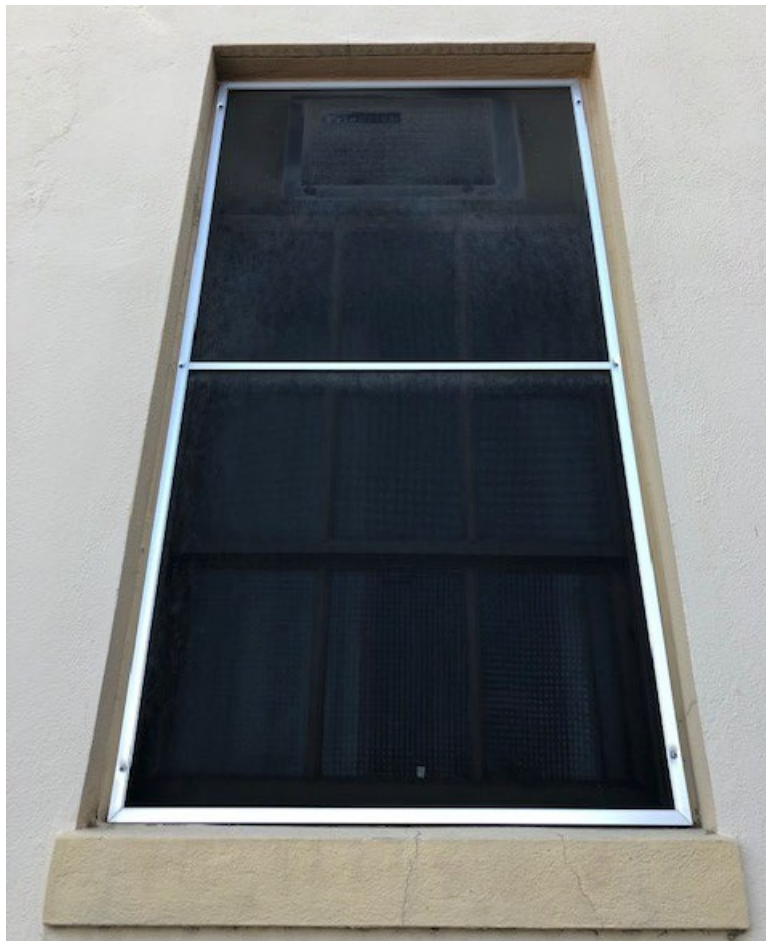
Photograph 8. Detail of typical six-over-six metal sash window with screen.

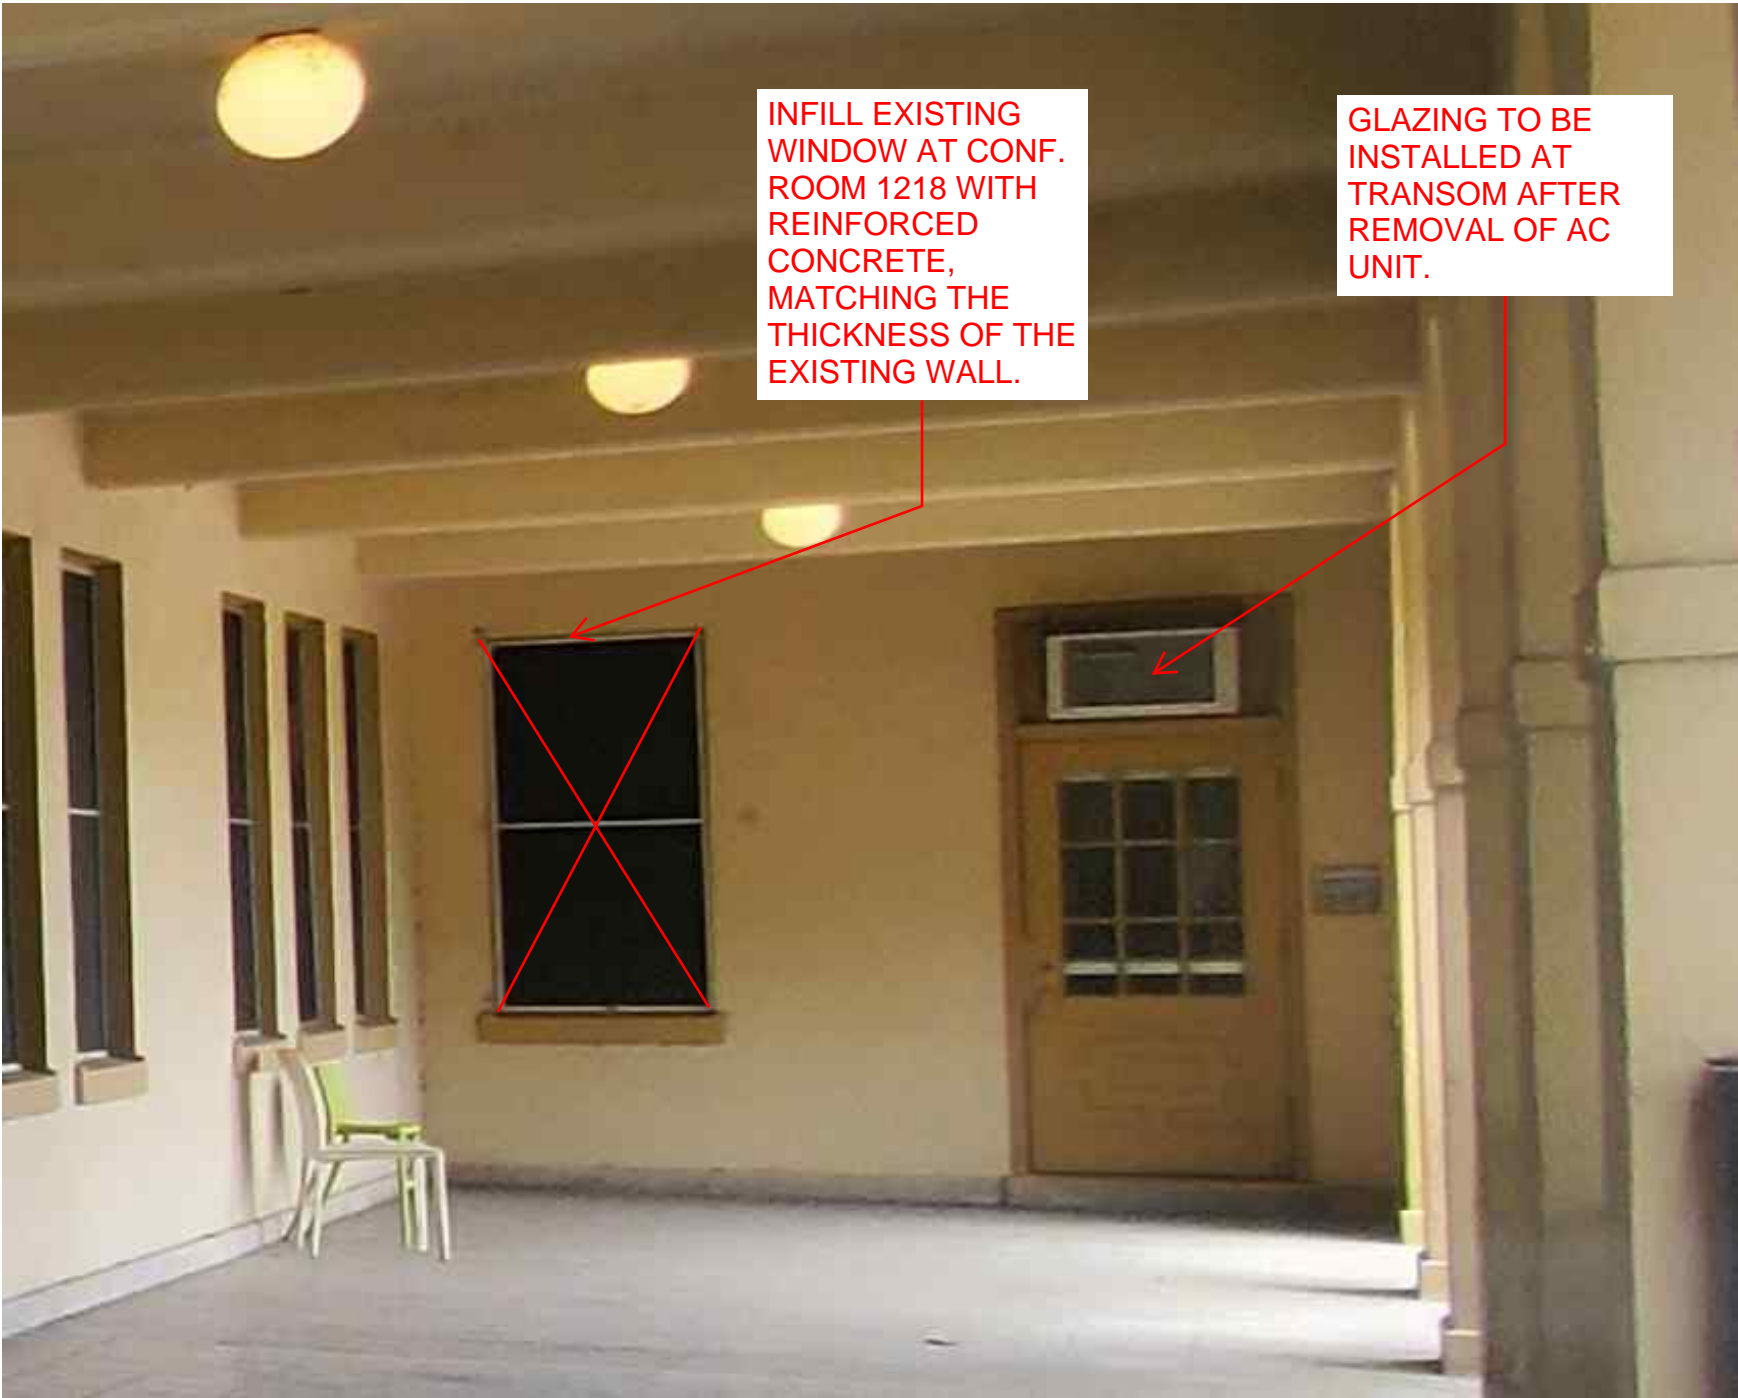
INFILL EXISTING WINDOW AT CONF. ROOM 1218 WITH REINFORCED CONCRETE, MATCHING THE THICKNESS OF THE EXISTING WALL.

GLAZING TO BE INSTALLED AT TRANSOM AFTER REMOVAL OF AC UNIT.

The project would remove and infill one exterior, double-hung, metal sash window with a screen, and remove existing infill within the transom above the exterior entry door at Conference Room 1218 and replace it with glass (see Attachment B for Project Drawing and Exhibit). The 2007 reuse guidelines identify double-hung, metal sash windows with screens were identified as significant character-defining features of Building 19, and metal doors with glazing and metal transoms on the south elevation as contributing features. However, Building 19 and the other contributing buildings to Shenandoah Plaza Historic District were listed in the NRHP for their collective Spanish Colonial Revival design, and the proposed exterior changes would not compromise the exterior Spanish Colonial Revival architectural features and details for which Building 19 is listed. No other historic properties in the APE would be physically impacted by this project.
