## Memorandum

To	Jonathan Ikan, Cultural Resources Manager, National Aeronautics and Space Administration (NASA)
Subject	Ames Research Center (ARC) Building 25 Rehabilitation Project
From	Trina Meiser, Senior Architectural Historian
Date	June 1, 2018

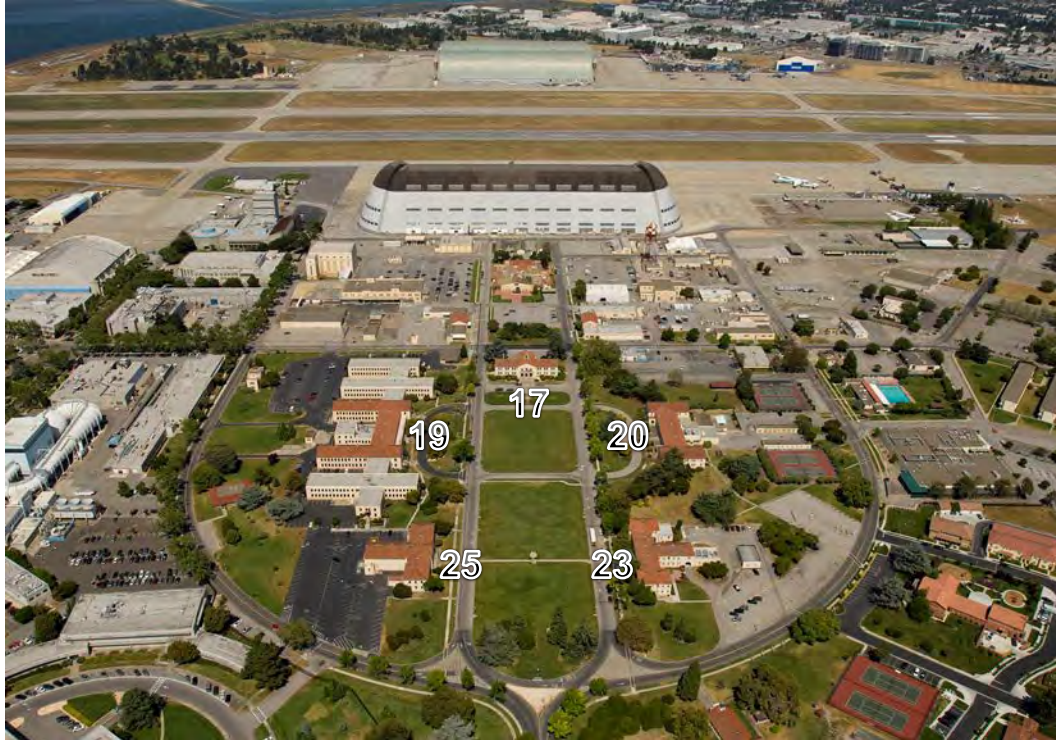
The APE for this undertaking contains five district contributors, which surround Shenandoah Plaza and form the core of the historic district that is associated with Spanish Colonial Revival-style architecture (**Plate 1**). The five buildings are Buildings 17, 19, 20, 23, and 25.

**Plate 1. Shenandoah Plaza overview (center), showing Buildings 17, 19, 20, 23 and 25.**

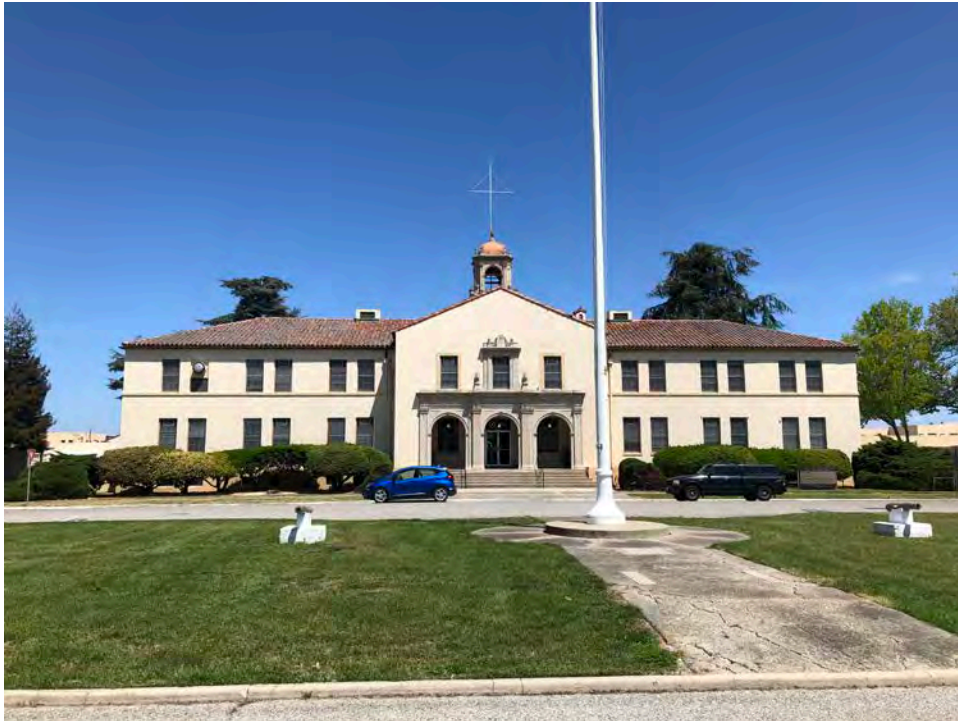
Built in 1933, Building 17 is a two-story Spanish Colonial Revival-style building with a symmetrical, cruciform plan, frame construction, stucco siding, and a low-pitch Spanish tile gabled roof (**Plate 2**). It is the most prominent building on Shenandoah Plaza, located at the head of the plaza. This building set “the design criteria that is followed through the original campus plan” (NRHP 1994). The building currently houses programs for Carnegie Mellon University.

**Plate 2. Building 17, view facing northeast.**

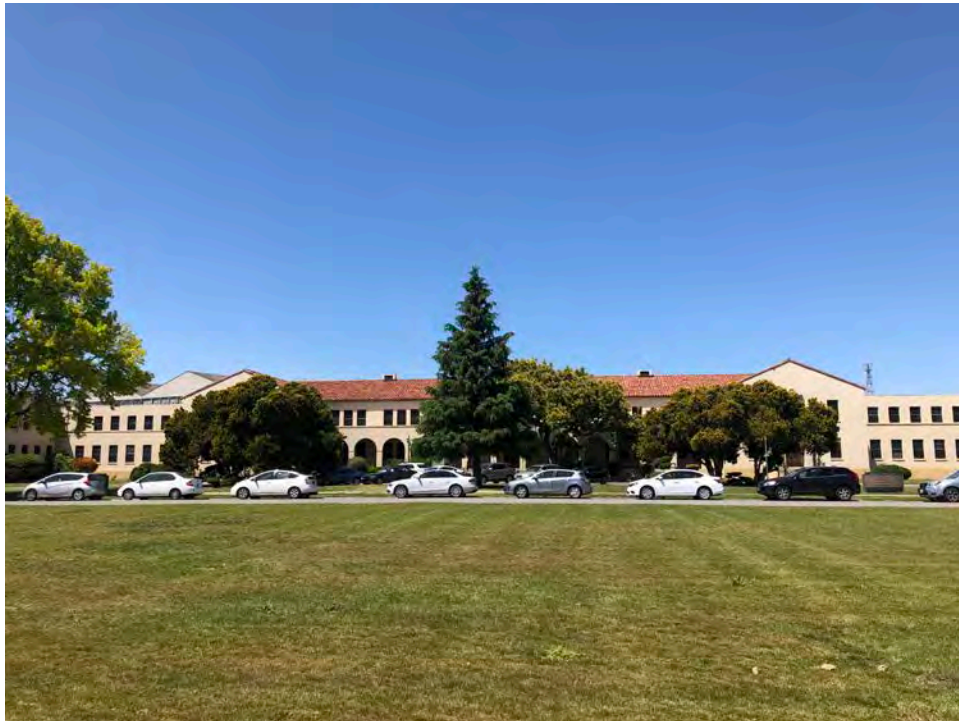
Building 19 is a two-story Spanish Colonial Revival-style building with a complex plan and several wings, frame construction, stucco siding, and a low-pitch Spanish tile gabled roof (**Plate 3**). Located on the north side of Shenandoah Plaza next to Building 25, it is one of the major buildings on Shenandoah Plaza that distinguishes the core of the district. The building is currently used for offices.

**Plate 3. Building 19, view facing northwest.**

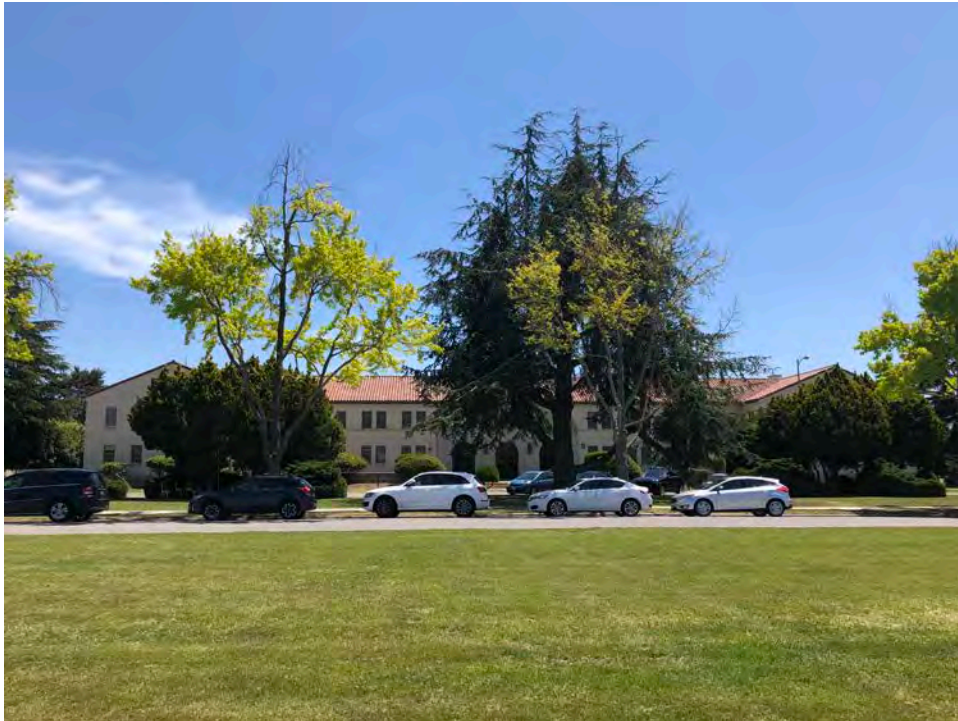
Building 20 is a two-story Spanish Colonial Revival-style building with an asymmetrical plan, frame construction, stucco siding, and a low-pitch Spanish tile gabled roof (**Plate 4**). Located on the south side of Shenandoah Plaza, it is one of the major buildings on Shenandoah Plaza that distinguishes the core of the district (NRHP 1994). The building currently houses educational programs for Singularity University.

**Plate 4. Building 20, view facing southeast.**

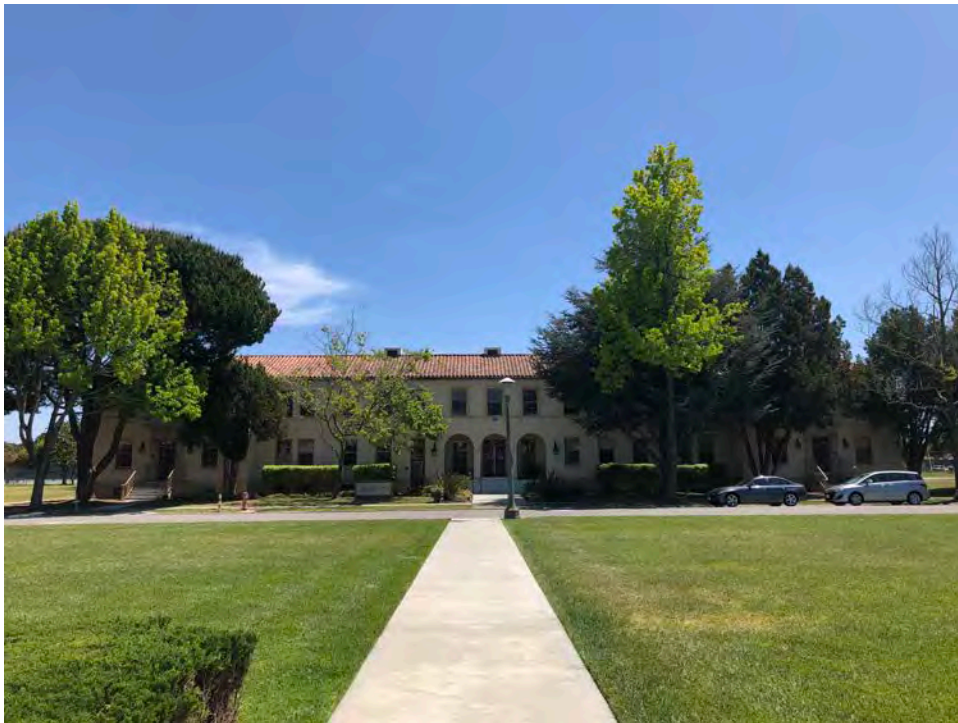
Built in 1933 and enlarged in 1936, Building 23 is a two-story Spanish Colonial Revival-style building with a T-plan, frame construction, stucco siding, and a low-pitch Spanish tile gabled roof (**Plate 5**). Located on the south side of Shenandoah Plaza, symmetrically opposite Building 25, it is one of the major buildings on Shenandoah Plaza. It is significant because of its representation, along with Building 25, of the Spanish Colonial Revival design and for its historical location at the original entrance of NAS Sunnyvale (NRHP 1994). The interior of the building was renovated in the 2000s and currently houses educational programs for Carnegie Mellon University.

**Plate 5. Building 23, view facing southeast.**

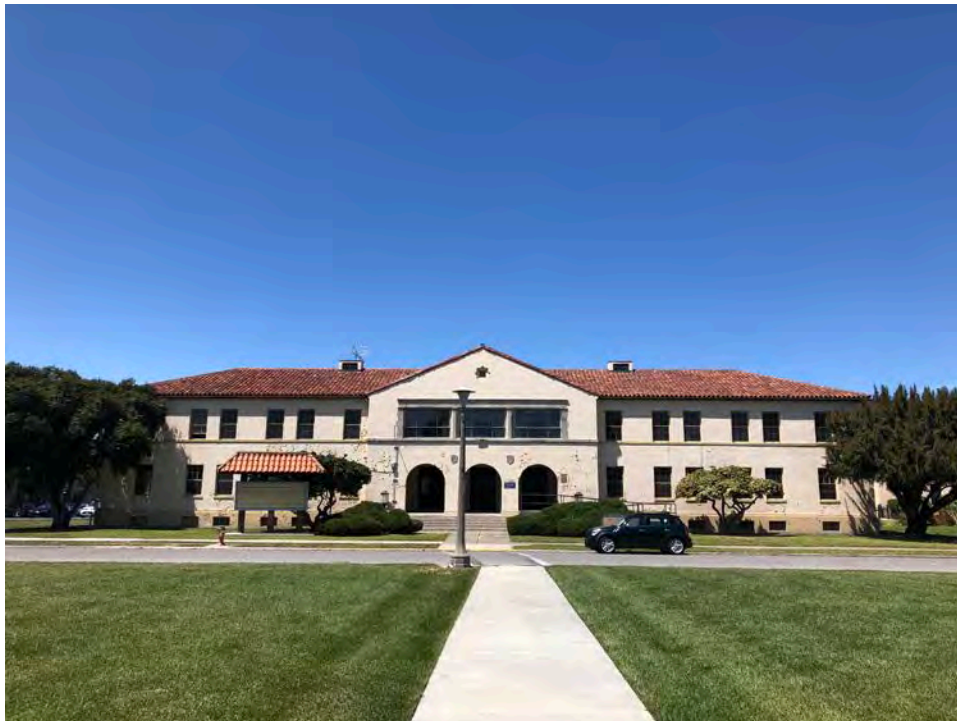
Built in 1933 as the Administration Building and Auditorium, Building 25 has features of the Spanish Colonial Revival style used for Shenandoah Plaza (**Plate 6**). The two-story with basement building has a T-plan, with a symmetrical, 15-bay-wide façade, and a centered high-bay wing that extends at the rear (**Plate 7**). The front of the building contains offices, and the rear contains a theater. It has a low-pitched Spanish tile hipped roof with a centered, open-front gable, integral-color stucco siding (painted over), and terra-cotta ornamentation. The main entrance has a porch with an arcade and a patio above (**Plate 8**). The fenestration is symmetrical and typical windows are six-over-six metal sash (**Plate 9**). Exterior doors are wood with glazing and decorative molding. The building is 150 feet by 110 feet with 7,745 square feet of floor space. The exterior remains in its original configuration, with the addition of an access ramp at the main entrance (**Plate 10**) and two sets of exterior metal stairs in the back (**Plate 11**). There is a corrugated metal shed attached to the building at the northwest side at the rear. Additional photographs of Building 25 are located in **Attachment D**.

**Plate 6. Building 25, view facing northwest.**

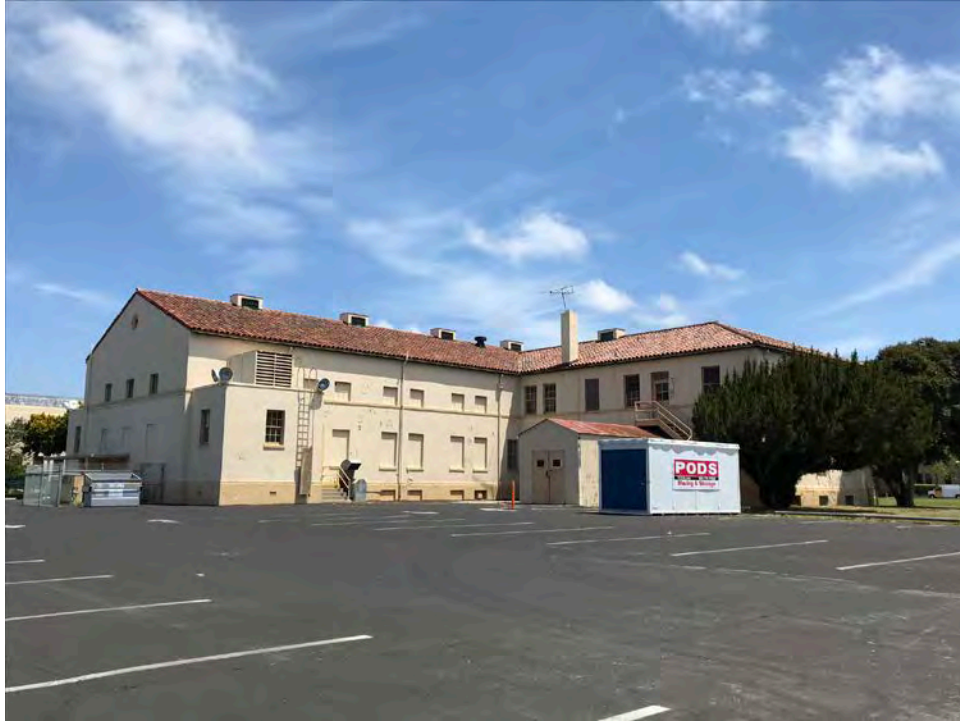
**Plate 7. Building 25, rear, view facing southeast.**

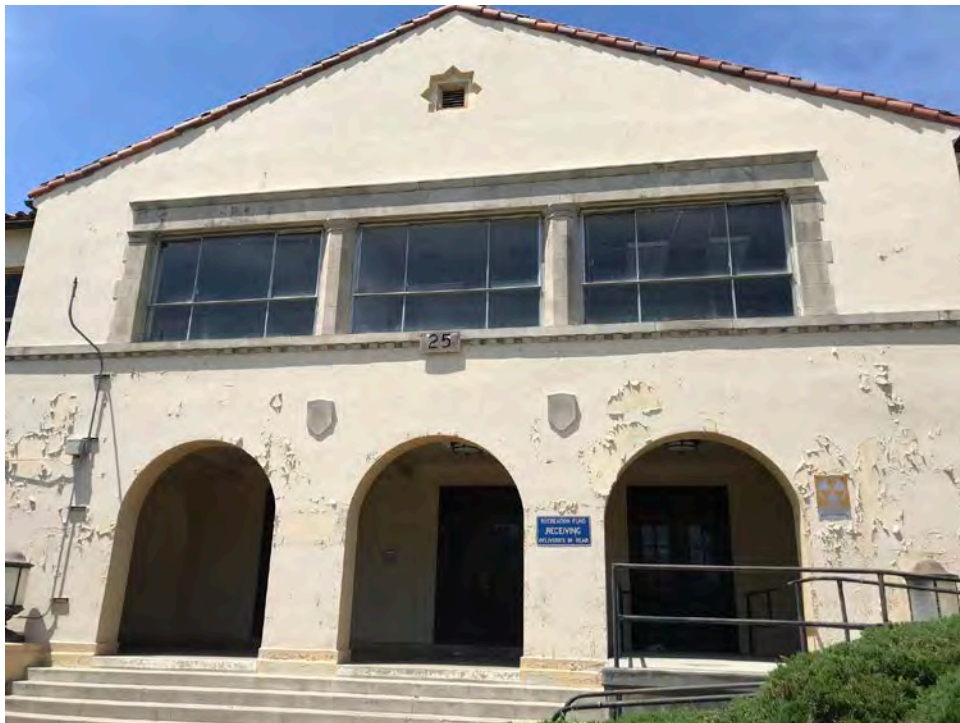
**Plate 8. Buildings 25, main entrance, view facing north.**

*Original entry doors* – Entry doors will be sanded, primed, and painted to match or approximate historic colors, which will be determined through testing. If elements of the doors are deteriorated, they will be replaced to match the material, profile, and appearance of the historic doors. Historic hardware will be preserved and repaired. Glazing will be replaced with safety glazing. The historic character and appearance will be preserved. Exterior doors that are non-original (two at rear of theater and two basement doors) will be replaced to conform to the historic design as substantiated through documentary and physical evidence (see detail of as-built plans provided in architectural drawings in Attachment C).

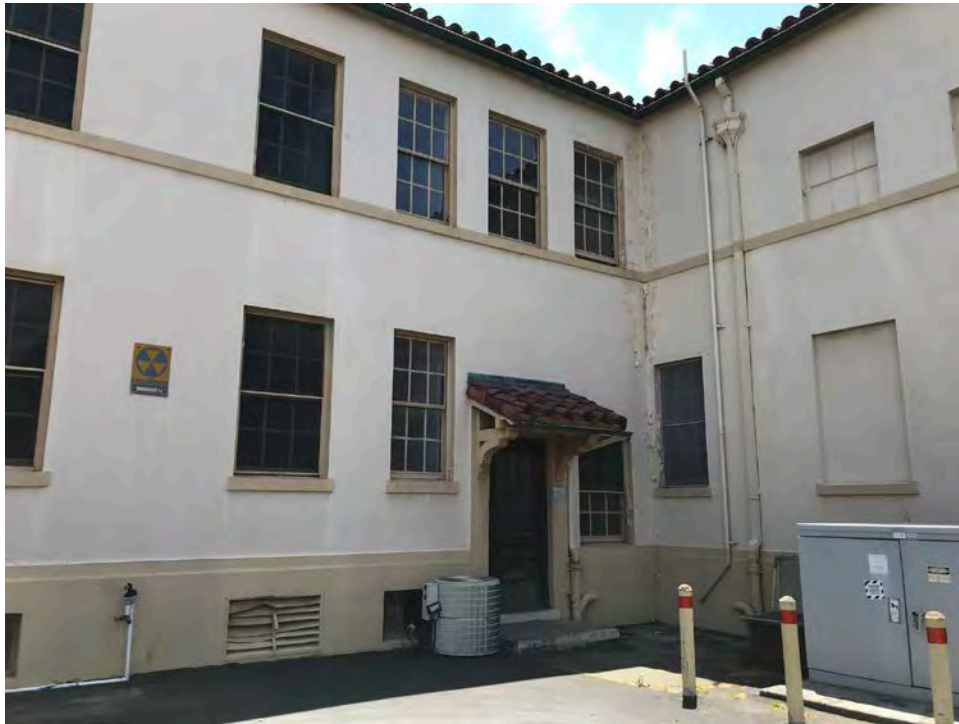
**Plate 9. Building 25, typical fenestration at rear, view facing southwest.**

Building 25 is characterized by symmetrical fenestration. Fenestration will retain its overall historic character and appearance, because there will be few changes to door/window openings, existing door and window surrounds will be repaired, and in-kind replacement of windows will conform to the historic appearance by using a custom design that will match the original. Alteration of two windows on the south side (front) will remove the existing windows and enlarge the first-floor window opening for a new ADA-accessible entrance at grade. However, because the proposed door opening will not substantially modify the width or height of the window opening, the balance of the fenestration will not change significantly. Three non-original door openings on the north side (rear) will be altered back to historically smaller window openings with windows to match the historical pattern. The removal of the doors will coincide with the removal of two non-historic exterior metal stairs. Above the main entrance of the building, three non-original aluminum windows that enclose the historically open patio will be removed, returning the patio to its original appearance. In the theater wing of the building, four clerestory window/vent ducts will receive new louvered vents that will be custom-designed to complement the mullion configuration of the historic window pattern. Bathroom windows will have removable adhesive translucent film installed on the interior glass for privacy. While alterations to fenestration will occur, the intent is to preserve or closely equate the historic character, appearance, and pattern of the fenestration overall.

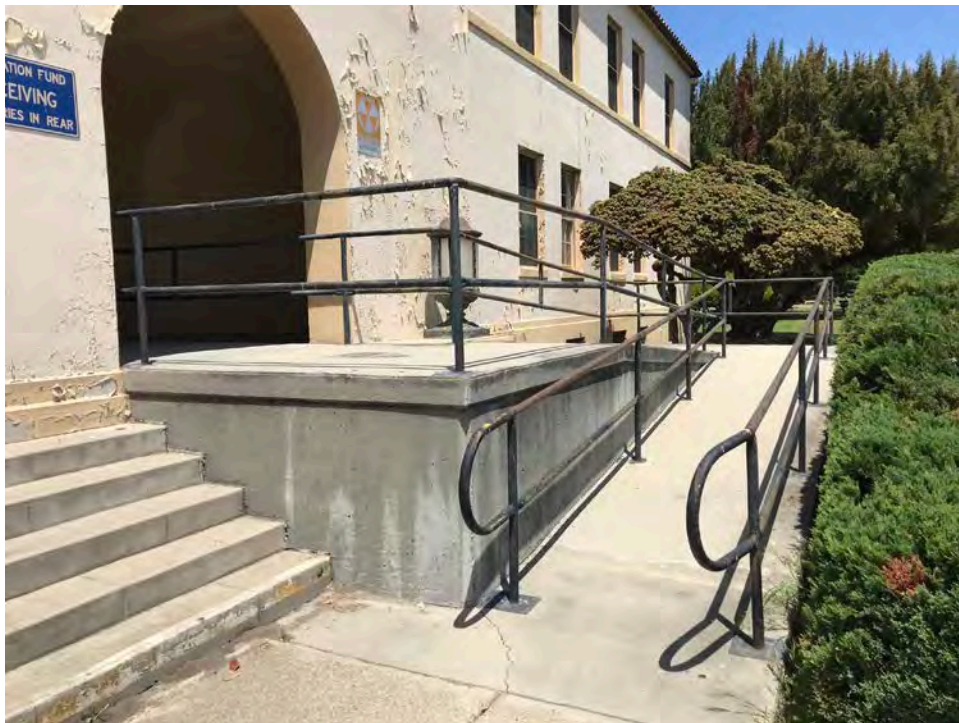
**Plate 10. Building 25, concrete ramp addition at main entrance, view facing northeast.**

- Ramp at front of building. Intent would be to modify the existing ramp with a more compatible design, and to upgrade the guardrails, handrails, curbs, and markings to comply with current accessible requirements.
- Non-original interior dividing walls
- Aluminum-framed windows in the porch
- Aluminum storefront doors at the basement
- Corrugated metal canopy over the basement stairs
- Corrugated metal enclosure
- Removal of the two non-contributing metal exit stairs. If intent is to keep stairs, they are currently non-compliant and will need replacement.

By virtue of the necessary repairs for seismic retrofit and rehabilitation, the project will include demolition of some features of Building 25, including the roof; windows; the ramp at the main entrance; two exterior metal stairs; a rear corrugated metal shed addition; and interior paneling and partition walls, flooring, and suspended ceilings, as well as hazardous materials. However, any physical destruction or damage will be mitigated by in-kind replacement of significant and contributing features in adherence to the Standards.

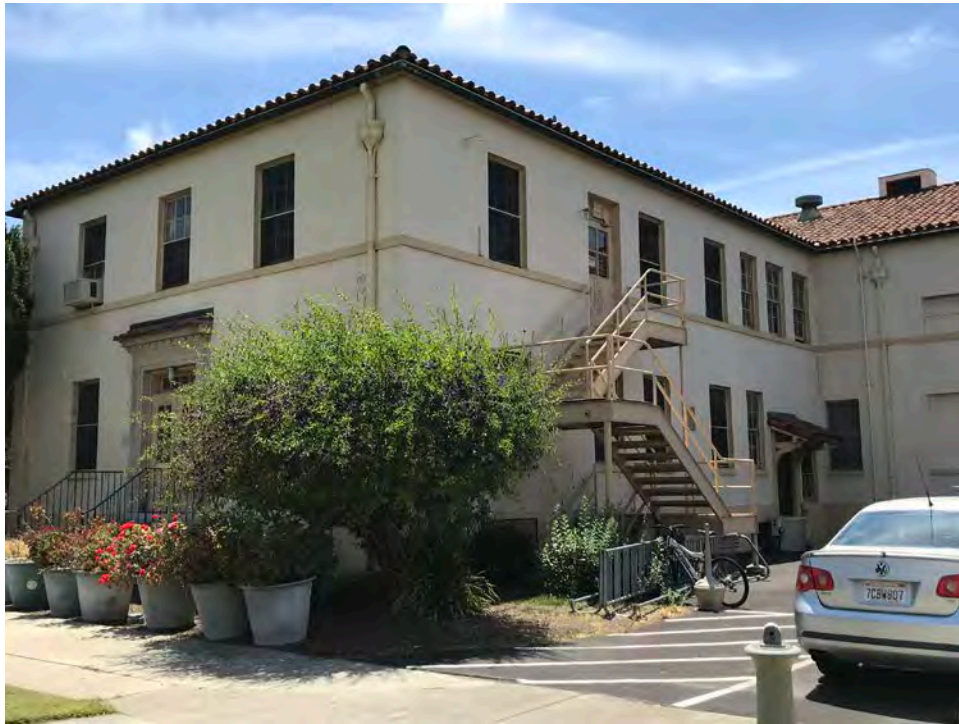
**Plate 11. Building 25, metal stair addition at rear, view facing southwest.**

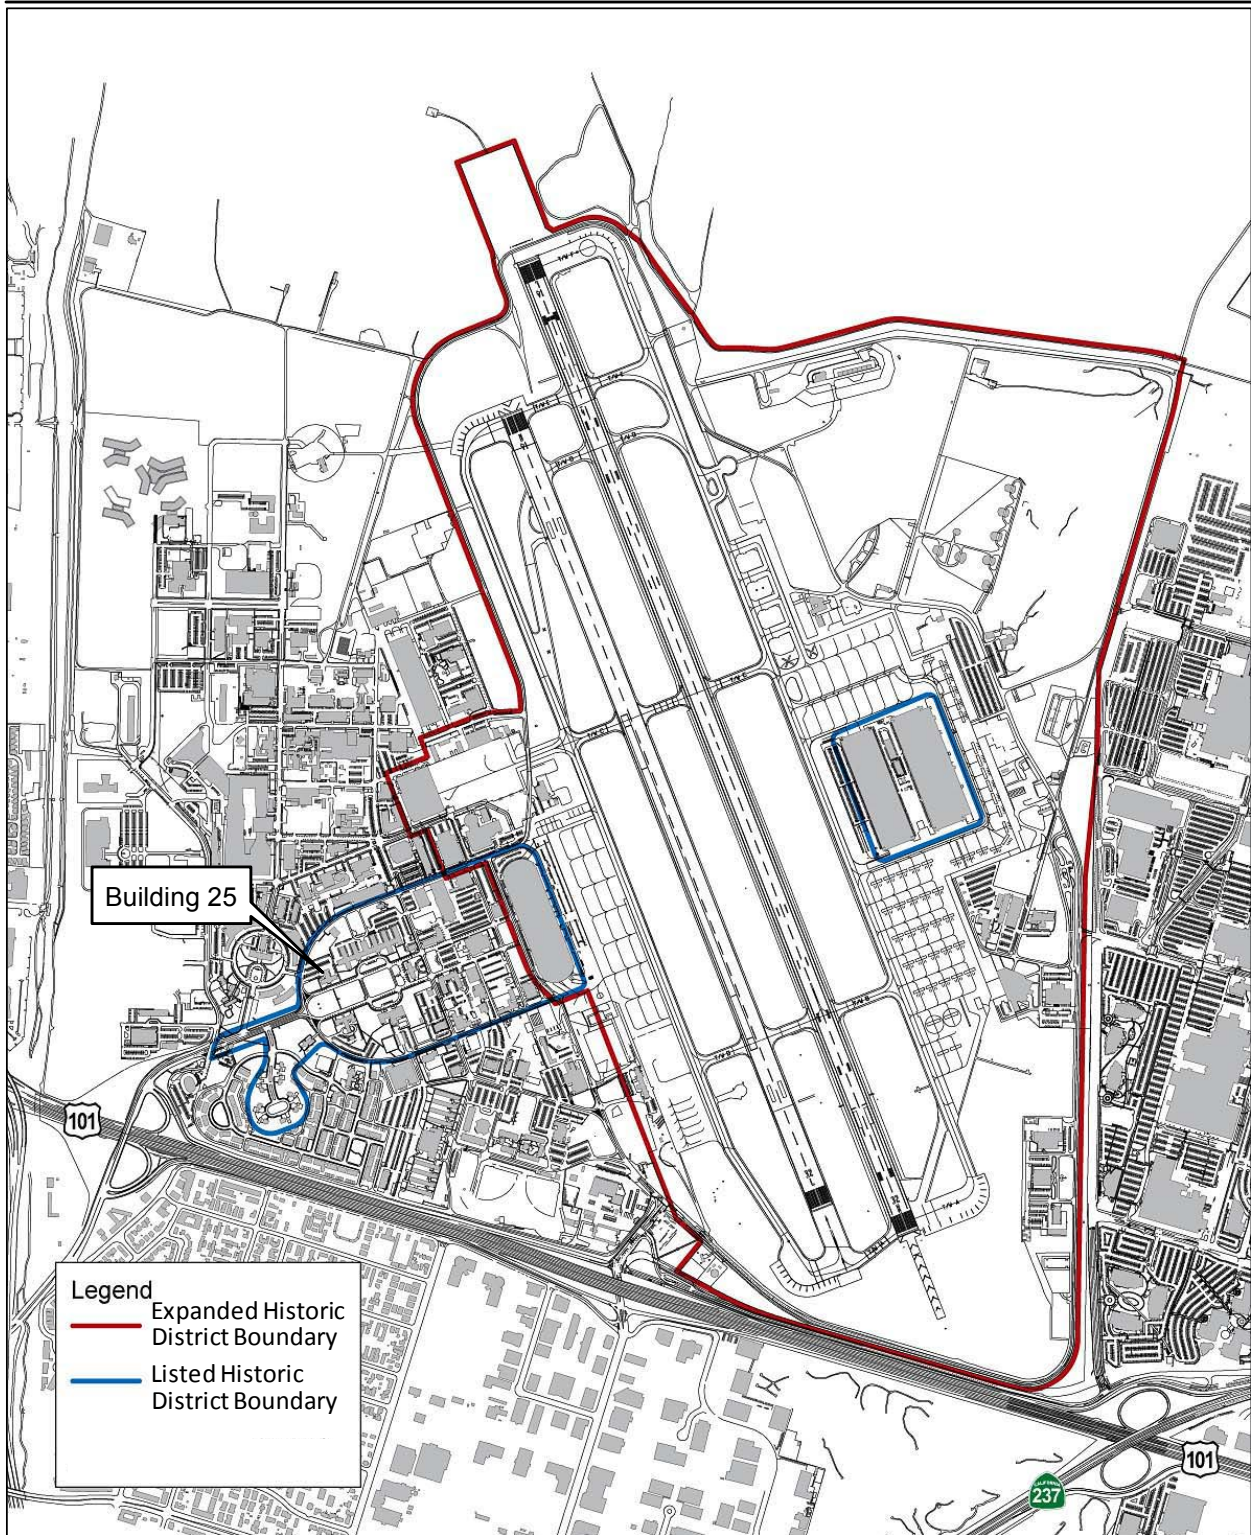
**Figure 3**  
**NAS Sunnyvale Historic District**

Source: Data compiled by AECOM in 2013

In 2013, AECOM conducted a study of Moffett Field and areas outside of the historic district to determine the eligibility of airfield resources (AECOM 2013). As a result of that study, NASA determined that the airfield was eligible as an extension of the NAS Sunnyvale Historic District, and expanded the boundary of the historic district (see Figure 3). SHPO concurred with this district expansion in June 2013.
