Prepared for:
NASA Ames Research Center
Moffett Federal Airfield, CA

Prepared by:
AECOM
Orange, CA
October 1, 2012

Pavement Evaluation Report For NASA Ames Research Center

Final Report

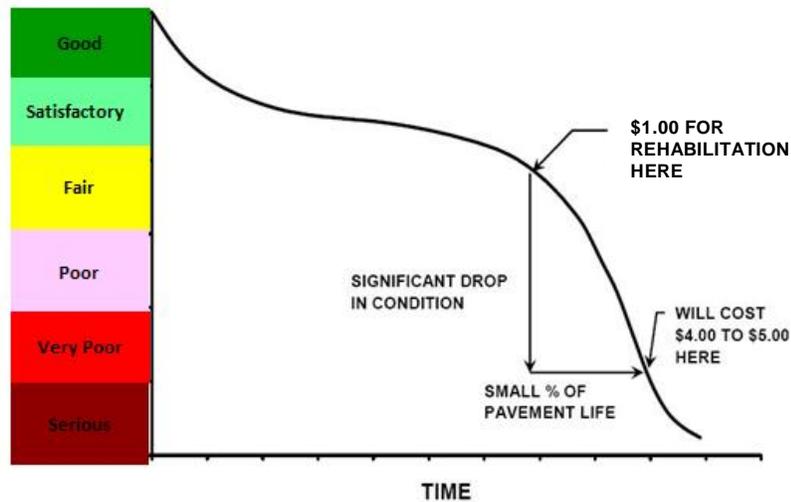
Figure ES-1 Pavement Life Cycle

(Source: FAA Advisory Circular 150/5380-7A 'Airport Pavement Management Program').

Generally pavements should be rehabilitated in the PCI range of 60 to 70. This means pavement is repaired before it requires reconstruction and when it is most cost-effective, as shown in Figure ES-1.

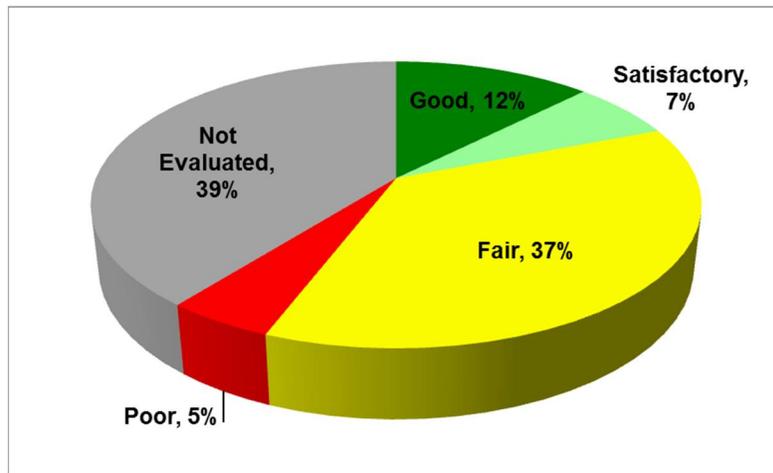
Figure ES-2 Overall Condition Summary

The overall current 2012 area-weighted PCI values of the inspected area, or approximately 61% of the total area, are shown in Figure ES-2 and Figure ES-3. The 2012 average values correspond to UFC ratings of “Fair” for runways and aprons, and “Satisfactory” for taxiways. As can be seen in Figure ES-2, the majority of the inspected pavement at Moffett is in the “Fair” category which corresponds to the appropriate timing for cost-effective repairs as shown in Figure ES-1.

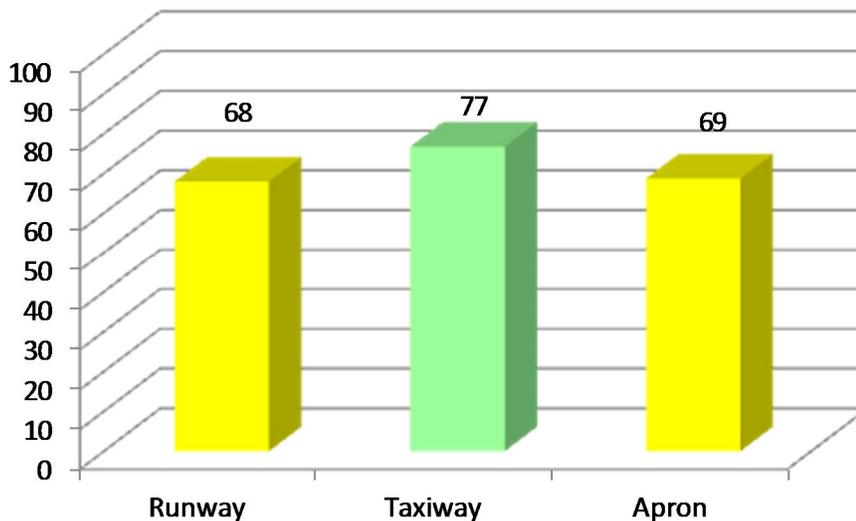
Figure ES-3 Condition Summary by Branch Type for Inspected Areas

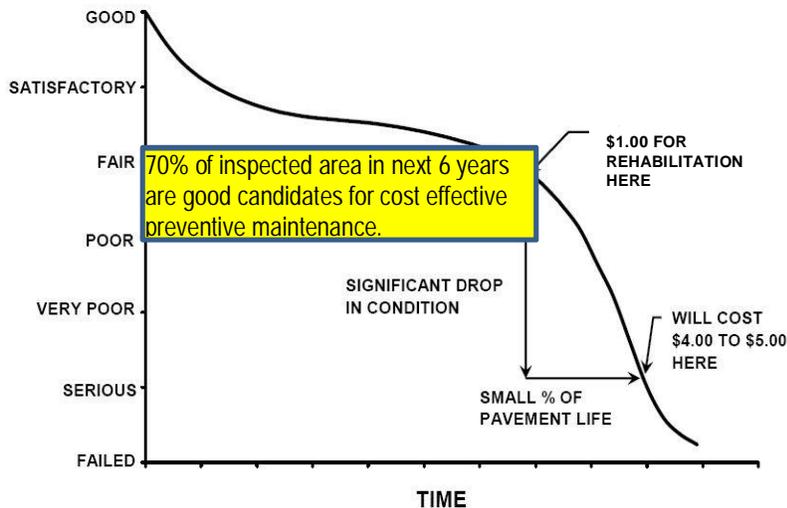
Figure ES-4 Projected Condition of Airfield Relative to Pavement Life-Cycle

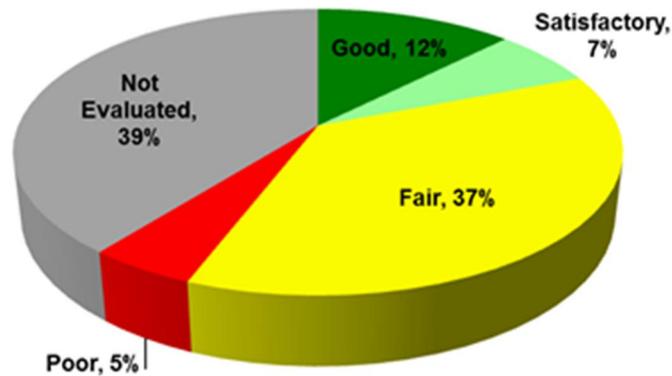
Overall, the 2012 average values correspond to ASTM ratings of “Fair” for runways and aprons, and “Satisfactory” for taxiways. Figure 4-1 provides a summary of the distribution of condition at Moffett Federal Airfield.

Figure 4-1 Condition Summary

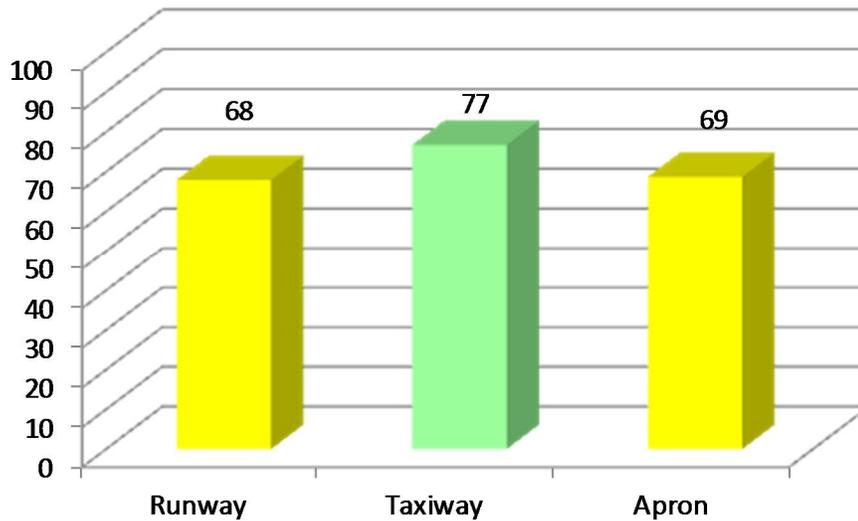
Figure 4-2 provides the area-weighted average pavement condition by branch use for the pavement sections surveyed.

Figure 4-2 Area-Weighted Average Condition by Branch Use

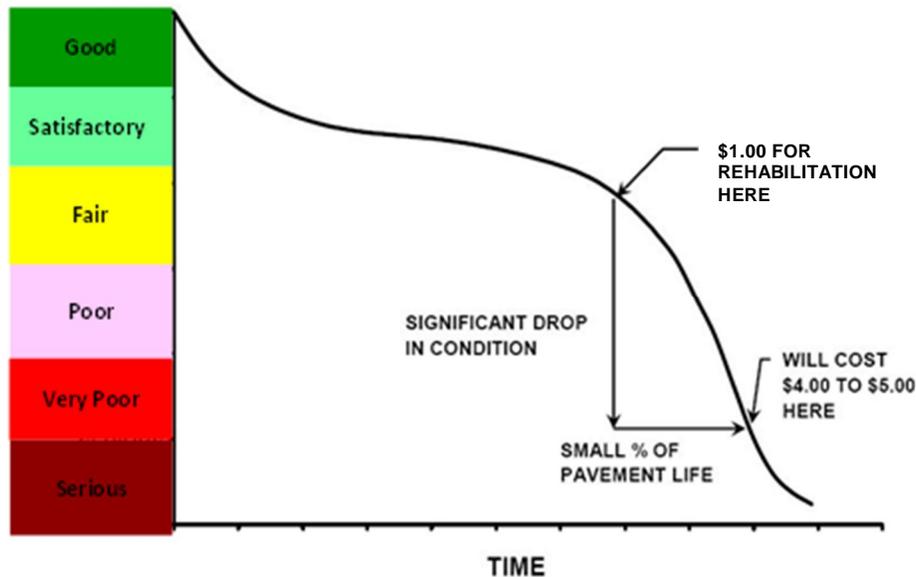
Figure 5-1 Pavement Life Cycle and PCI

A Pavement Condition Index (PCI) survey was completed in FY'08 and the results showed several areas on the airfield that were in 'Fair' or 'Poor' condition, which translates to PCI values less than 70. Generally pavements are rehabilitated once their PCI value is below 60 or 70, depending on the type and use of the pavement. PCI life cycle trends are shown in Figure 5-1 below. As can be seen, the worse the condition of the pavement, the more expensive the rehabilitation treatment will be. For example, preventive maintenance is generally applied to pavement in the 'Satisfactory' or 'Good' condition category; major rehabilitation such as resurfacing and slab replacements are done when pavement is in 'Fair' condition; and once pavements are 'Poor' or worse, they generally require reconstruction. In the absence of reconstruction or preventive maintenance being completed which is often the case due to limited budgets, stop-gap repairs can be completed to help provide for safe operations of aircraft along the pavement until such time as reconstruction can be completed. It is important to appreciate the difference between preventive maintenance and stop-gap repairs. Preventive maintenance is applied to pavements in fair to good condition to help improve their condition and increase the life cycle of the pavement. Stop-gap treatments, conversely, are intended to hold the pavement in a safe condition until such time as reconstruction can be completed. Stop-gap treatments intend to address the bare minimum in repairs because any funding spent on these repairs provides no long term benefits aside from safety.
