Re-Use Guidelines
Appendices

Hangar 3 (Building No. 47)
NASA Ames Research Center
Moffett Field, California

August 30, 2006

EXECUTIVE SUMMARY OF BUILDING 46

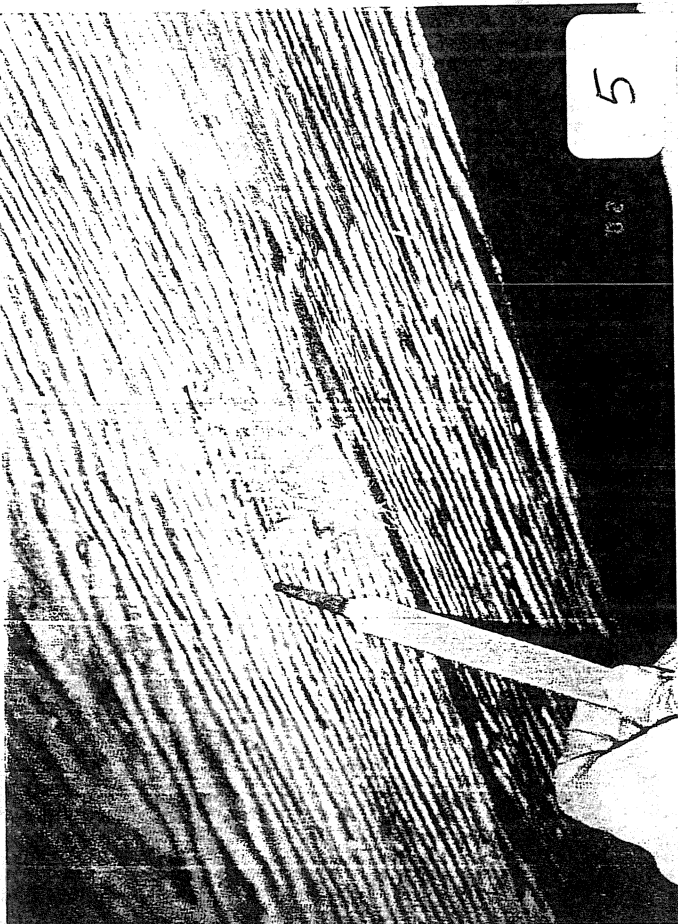
5. Hangar 2. Scraping the surface of the structural elements revealed the presence of degradation resulting in loose fibers on the surface of these elements.
6. Hangar 3. A white crystalline deposit was noted on the surface of many of the structural elements in this hangar.
